**AGENDA of the  
Portfolio Committee : Investment & Infrastructure  
2 August 2023  
(Also the agenda for the Mayoral Committee Meeting : 16 August 2023)**

**2.  
OVERSTRAND MUNICIPALITY: NERSA FINDINGS FROM THE COMPLIANCE  
AUDITS CONDUCTED**

**SU Muller  
4 July 2023**

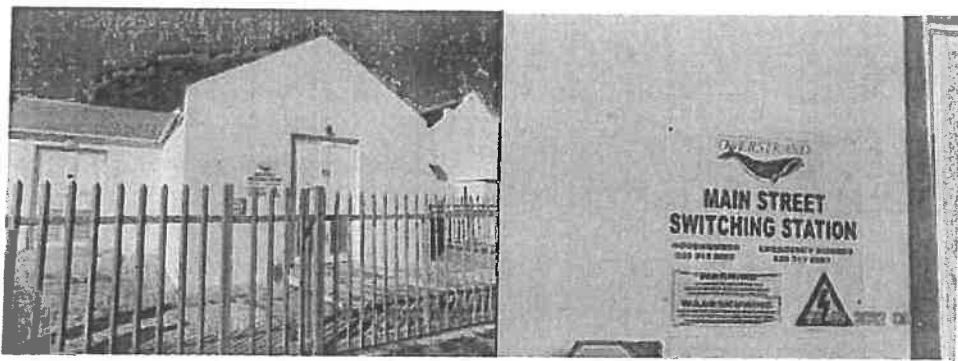
Substation fenced with Lockable door and with visible warning signs.

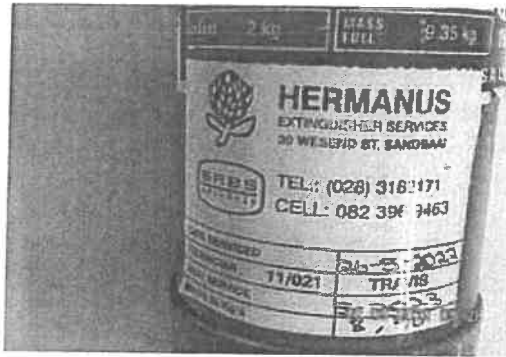
Fire extinguisher's serviced

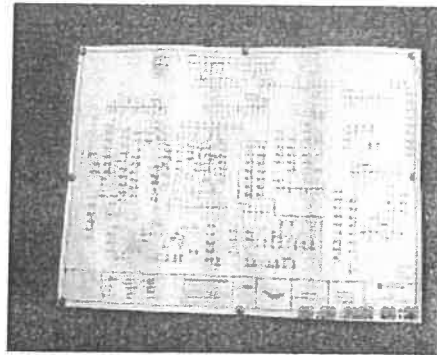
SLD mounted on the wall.

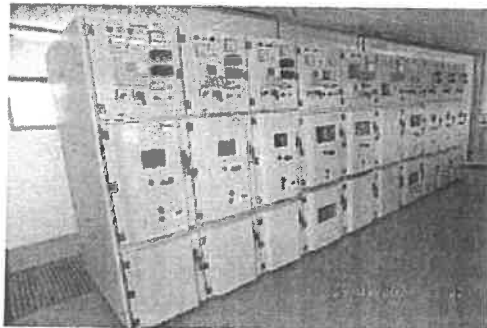
11 kV panels in good condition and status indicators.

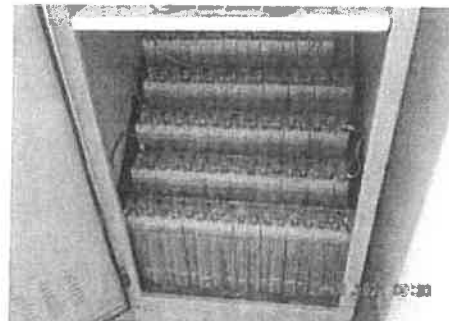
Batteries well maintained and the battery in working condition.

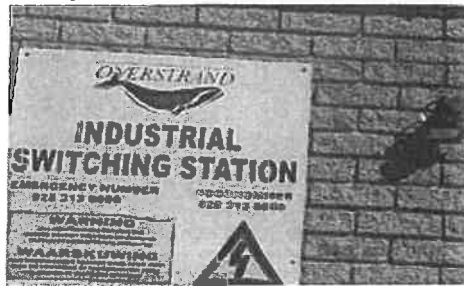
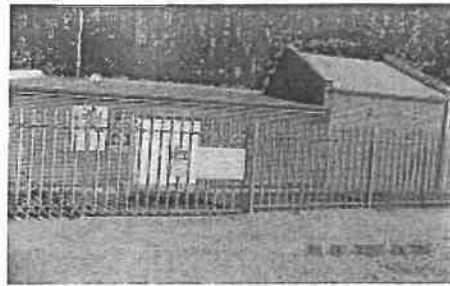
Unauthorised entry controlled by means of a fence, lockable gate and doors.

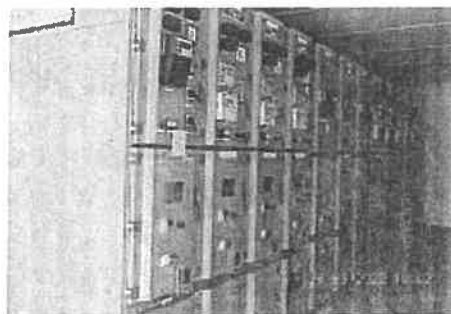
11 KV Panels in good condition.

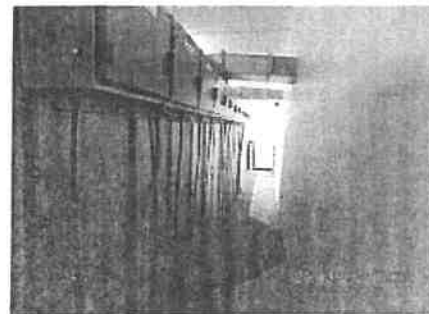
Cable Trenches covered at all areas

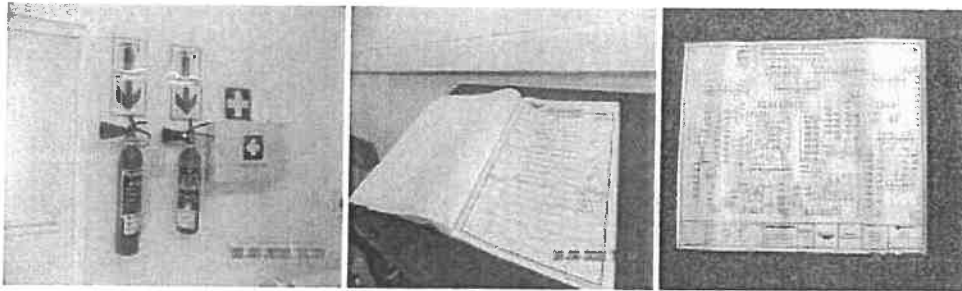
**Fire extinguisher serviced, Logbook available and Single line diagram mounted on the wall.**

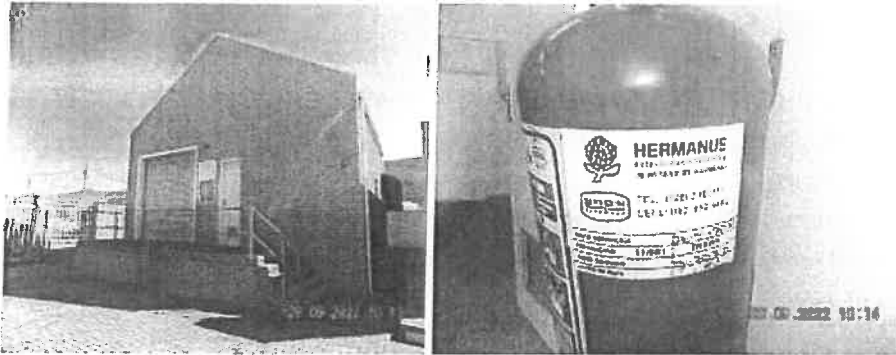
Unauthorised entry controlled by means of a fence, lockable gate and doors. Fire extinguisher service serviced in May 2022.

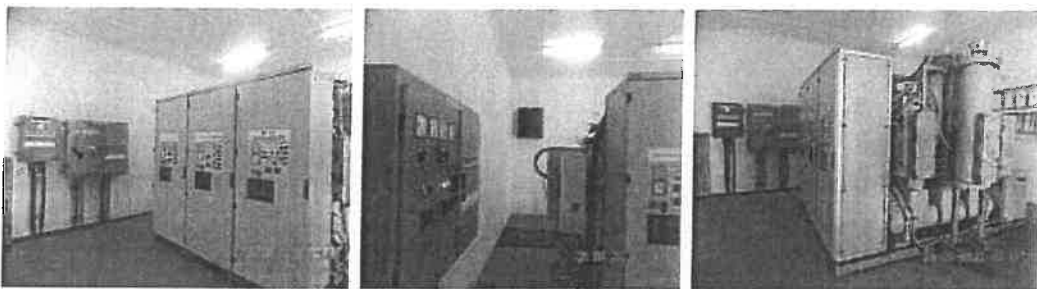
Instrumentation and 66 KV Bus coupler operational and batteries maintained.

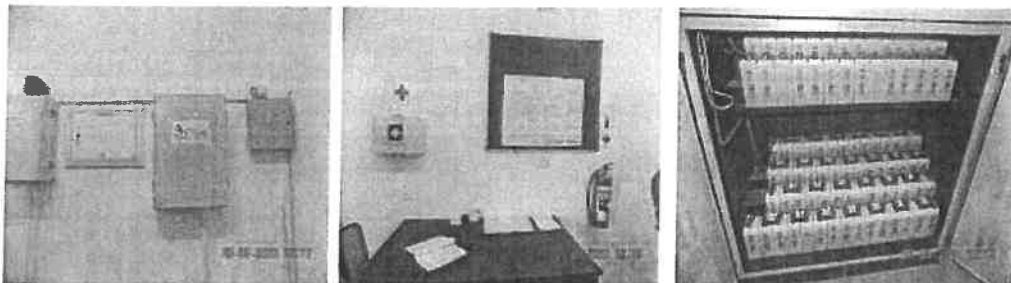
Power Quality Instrumentation installed, single line diagram available and Battery electrolyte below at maximum level.

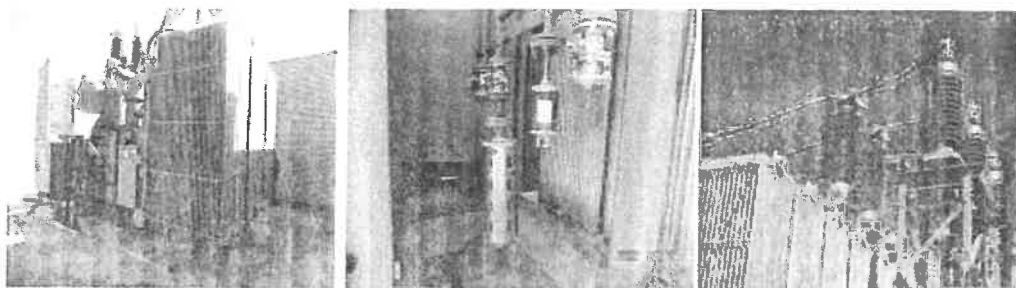
20MVA ABB Transformer manufactured in 2013 was out of service at the time of the Audit.

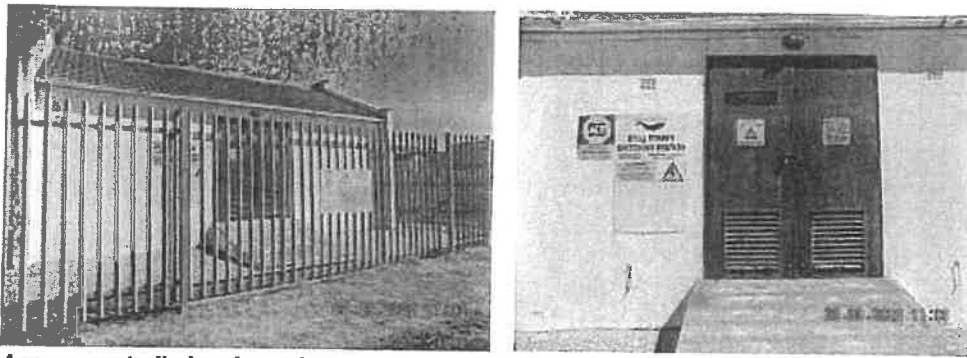
Access controlled and warning as well as safety signs were available.

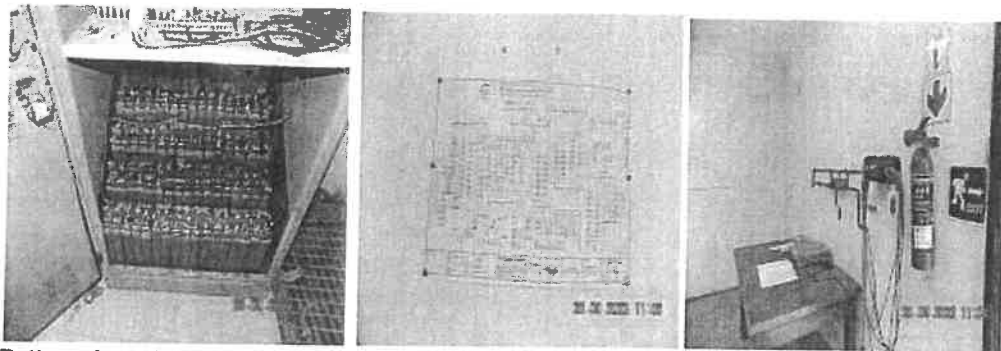
Battery electrolyte below at maximum level. SLD available and substation logbook available.

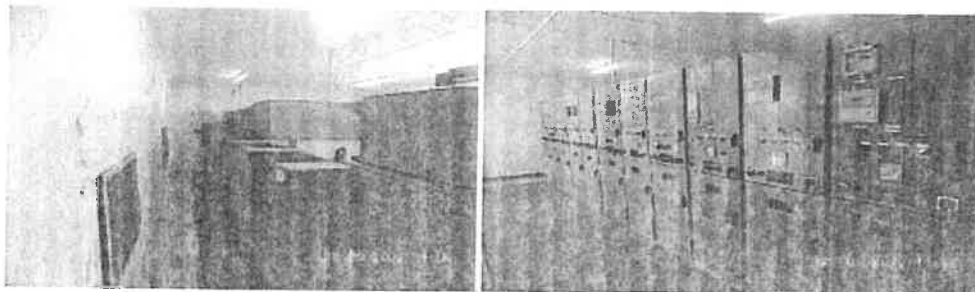
Cable trenches closed.

Switchgear labeled.

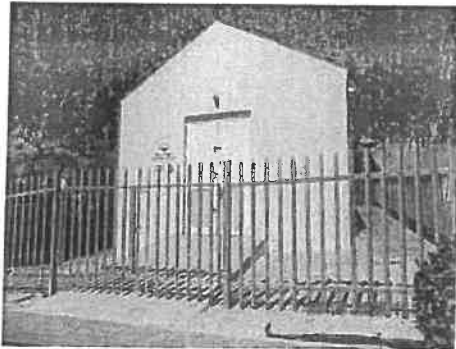
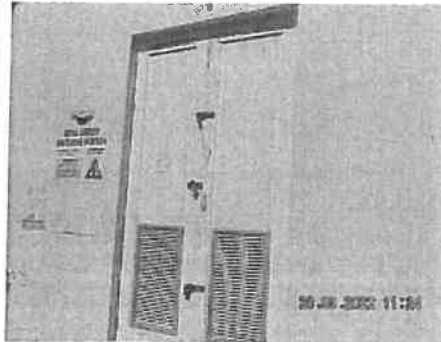
Access controlled and warning sign available.

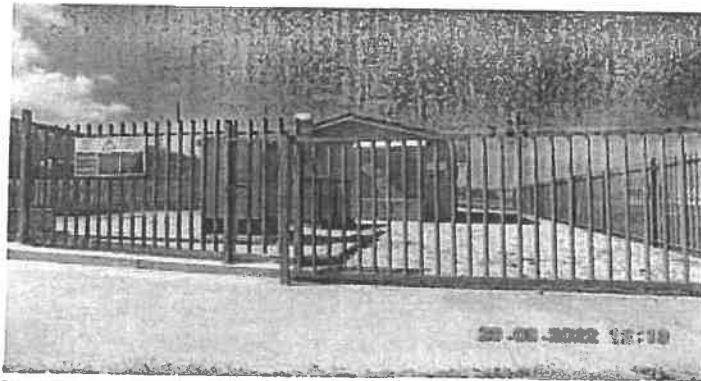
Access controlled and warning as well as safety signs were available.

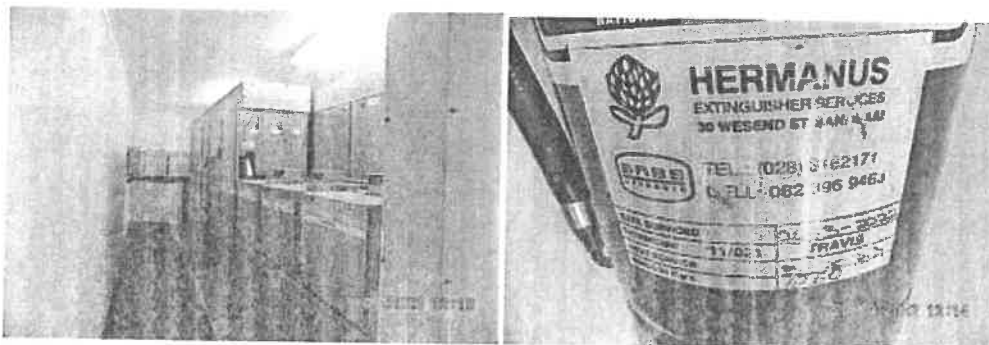
Cable Trenches were covered.

Fire extinguisher was serviced March 2022.

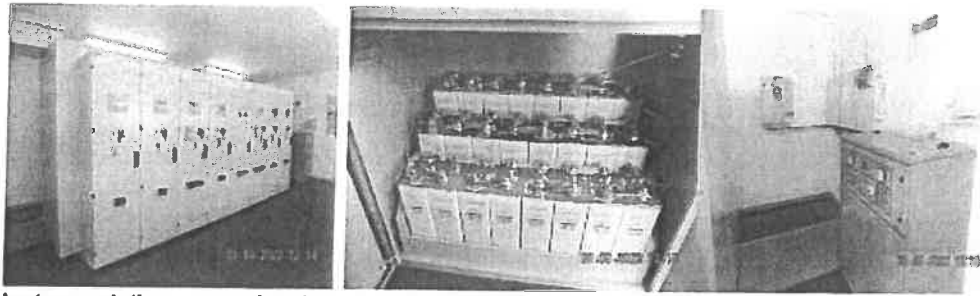
**Instrumentation operational and batteries maintained and cable trenches closed at all designated areas.**

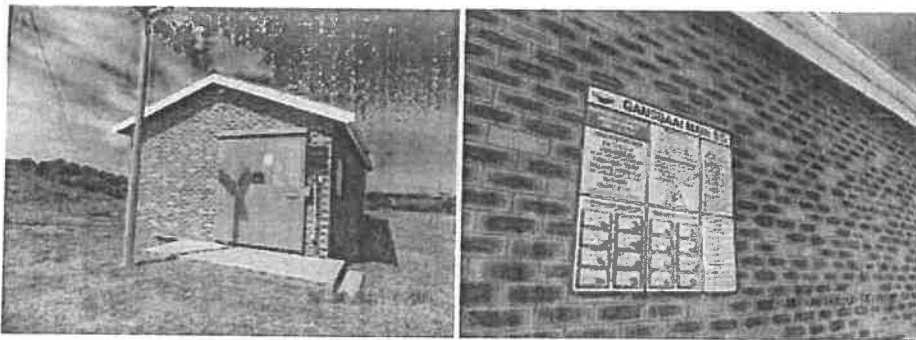
**Unauthorised entry controlled by means lockable gate and doors**

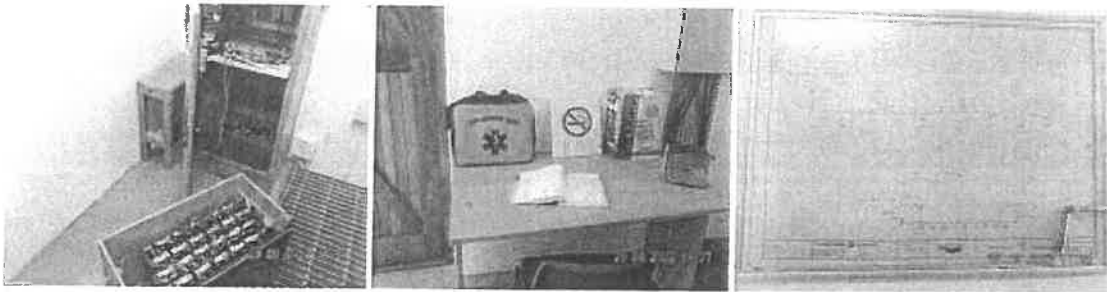
batteries maintained, logbook available and single line available and mounted on the wall.

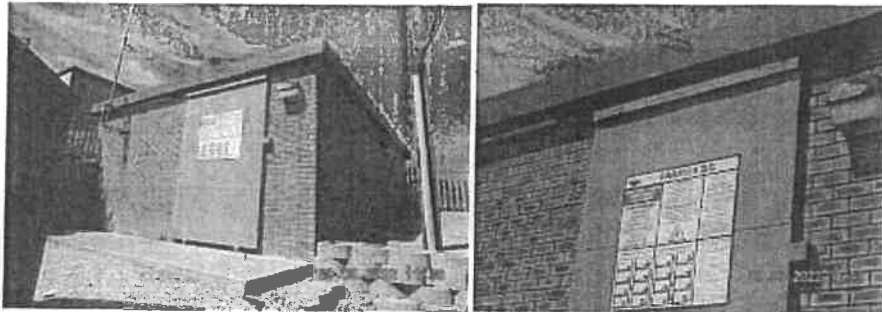
Unauthorised entry controlled by means lockable gate and doors

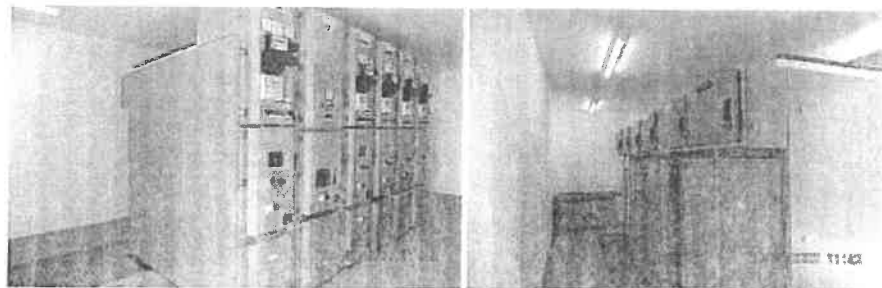
Switchgear panels in good condition, status indicator operational and Cable trenches covered.

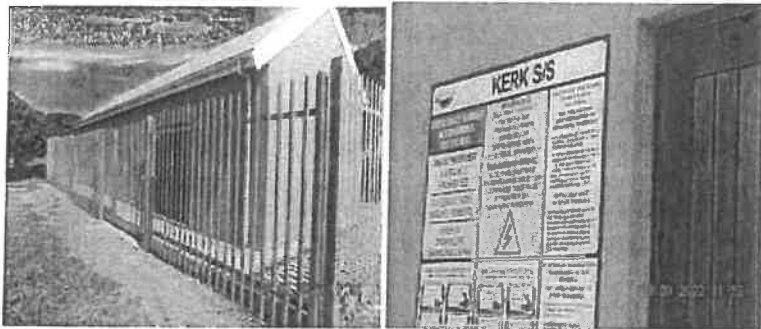
Unauthorised entry controlled by means lockable gate and doors

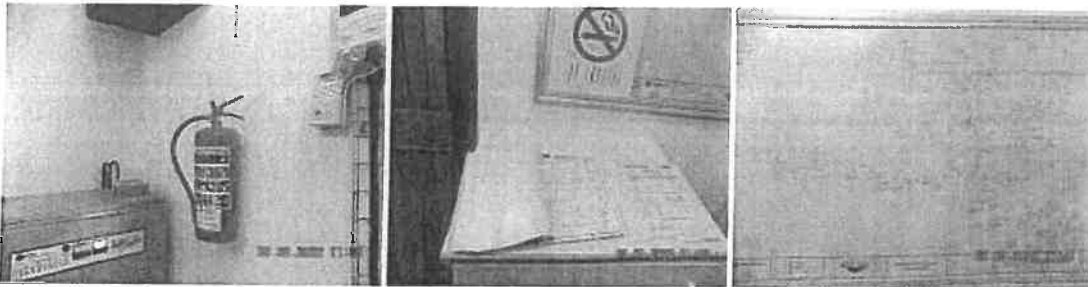
Fire extinguisher serviced, logbook available and single line available and mounted on the wall

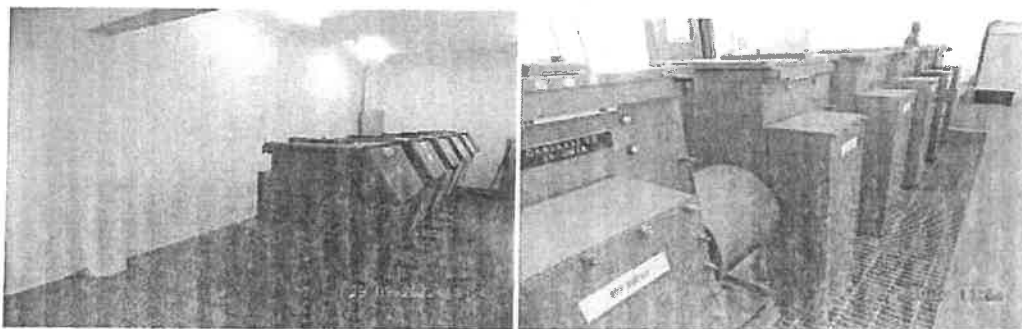
Switch gear operational and in good condition

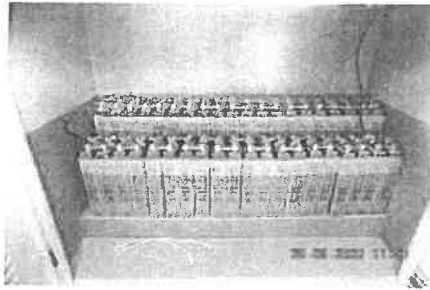
Batteries well maintained.

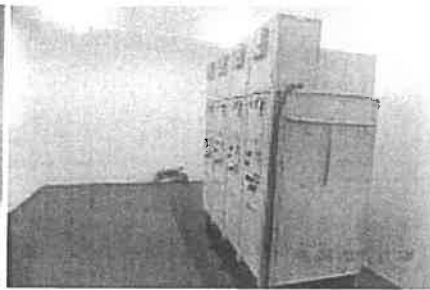
Switchgear panels in good condition

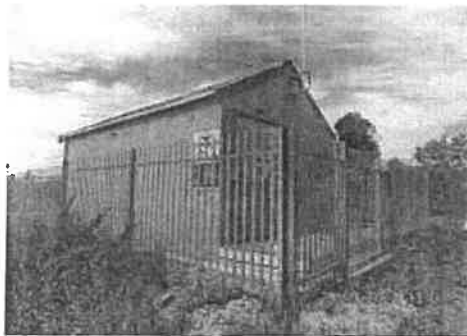
Unauthorised entry controlled by means lockable gate and doors

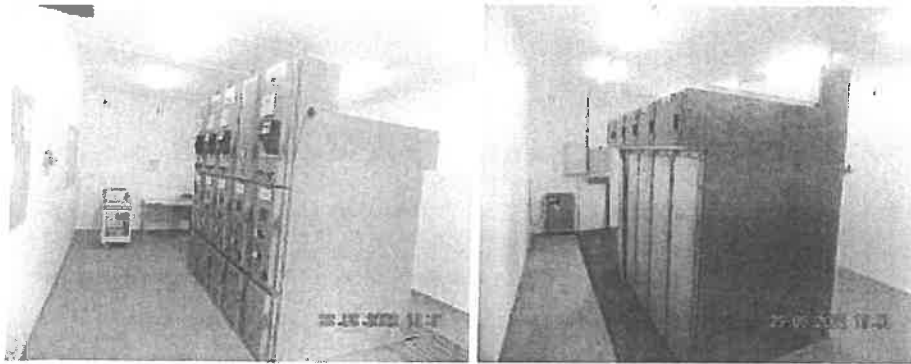
Switchgear panels in good condition, status indicator operational and Cable trenches covered.

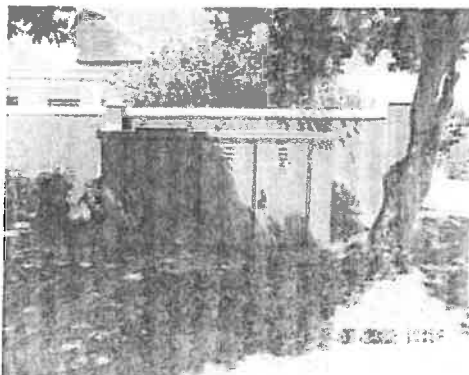
Mini-substation well secured.

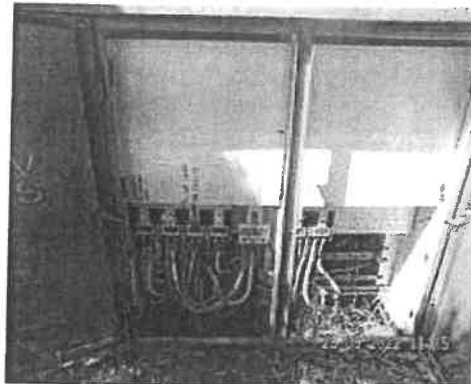
**LV and MV panels were clearly labelled.**

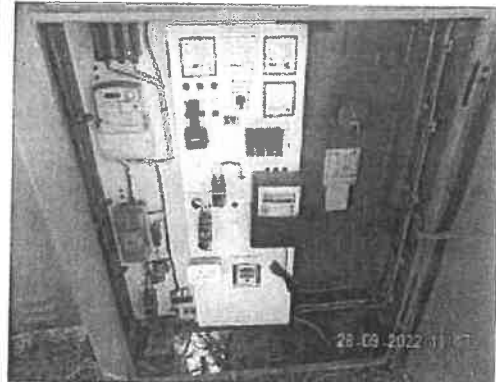
**The status indicators were operational.**

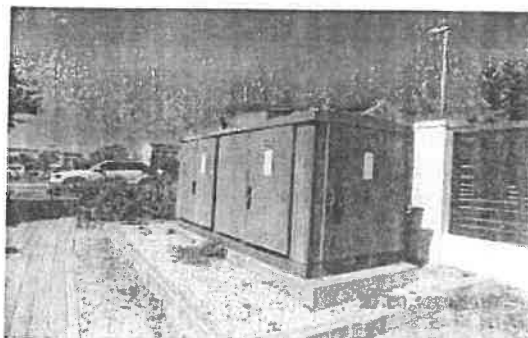
**Mini-substation well secured on a proper plinth.**

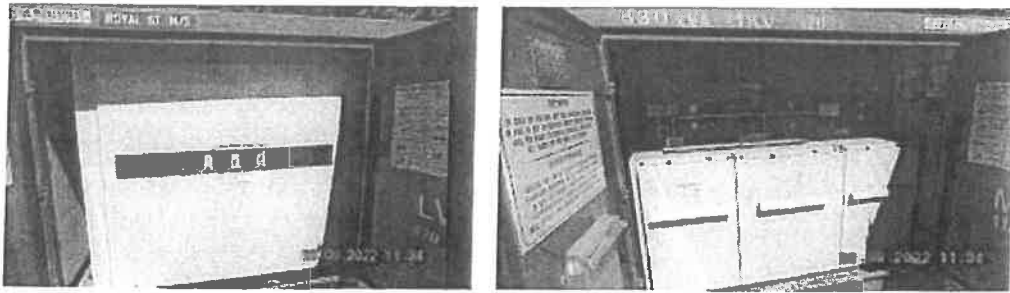
MV and LV compartments were in good condition.

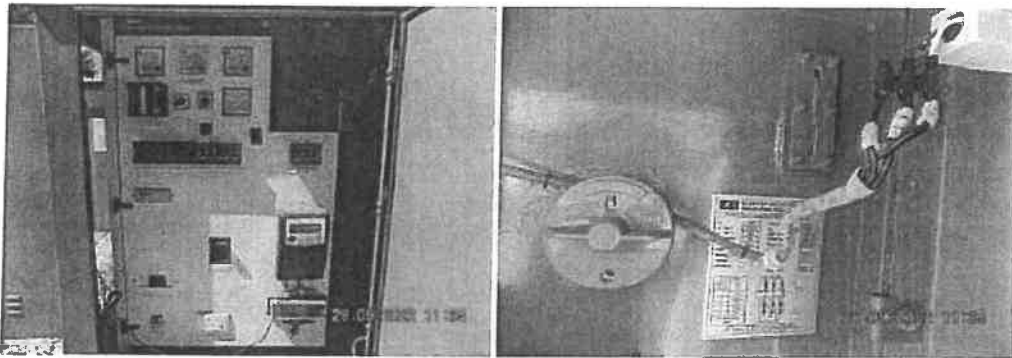
The status indicators were operational.

Acceptable oil level.

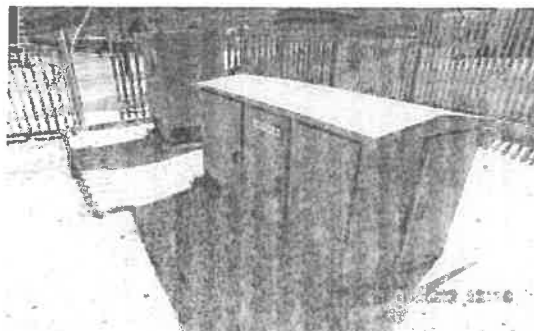
Enclosure was not mounted on a proper plinth.

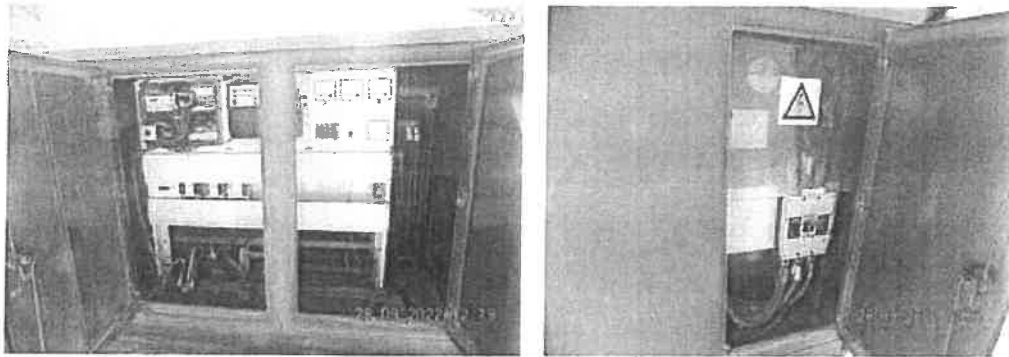
**MV and LV compartments were in good condition.**

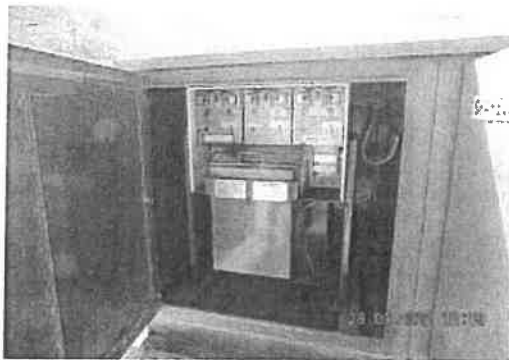
**RMU labelled**

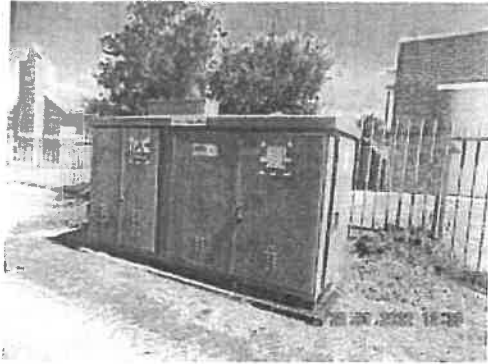
Enclosure was not mounted on a proper plinth.

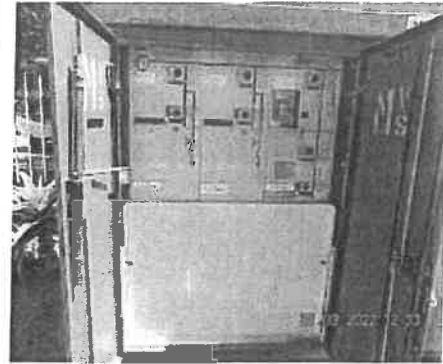
RMU clearly labelled.

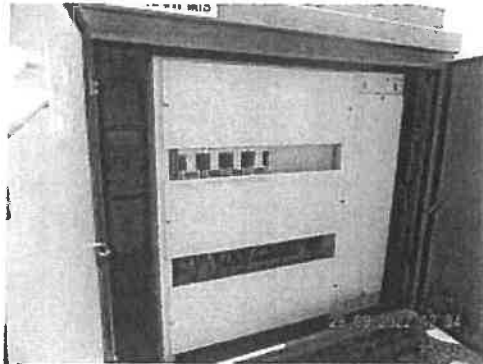
MV and LV compartments were in good condition.

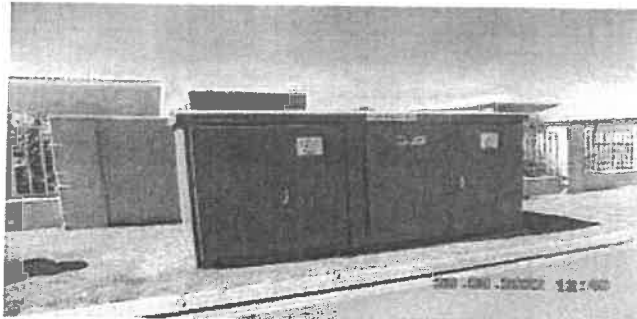
Enclosure was not mounted on a proper plinth

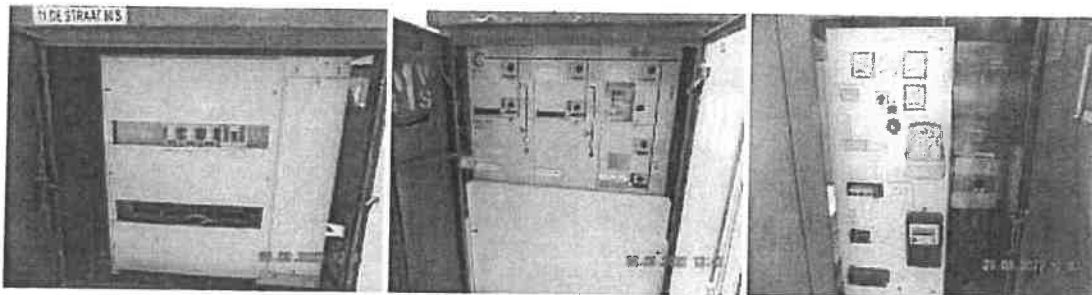
MV and LV compartments were in good condition.

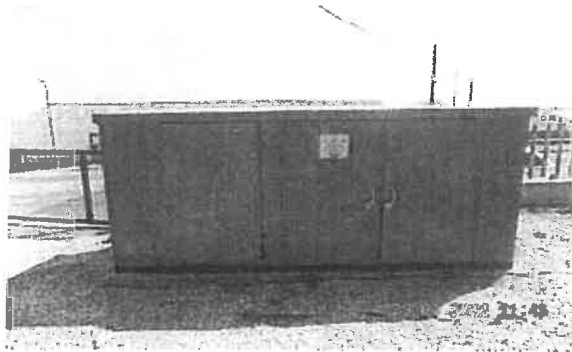
Enclosure secured on plinth.

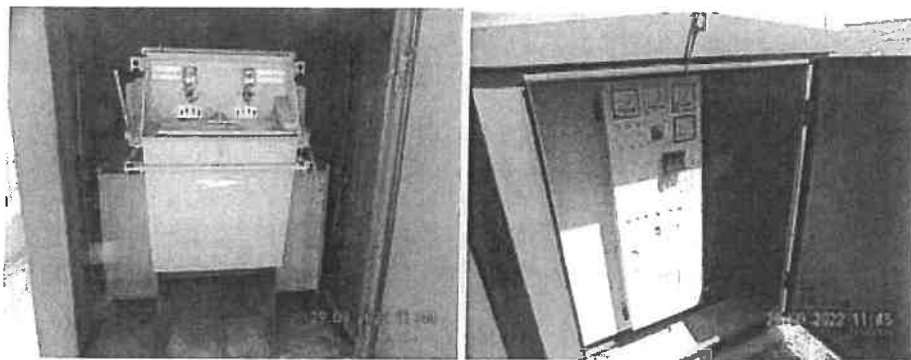
Switchgear in good condition and MV and LV compartments were in good condition.

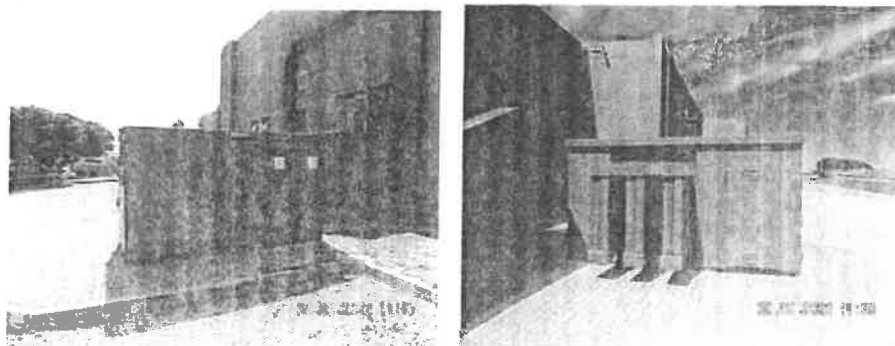
Enclosure secured on plinth.

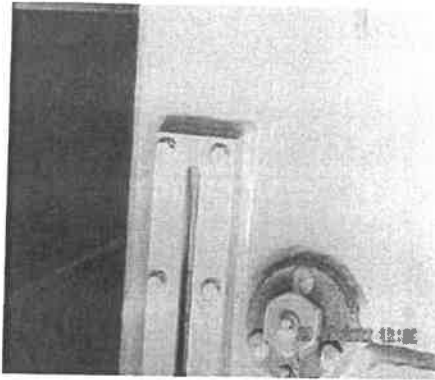
Acceptable oil level.

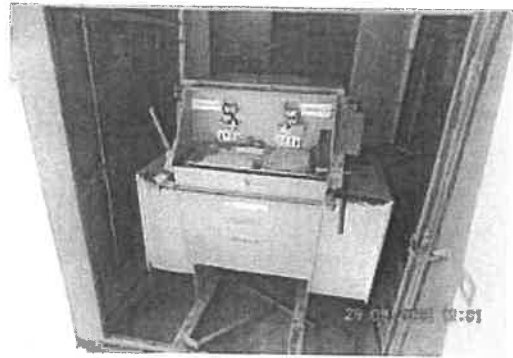
Switchgear in good condition.

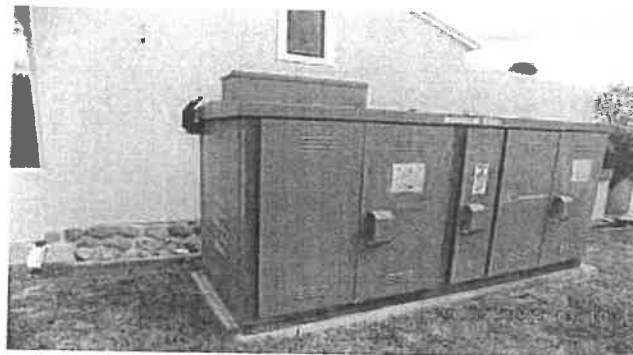
Enclosure secured on plinth.

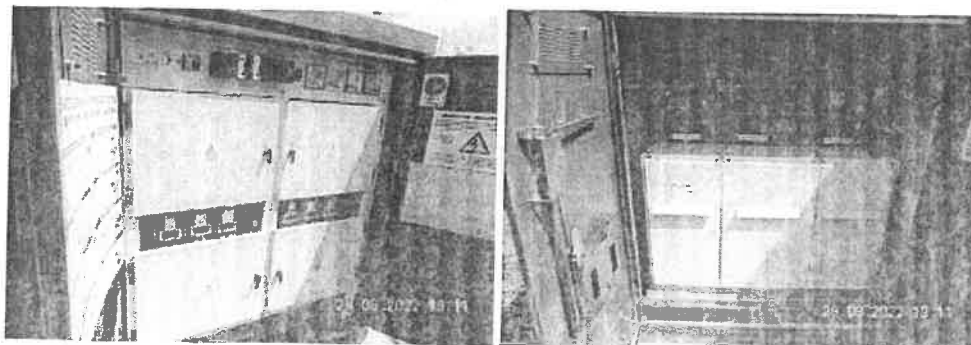
Switchgear in good condition and MV and LV compartments were in good condition

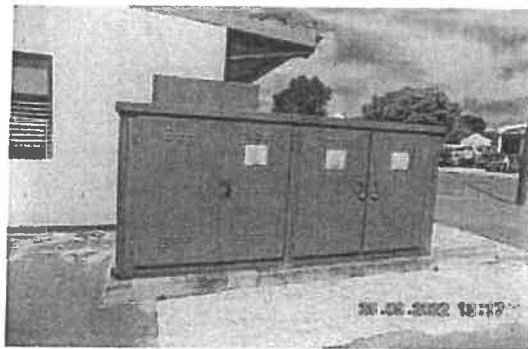
**Enclosure secured on plinth.**

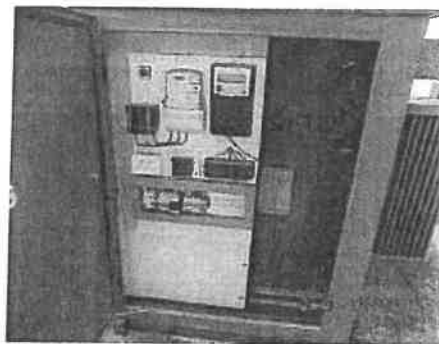
**Metering instrumentation functioning.**

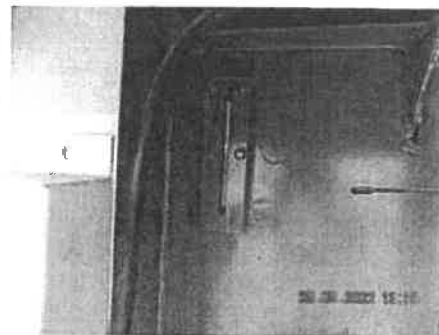
**Oil Level on acceptable level.**

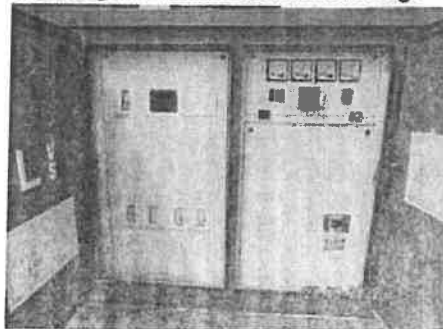
**Switchgear in good condition and MV and LV compartments were in good condition**

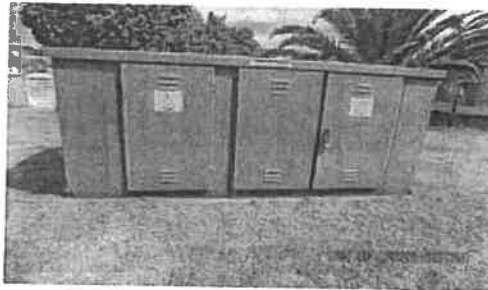
Enclosure secured on plinth.

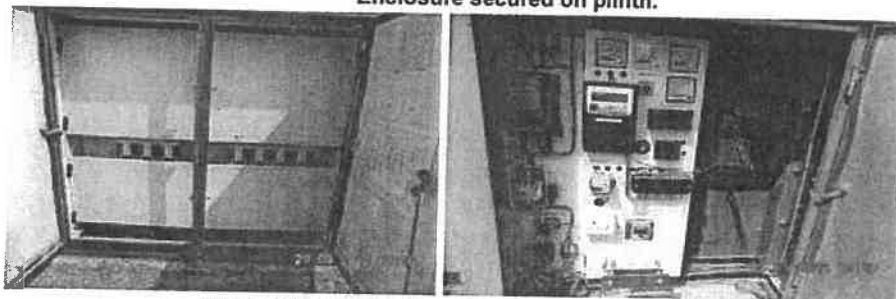
MV and LV compartments were in good condition

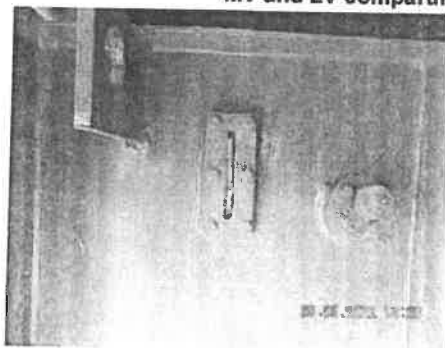
Oil Level on acceptable level.

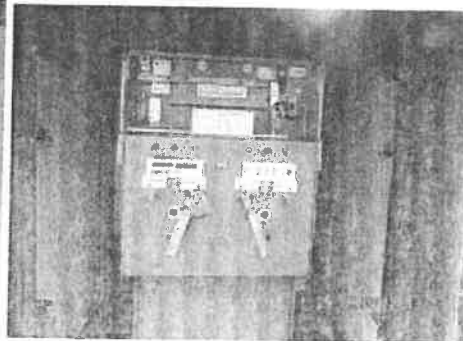
Switchgear in good condition.

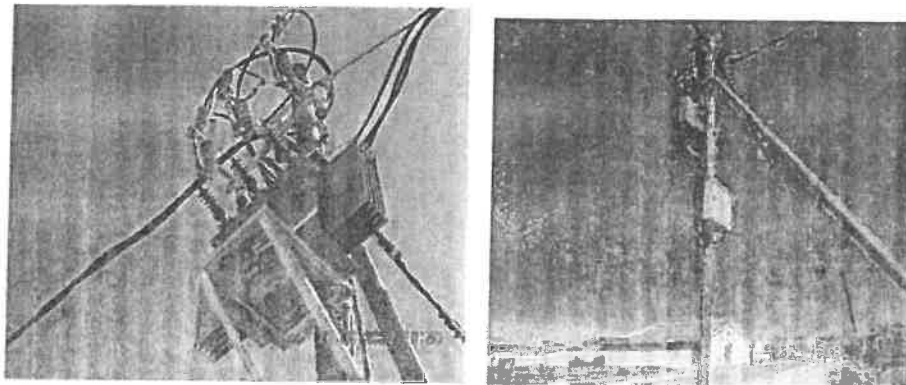
The Electro Inductive transformer and the wooden pole structure in good condition.

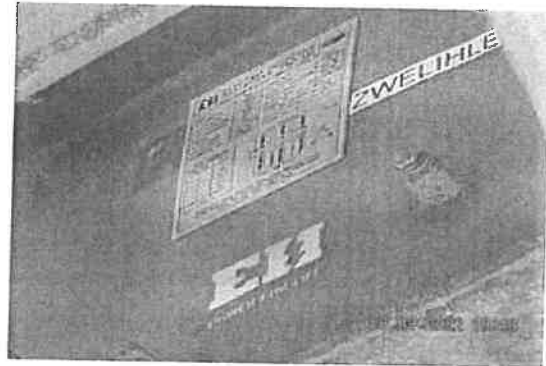
50KVA Electro Inductive transformer.

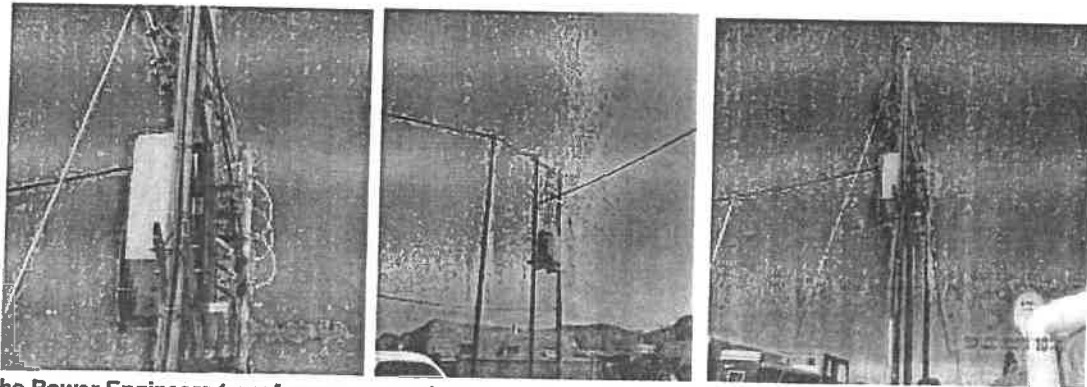
The Power Engineers transformer secured on a wooden pole structure and lines at acceptable heights.
