Public Participation document:

CALEDON FARMS

Overstrand Heritage Landscape Group:

Overstrand Municipality

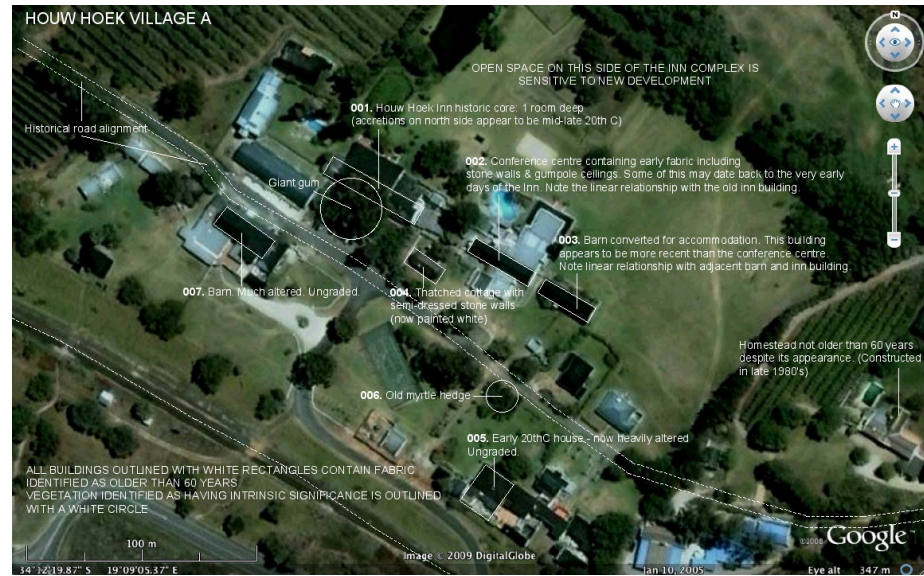
Site name: Houw Hoek Inn A001 **Type of resource:** Building
Location: 3419AC: 34 12' 18.30" S, 19 09' 03.64" E Google Earth 2009
Erf/Farm : / Caledon Farms
Address:

Double storey with single storey extensions. Hipped 'Harveytile' roof (corrugated sheets presumably underneath). Varnished timber 'Harveytile'-hooded d/s sash windows: many on southwest (road) side being small-paned, with some being suspect 20th C replacements. Most fenestration on this side probably dates from 1860, nonetheless. 19th C beamed and boarded first floor/ground floor ceiling. Lawned, treed setting on northeast side sloping down to river. Landmark gum tree at front entrance is said to be one of the largest in the Western Cape.

Original use: Hotel
Current use: Double and single storey linear building
Landscape type: Continuing
Design/Style: English Georgian features
Construction date: Late 18th century
Historical period in which constructed: Dutch
Theme: Transport network
Outspan

Apparently built in 1779 on the site of an earlier toll gate: originally as a thatch roofed single storey structure approximately half of its present length. First floor added in 1860. Said to be the oldest inn and licensed hotel in the country. Forms the core of an early linear rural development.

Significance: Architectural: as an early, albeit extensively altered example of its period.

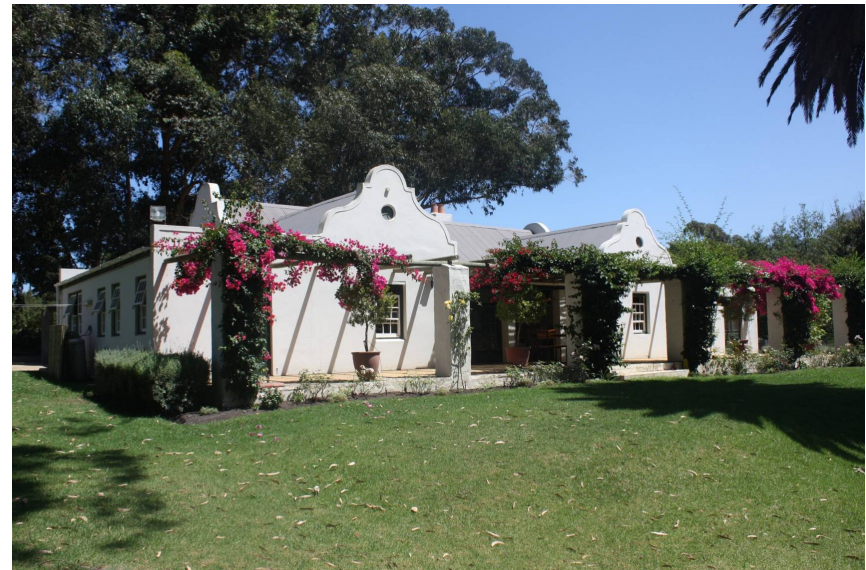
Significance: Ability to demonstrate the role of the Valley as a place of agricultural production and settlement dating to the mid 19th century.
The best example of historical vernacular farmhouse in the Valley in terms of its surviving 19th century fabric early 20th layering and associated period features.
Quality of its treed and riverine setting.

Constraints and Opportunities: Adaptive reuse potential

Ongoing repair and maintenance

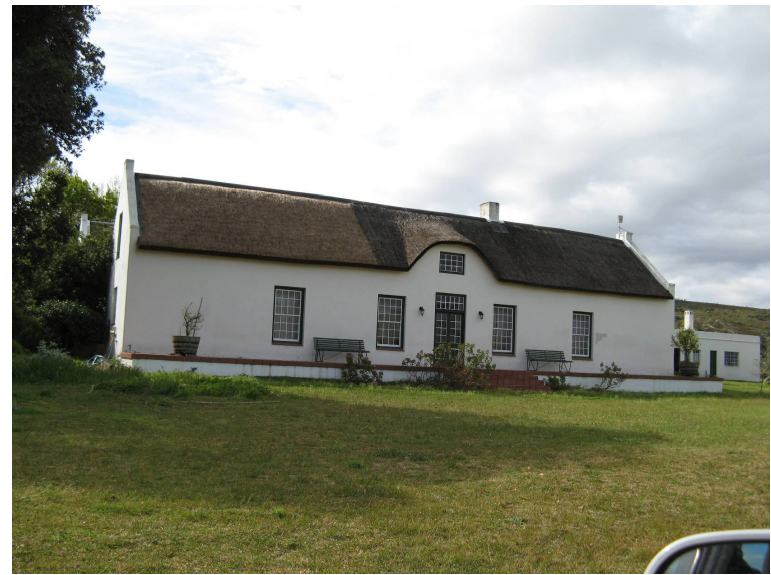
Constraints and Opportunities: Gdv 5: Roof needs replcing
Deterioration of associated bywoners/labourers cottages

Ongoing repair and maintenance

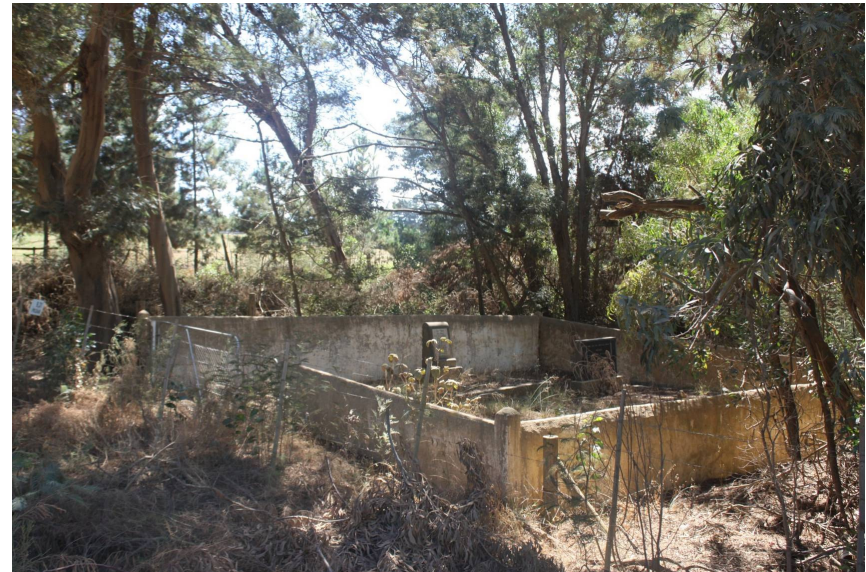
Constraints and Opportunities: In need of repair and maintenance

Ongoing repair and maintenance

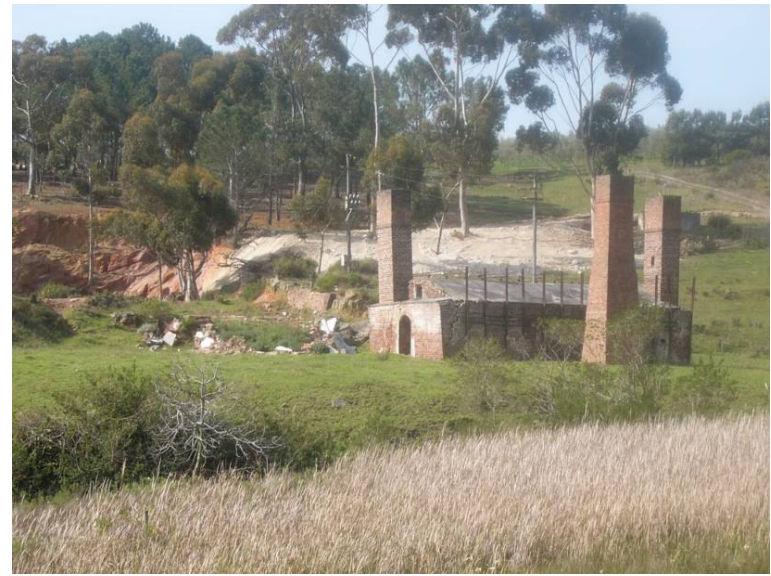
Unplastered red brick structure with 3 chimney stacks. Associated stream/water furrow. Associated dwellings subject to further investigation. Structures in this location shown on 1944 and 1962 topocadastral.
Materials: Brick
Associated landscape features: Associated stream/furrow.

Original use: Industrial
Current use: Brick kiln
Landscape type: Industrial relic
Design/Style:
Construction date: Early 20th century
Historical period in which constructed: Union
Theme: Industrial architecture

Ongoing repair and maintenance

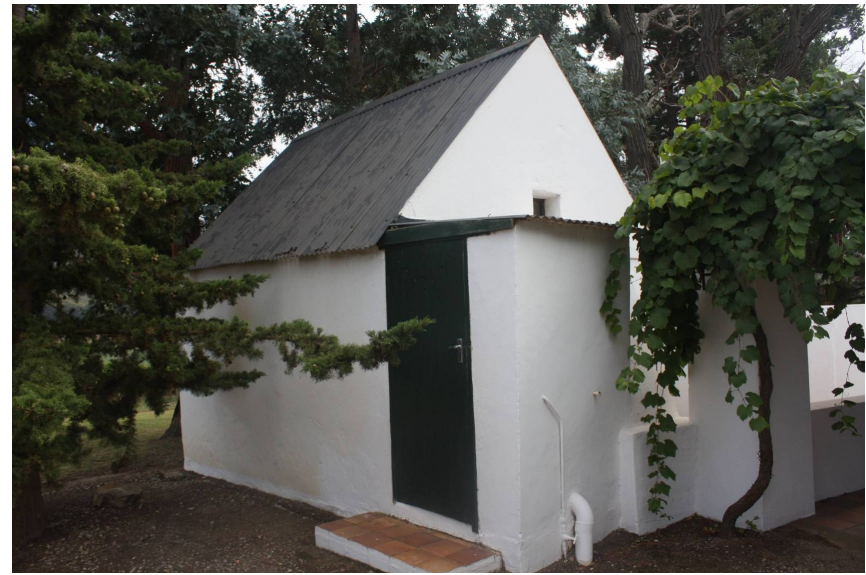
House built by Ella Gordon when she owned Braemer farm from 1900-1907. She sold the farm in 1907 and moved to Karwyderskraal. A very small rectangular cottage with supports at one end. Pitched corrugated iron roof. Low entrance and projecting chimney. Materials: Brick; Corrugated iron
Associated landscape features: Associated cluster of pine and 2 massive gum trees.

Original use: Agricultural
Current use: Cottage
Landscape type: Continuing
Design/Style: Vernacular
Construction date: 1902-1907
Historical period in which constructed: Union
Theme: Local personalities
Vineyard/Orchard cultivation
Tourism

Ongoing repair and maintenance
Formal protection in terms of zoning scheme regulations (Grade 3B)

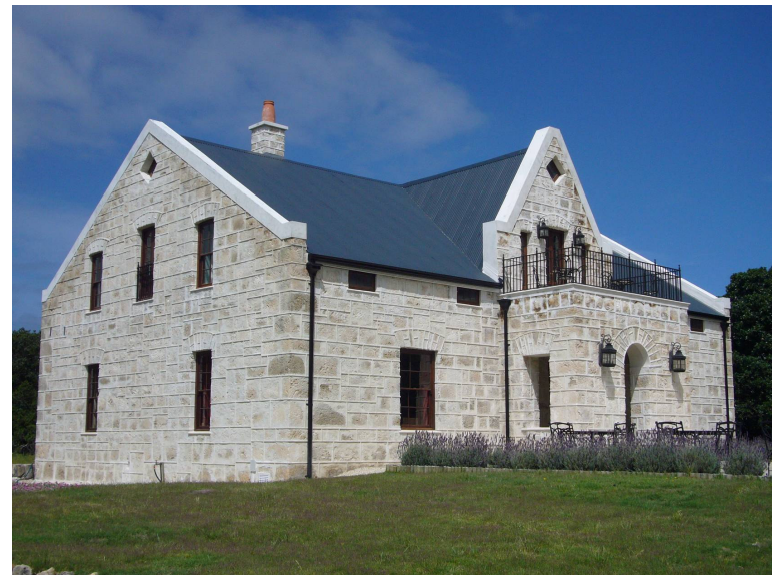
Single storey dressed stone structure with attic windows and corrugated iron roof.
Front gable with verandah added circa 1902.
Materials: Stone; Corrugated iron
Associated landscape features:

Original use: Agricultural
Current use: Building complex
Landscape type: Continuing
Design/Style: Eclectic
Construction date:
Historical period in which constructed: Union
Theme: Recreation
Tourism

Ongoing repair and maintenance

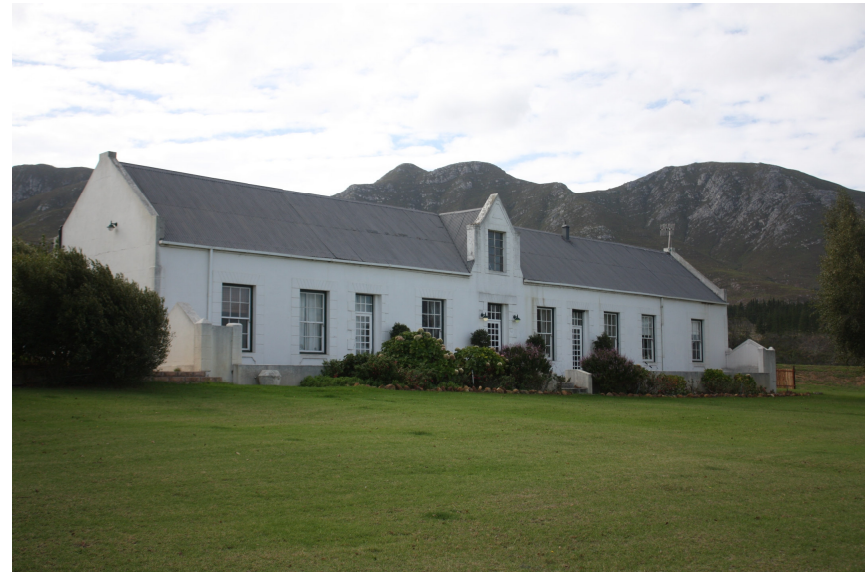
T-shaped 10 bay farmhouse with pitched corrugated iron roof. Triangular front gable and parapet gable ends. Raised stoep. 3.2 sashes and new door. Openings have plastered quoining.
Materials: Brick; corrugated iron
Associated landscape features: 3 outbuildings
Unplastered stone enclosures or kraals.

Original use: Agricultural
Current use: Werf
Landscape type: Continuing
Design/Style: Cape Vernacular
Construction date: Early to mid 19th century
Historical period in which constructed: British Colonial
Theme: Historic settlement pattern

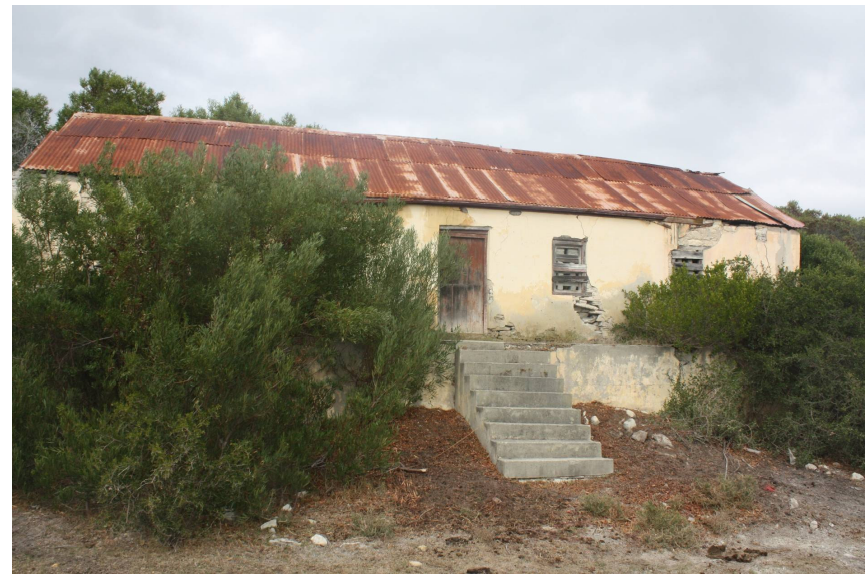
Original use: Agricultural
Current use: Cottage
Landscape type: Relic
Design/Style: Vernacular
Construction date: Late 19th century
Historical period in which constructed: British Colonial
Theme: Historic settlement pattern

Constraints and Opportunities: Condition poor, unoccupied.
Adaptive reuse potential

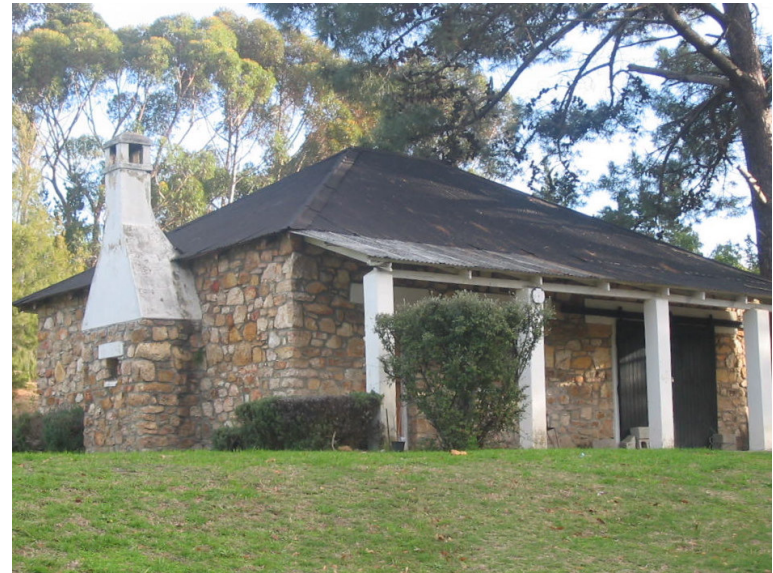
Hipped corrugated iron roofed stone cottage with external projecting kitchen hearth.
Varnished med-paned casement windows presumably stripped of their original paint.
Plain plaster colonnaded corr iron verandah on northeastern side facing the N2.
Materials: Stone; corrugated iron
Associated landscape features:

Original use: Agricultural
Current use: Verandah cottage
Landscape type: Continuing
Design/Style:
Construction date: Early 20th century
Historical period in which constructed: Union
Theme:

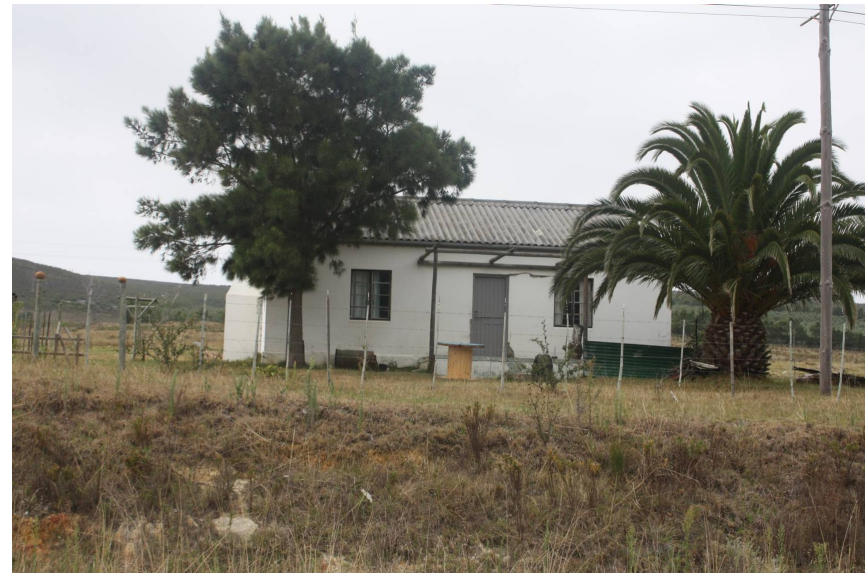
3 bay cottage with pitched asbestos iron roof. Steel framed windows. Stable front door. Projecting chimney. Associated pine and palm trees.
Materials: Brick; Corrugated asbestos
Associated landscape features: Associated pine and palm trees.

Original use: Agricultural
Current use: Cottage
Landscape type: Continuing
Design/Style: Vernacular
Construction date: Later 19th/early 20th century
Historical period in which constructed: British/Union
Theme: Historic settlement pattern
Vernacular architecture
Traditional tree plantings

Ongoing repair and maintenance
Formal protection in terms of zoning scheme regulations (Grade 3C)

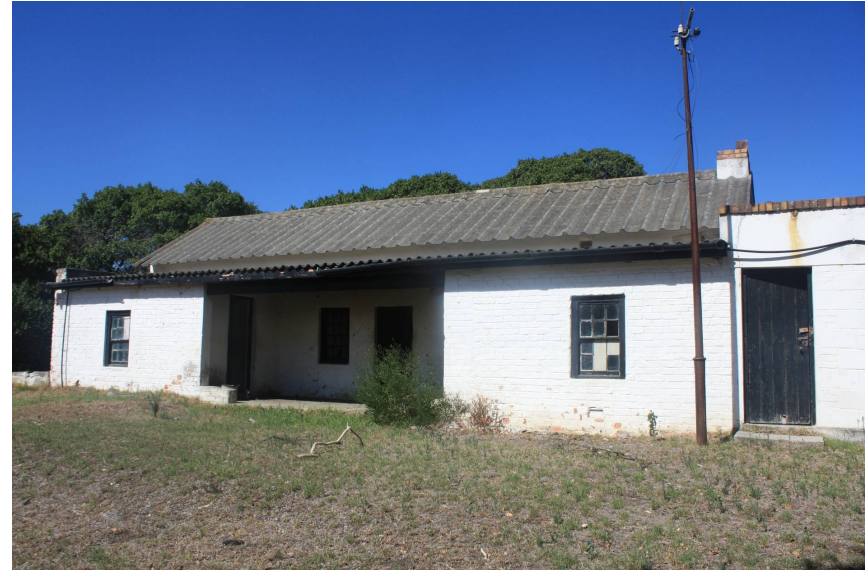
Constraints and Opportunities: Poor condition and currently vacant
Adaptive reuse potential

Ongoing repair and maintenance

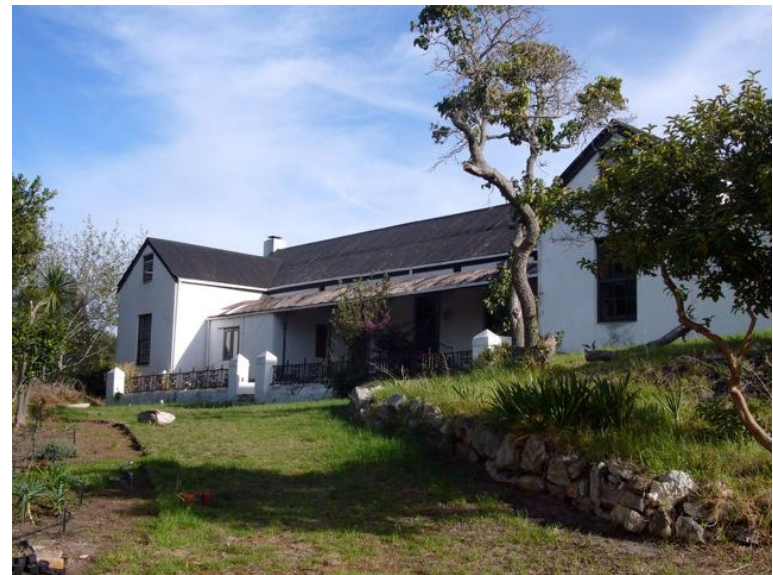
Single storey farmhouse with twin projecting straight-gabled bays flanking a central cast iron colonnaded verandah with surviving period decorative cast iron brackets. Med-paned d/s sash windows, double panelled front door.
Intact period homestead apart from a number of minor additions including a part front verandah enclosure.
Nearby barn structure (former Lamloch coffee shop & grill house), appears to be more recent & possibly not older than 60 years
Twin projecting wings; central verandah; surviving period fenestration; cast iron brackets & railings
Materials: Brick; Corrugated iron
Associated landscape features: Outbuildings
Low garden wall with surviving period cast iron decorative railings.
Lawn setting with some surviving oak trees.

Original use: Agricultural
Current use: House
Landscape type: Continuing
Design/Style: Victorian
Construction date: Early 19th century
Historical period in which constructed: British Colonial
Theme: Historic settlement pattern

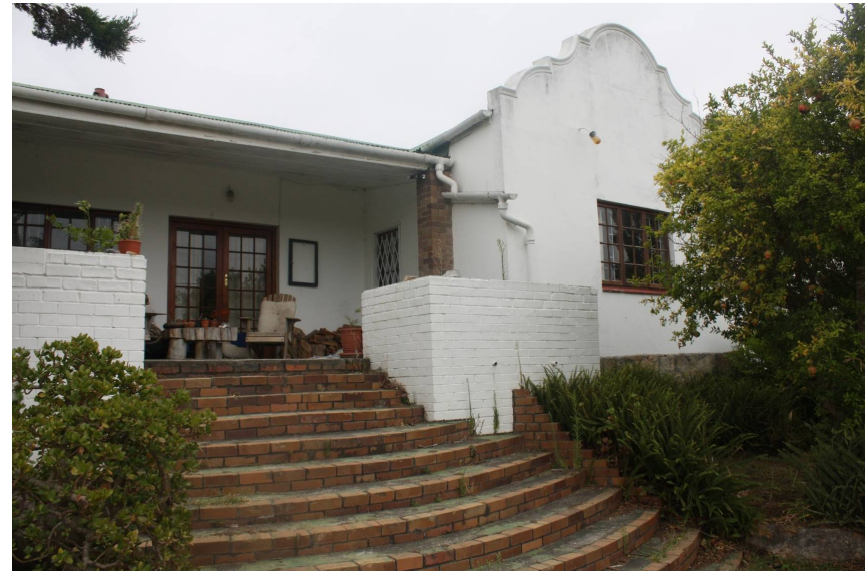
Dawn homestead: Rectangular older core with pitched corrugated iron roof and protruding Cape Revival gabled bays. Central veranda and brick stairs. Raised platform with random stone plinth (un-plastered on protruding bays). Original joinery has been replaced. Face brick veranda columns and stairs. Later rear and side extensions. Associated cypress tree.

Significance: Ability to demonstrate the role of the Valley as a rural settlement in the late 19th/early 20th century.

Some architectural value in terms of remaining period features.

Ongoing repair and maintenance

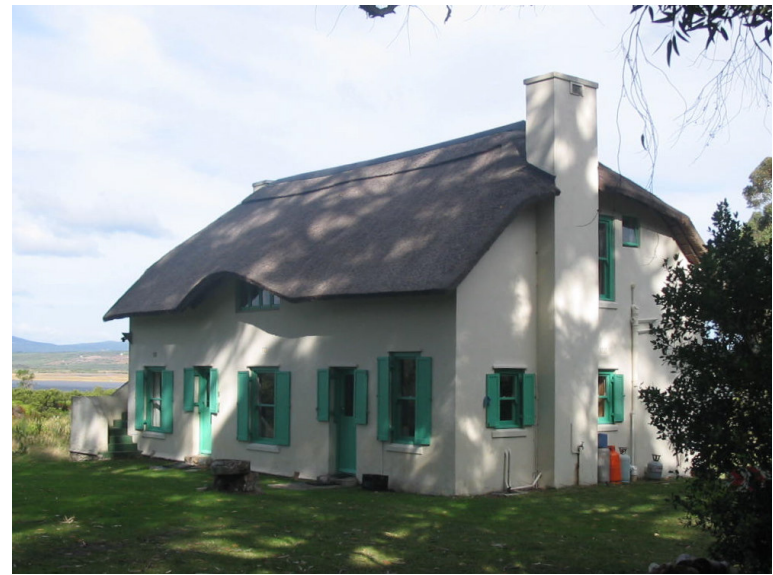
Half-hipped thatch house with attic. Painted large pane sash windows; solid panel shutters. Projecting chimney flue; external stair to attic.
One of two houses in heavily treed setting. (The other house is late 20th C & therefore not historical.
Materials: Brick; Thatch
Associated landscape features:

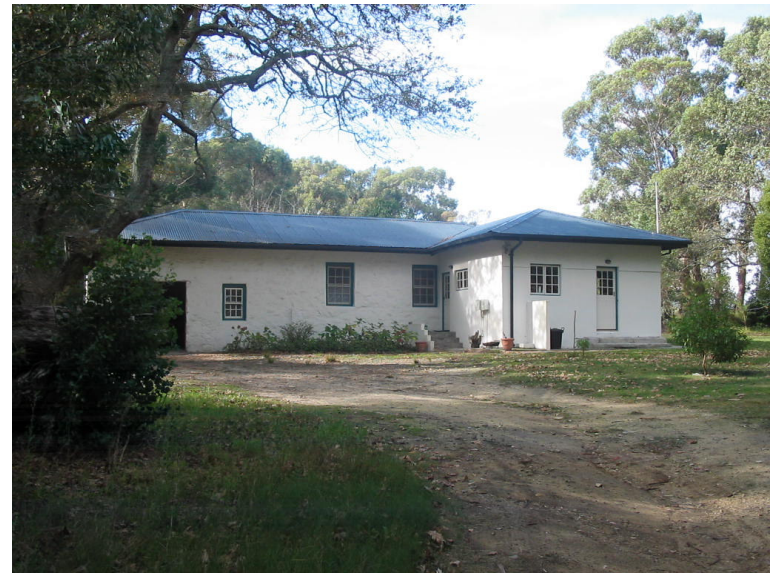
Hipped corrugated iron roofed house with projecting eaves; asymmetrical projecting front wing. Earlier fabric includes surviving rough plastered stone walls with small pane double sliding sash windows. Later fabric includes small pane casements & stable dors with small pane upper leafs.
Heavily trees eucalypt setting.
Materials: Stone; Corrugated iron
Associated landscape features:

Suspect late 19th/early 20th C – apparently originally a thatched long house, according to current occupant. Gutted by fire in mid 20th C and re-built with a new roof & projecting front wing, incorporating some original stone wall fabric and fenestration.

Ongoing repair and maintenance

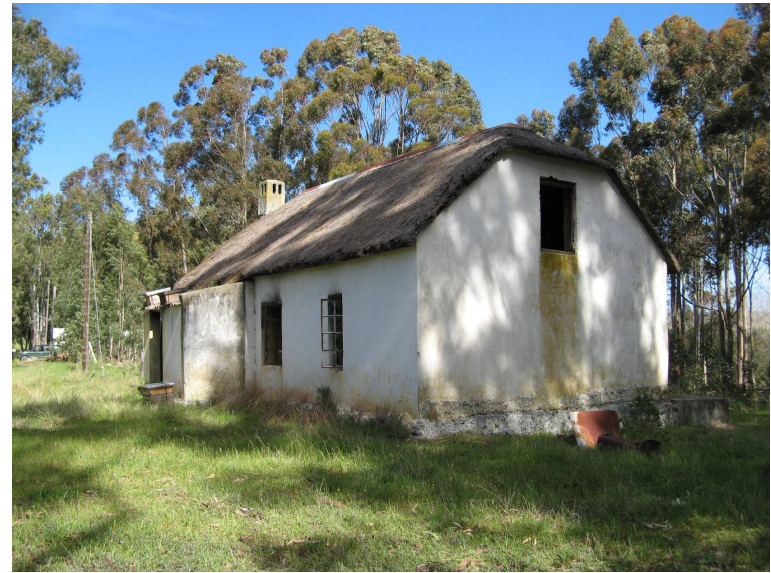
Significance: Older cottages present a bygone pattern of landuse and settlement

Constraints and Opportunities: Alien growth is unchecked and is an immediate fire and environmental hazard. Older cottages at risk - unoccupied and going to ruin. Tourism industry may provide necessary impetus to restore some of cottages for holiday accommodation.

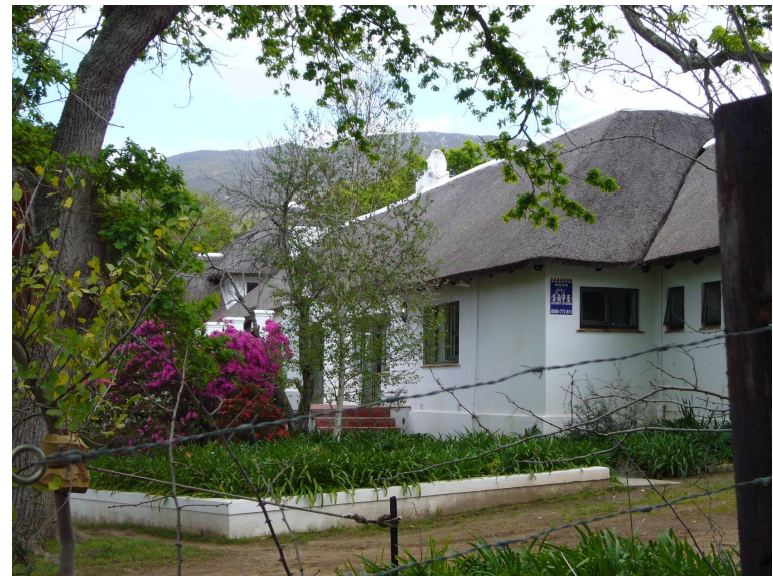
Situated of the R326, Stanford. Highly wooded context, access problematic. House has thatched roof with overhanging eaves and has been much altered.
Materials: Brick; Thatch
Associated landscape features:

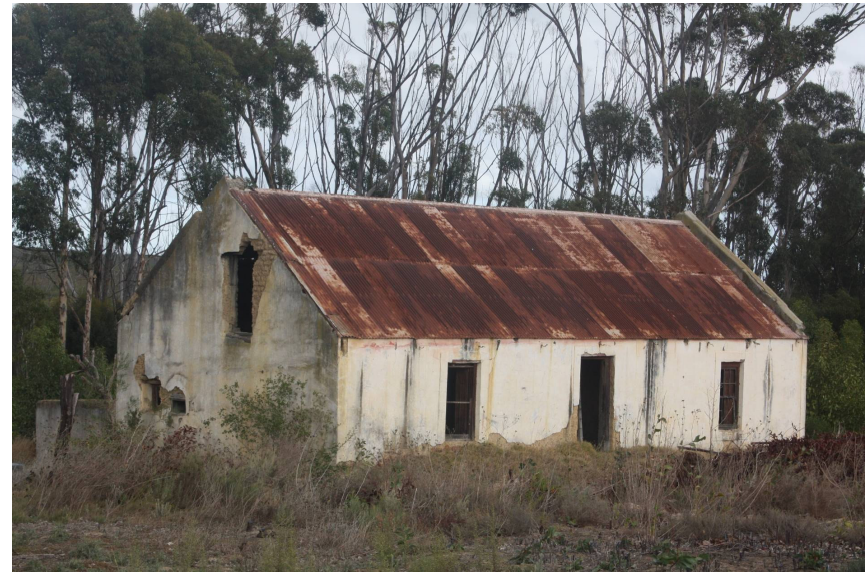
Rectangular 3 bay house with pitched corrugated iron roof. Parapet gable ends. Mud brick and stone construction. Stable front door and internally shuttered 3x2 sashes. Unoccupied and in derelict condition.

Some intrinsic value in terms of remaining historical fabric and features. However, derelict condition does not warrant conservation.
