Public Participation document:

KLEINMOND

Overstrand Heritage Landscape Group:

Overstrand Municipality

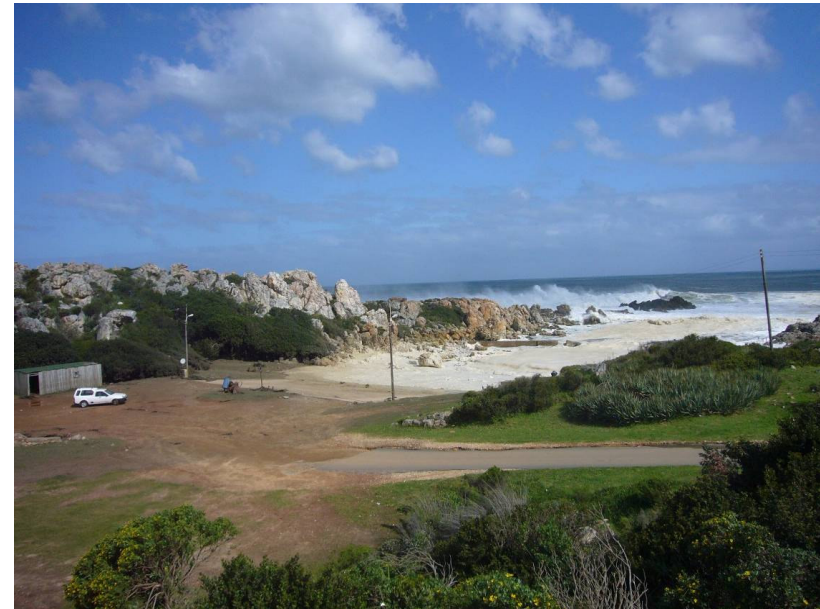
Site name: Jongensklip Harbour Visbaai Type of resource: Harbour
Location: 3419 AC: 34 20' 47.25" S, 19 0' 46.66" E Google Earth
Erf/Farm : 5504, 5456/
Address: Kleinmond

Harbour with remnants of old fisherman's cottages and fish house (small breakwater plus footprints of 3 terraced houses).

Traditionally used from early times as grazing area
c1850 a number of fishermen settled at the e harbour at Kleinmond. This settlement later became known as Jongensklip in 1915.

Ongoing repair and maintenance

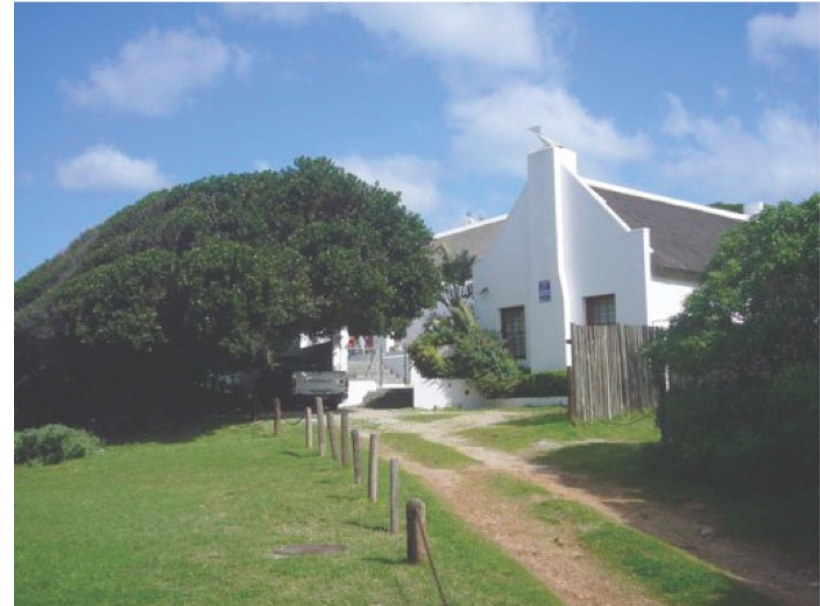
Simple rectangular Cape cottage with white washed walls, thatched roof, with smaller outbuilding with two rooms. Substantially rebuilt
Materials: Brick; thatch
Associated landscape features:

Original use: Residential
Current use: Villa
Landscape type: Continuing
Design/Style: Vernacular
Construction date: 1860
Historical period in which constructed: Mid to late 19th century
Theme: Religion

Dominee Pieter Kuypers Albertyn, local minister to the Caledon congregation of the Dutch Reformed Church.

Ongoing repair and maintenance

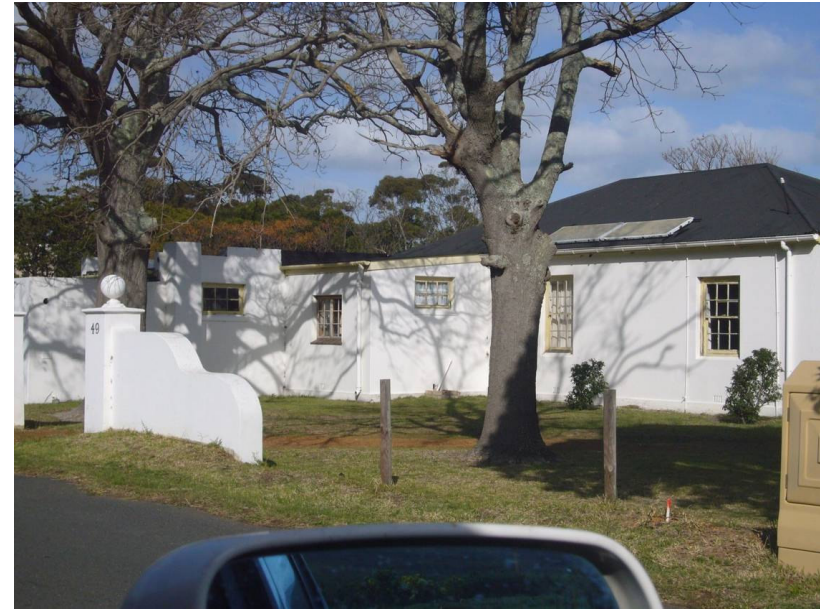
Hipped corrugated roof dwelling and outhouses set on substantial grounds.
Verandah with masonry columns. Wooden sash windows.
Materials:
Associated landscape features:

Original use: Residential
Current use: House
Landscape type: Continuing
Design/Style:
Construction date: 1920s
Historical period in which constructed: Union
Theme: Recreational

Ongoing repair and maintenance
Formal protection in terms of zoning scheme regulations (Grade 3B)

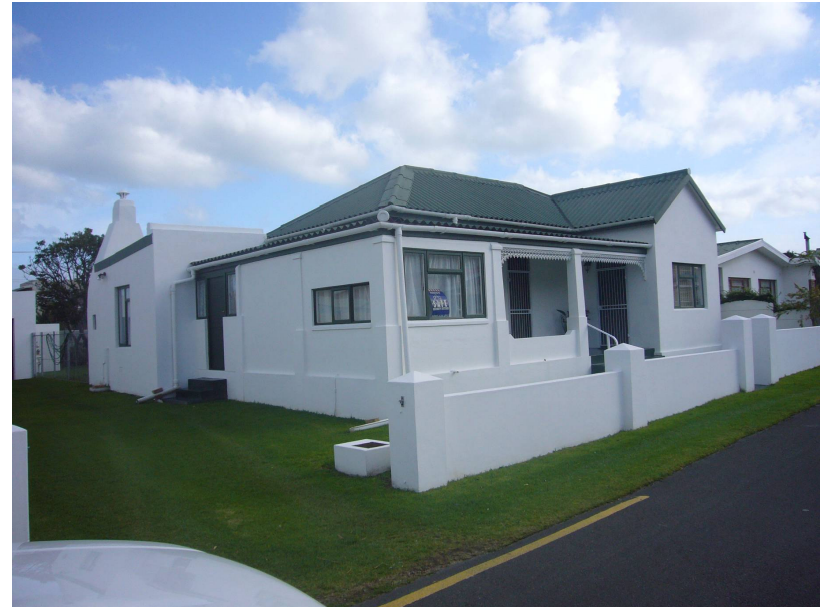
Simple freestanding villa with protruding bay, corrugated iron roof with stoep kamer, partially enclosed verandah.
Materials: Brick; corrugated iron
Associated landscape features:

Original use: Residential
Current use: Villa
Landscape type: Continuing
Design/Style:
Construction date: 1930s
Historical period in which constructed: Union
Theme: Recreation

Ongoing repair and maintenance
Formal protection in terms of zoning scheme regulations (Grade 3C)
