Public Participation document:

ONRUST

Overstrand Heritage Landscape Group:

Prepared for the

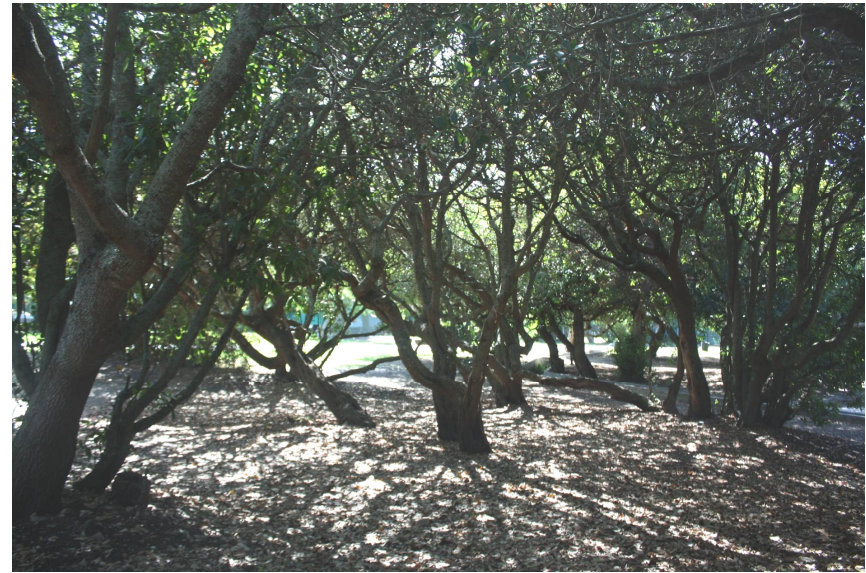
Lies between town and coastline. Features milkwood trees.
Old changing cubicles replaced in 1955. Repairs to path to Davies pool and improved lavatory & refuse removal investigated.
Materials:
Associated landscape features: Mature milkwood trees

Original use:
Current use:
Landscape type:
Design/Style:
Construction date:
Historical period in which constructed: Early 20th century
Theme:

Heritage Management Recommendations:
Ongoing repair and maintenance
Formal protection in terms of the zoning scheme regulations (Grade 3A)

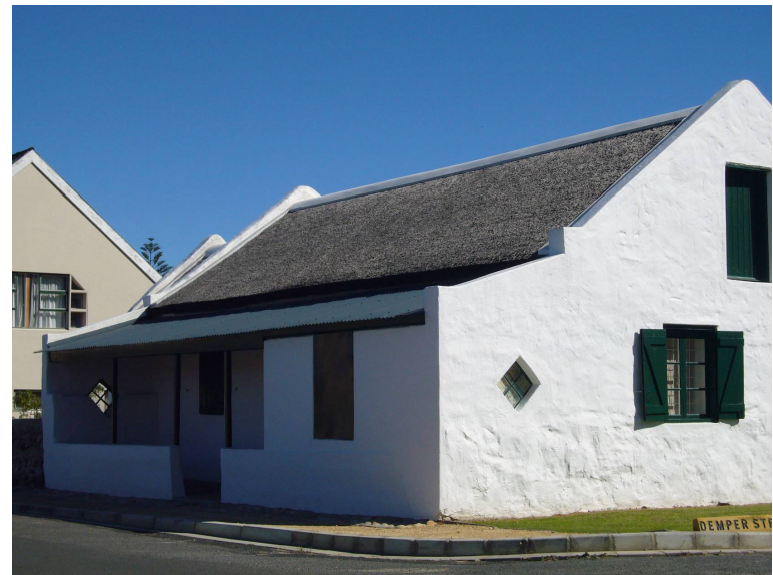
Original use: Residential
Current use: Cottage
Landscape type: Continuing
Design/Style: Vernacular
Construction date: 1908
Historical period in which constructed: British Colonial
Theme: Vernacular architecture
Fishing and recreation

Ongoing repair and maintenance

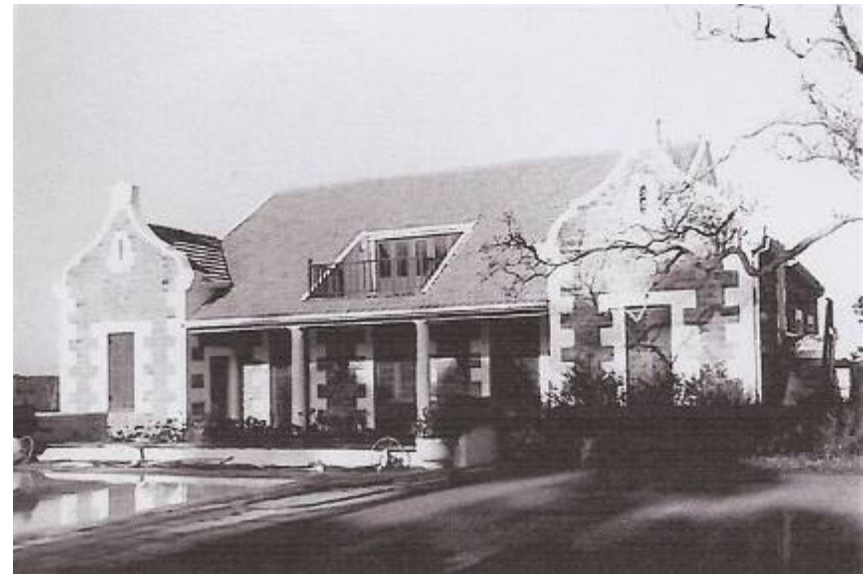
Built for Mr. Walter Mac Farlane as an Inn. Mac Farlane owned the Onrust hotel and the farm "Onrust River". Later it was occupied as a residence by Valentine Beyes, Bookie van Schoor and the Figg family. In 1993-4 it was extensively restored and is presently used as a holiday home by the Rupert family

Heritage Management Recommendations:

Ongoing repair and maintenance

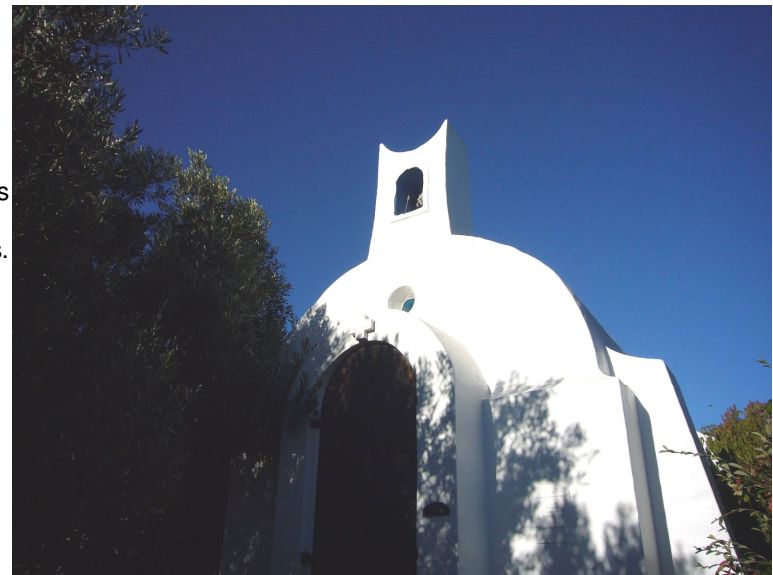
Style of chapels on Greek Islands. Small domed building with bell tower. Stained glass windows by Leo Theron. Carved wooden doors and stone rails by Tertia Knaap. Contains religious relics and artworks. Associated labyrinth, cypresses and olive trees. Landmark location on axis with Green Street. Application for provincial heritage site status submitted in 2006.

Designed by Pretoria architect Jack van Rensburg in 1982. Built and consecrated as Greek church in 1983) Idea of artists Maxie Steytler and Tertia Knaap, Popular wedding venue e.g. FW de Klerk. (Annandale 2133, 2140)

Ongoing repair and maintenance

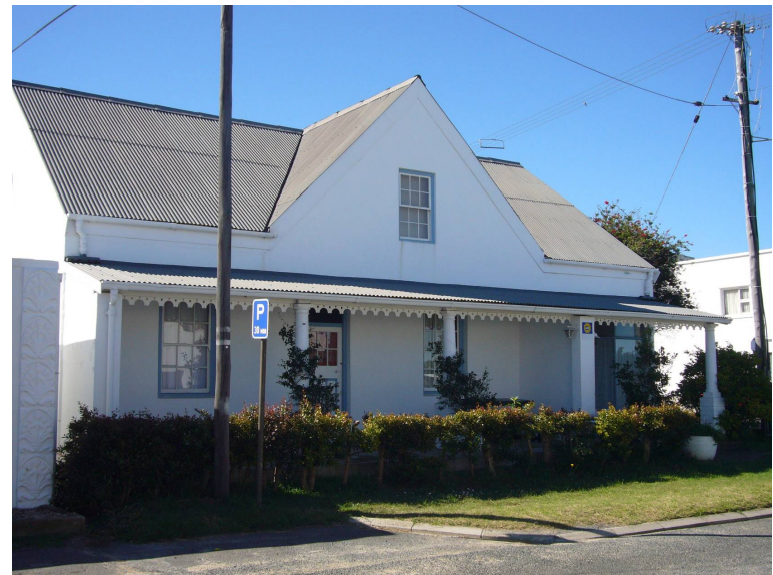
Veranda cottage with pitched corrugated iron roof. Side room with shop front.
Veranda has precast columns with brick bases. Decorative bargeboard matches 10-12 Viljoen Street and appears to be new. Low hedge in front. Sash windows and front door are a recent addition. Front gable added circa 1989.
Materials: Brick; Corrugated iron
Associated landscape features:

Original use: Residential/Commercial
Current use: Verandah cottage
Landscape type: Continuing
Design/Style:
Construction date: Early 20th century
Historical period in which constructed: Union
Theme: Commerce

This is the site of first butchery shop in Onrust owned by Elias Francken. It was an elongated corrugated iron structure and small room. In 1936 the corrugated iron structure was demolished and butcher shop became a carpentry shop. The present building was erected in circa 1948. It became Warwick Chef School or 'Onrust Kitchen' in 1989.

Heritage Management Recommendations:

Ongoing repair and maintenance

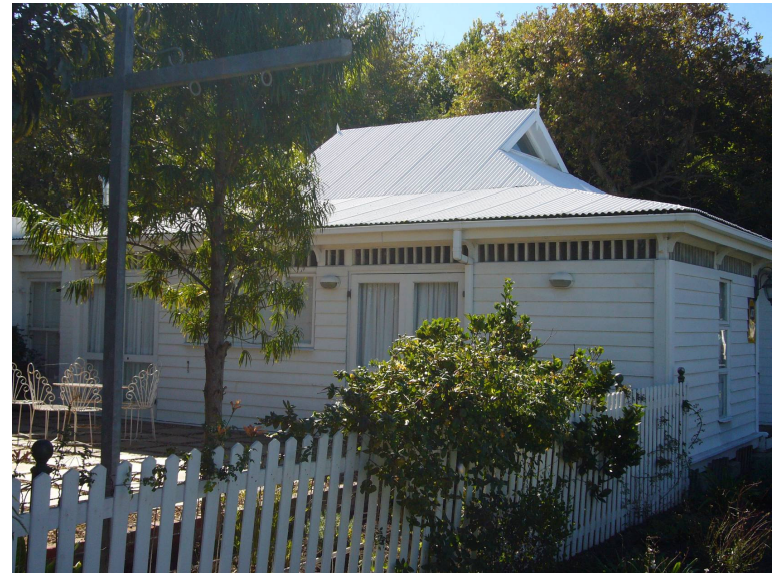
A prefabricated timber dwelling with low pitched corrugated iron roof and roof ventilators, now glazed. Bracketed eaves. New wing and joinery replaced.

Previously the Strand Pavillion it was brought to Onrust in 1921 and converted into a dwelling.

Ongoing repair and maintenance

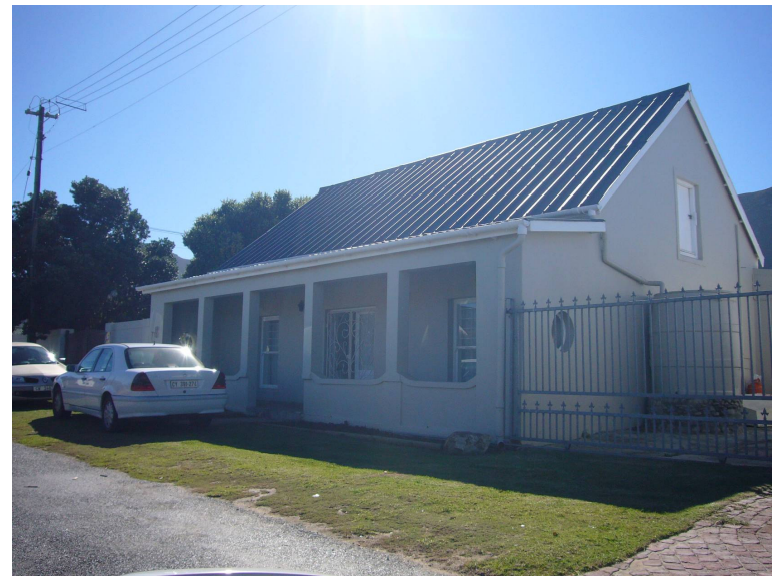
3 bay veranda cottage with pitched asbestos roof. Veranda as dipped balustrade and square masonry columns. Replaced joinery. Loft door.
Materials: Brick; Corrugated iron
Associated landscape features:

Ongoing repair and maintenance
Formal protection in terms of the zoning scheme regulations (Grade 3B)

- Conserve
- Remedial action to enhance

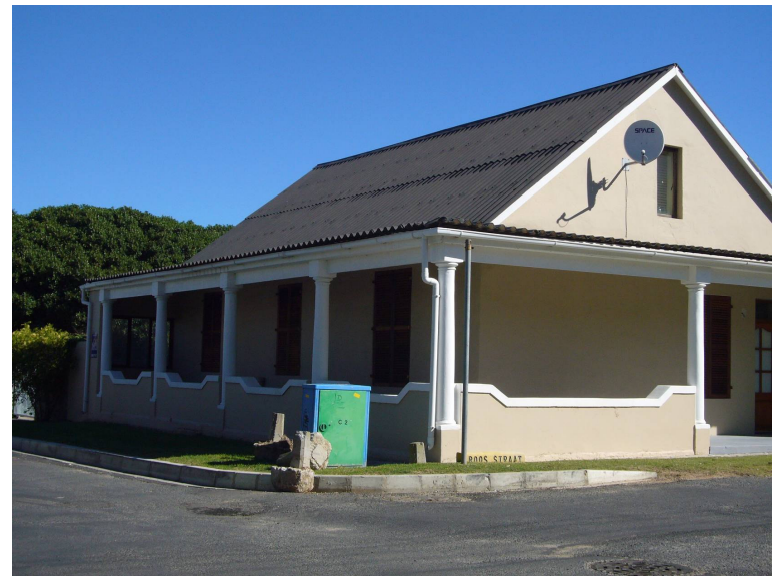
It was built in the 1920's as a holiday home and served as the second school in Onrust between 1928 -1931. The property was owned by Mr Wessels then Albertyn. Restored in 2002

Heritage Management Recommendations: Ongoing repair and maintenance

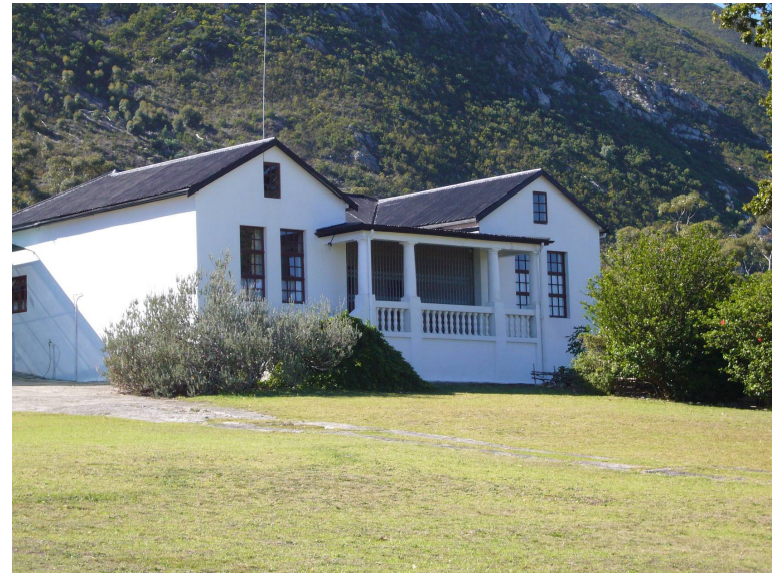
Twin gabled bays with central veranda. Corrugated iron roof. Later 1930s veranda addition with precast columns and balustrade. Steel framed replacement windows. Small casement windows to end front gables. Important relationship with setting in terms of mountain backdrop. Altered agricultural context in terms of surrounding gated residential development.

Heritage Management Recommendations: Ongoing repair and maintenance

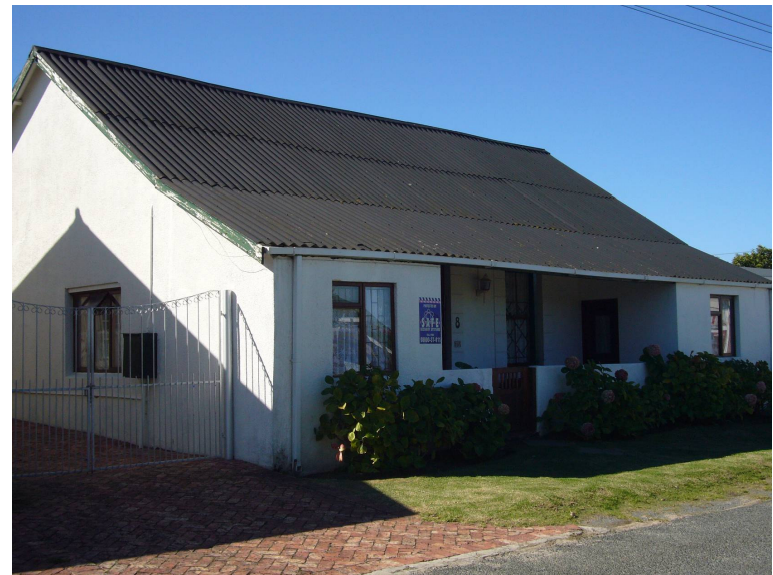
Sandstone & brick: asbestos pitched roof. Stoep kamers with new timber casements windows. Solid balustrade. 2x2 sashes. Plastered quoining.
Partially enclosed front stoep.
Materials: Sandstone and brick; corrugated asbestos
Associated landscape features:

Original use: Residential/Commercial
Current use: Verandah cottage
Landscape type: Continuing
Design/Style:
Construction date: 1916
Historical period in which constructed: Union
Theme: Recreation
Commerce

First shop open by Tante Miems Kuys in 1916 on left side of stoep

Heritage Management Recommendations:
Ongoing repair and maintenance

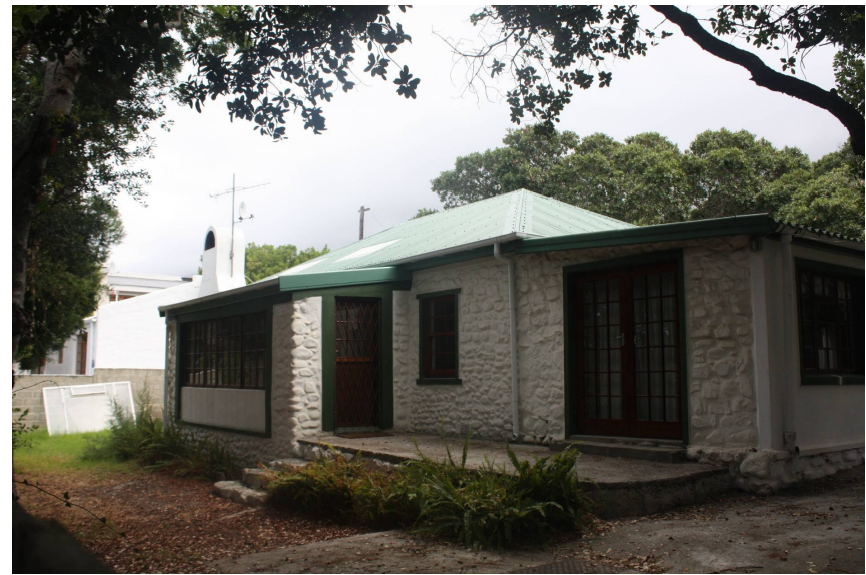
Rusticated appearance (stonework) typical of holiday houses dating to this period.

Ongoing repair and maintenance

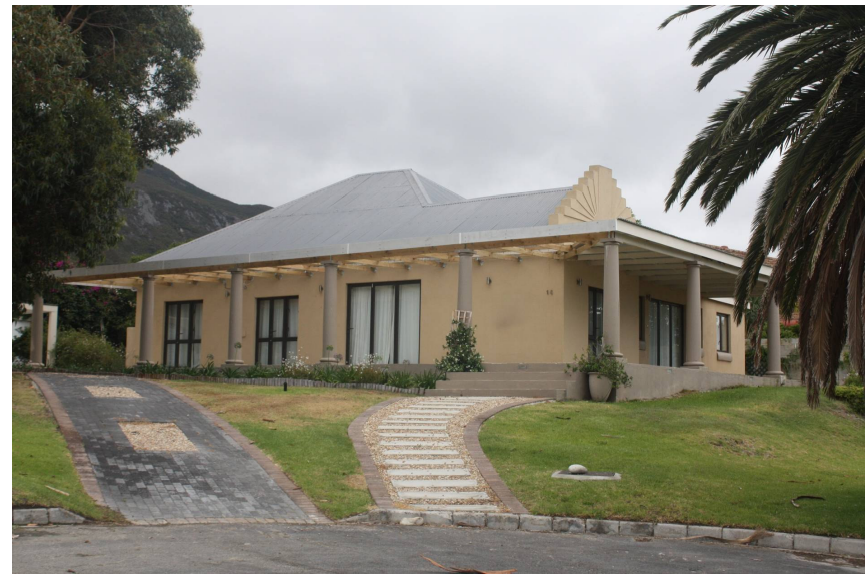
Old farm house with hipped corrugated iron roof and front protruding gabled bay. Sunray fanned gable. Wrap around veranda with precast columns.
New aluminium windows and doors.
Materials: Brick; corrugated iron
Associated landscape features:

Original use: Agricultural
Current use: House
Landscape type: Continuing
Design/Style: Art Deco
Construction date: 1949
Historical period in which constructed: Republic
Theme: Historic settlement pattern

Built in 1949 for Ted Wood who had acquired the small-holding and the garage below the property. The plot in front of the house had an orchard or guava trees. When the plot was subdivided the street was named after Ted Wood.

Heritage Management Recommendations:

Ongoing repair and maintenance

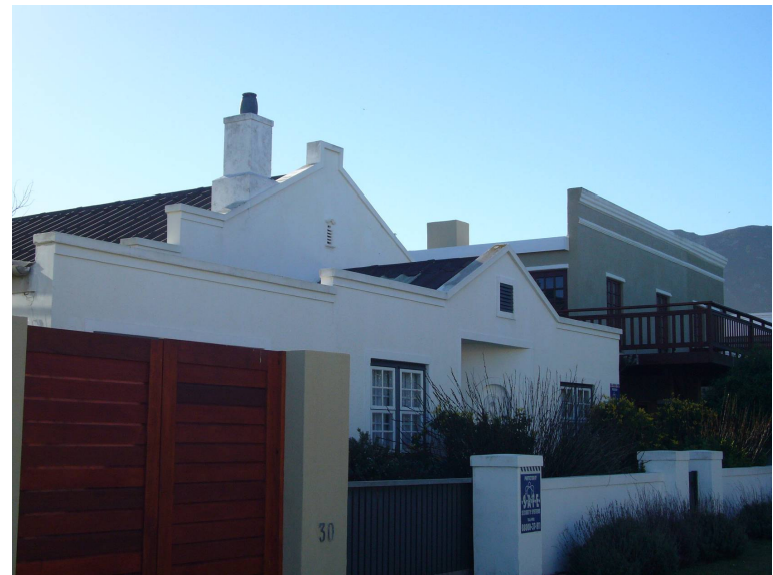
Veranda house with pitched corrugated iron roof. Parapet gabled ends and roof vents Context has been highly altered by adjacent over-scaled development. Addition on gable end providing new entrance off Green Street.
Materials: Brick; Corrugated iron
Associated landscape features:

Original use: Residential
Current use: House
Landscape type: Continuing
Design/Style:
Construction date: 1945
Historical period in which constructed: Post WWII
Theme: Recreation

Heritage Management Recommendations:

Ongoing repair and maintenance
Formal protection in terms of the zoning scheme regulations (Grade 3C)

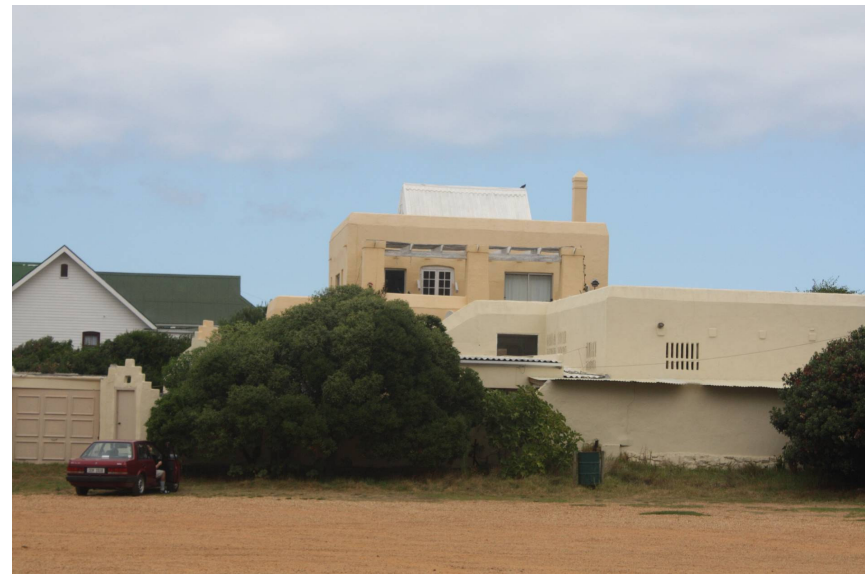
Ungraded
Double storey house originally with thatched roof and hipped gables. Has been highly modified with new roof.
Materials:
Associated landscape features:

Hilltop was bought by Clark-Browns from the Lourens family. Double storey house built by the Italian Prisoner's of War with an external staircase. The legislation stipulated single storey buildings but the second storey was motivated that the second storey was an attic. This area served as the studio for St Luke's Art & Creative School (artist Audrey Fourie).

Heritage Management Recommendations:

Ongoing repair and maintenance
Formal protection in terms of the zoning scheme regulations (Ungraded)

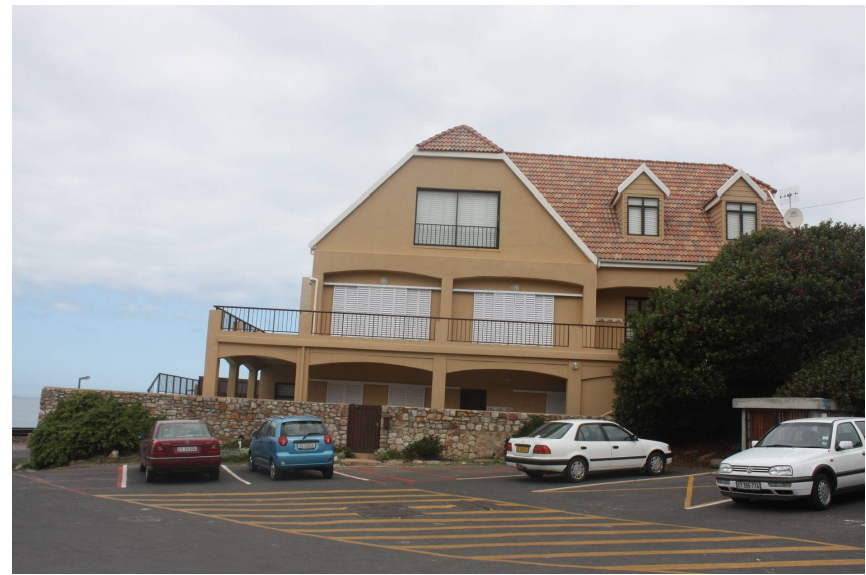
Ungraded
Large building originally with thatched roof and hipped gables. High modified with new roof and additional storey.
Materials:
Associated landscape features:

Built circa 1944 by Italian prisoners of war for Mr Barnett Kramer. Built down 1970 and rebuilt in 1971. Feud with hotel over liquor licence. Bathing boxes rent out on site by the owner. Last one demolished in 1962.

Heritage Management Recommendations:

Ongoing repair and maintenance
Formal protection in terms of the zoning scheme regulations (Ungraded)

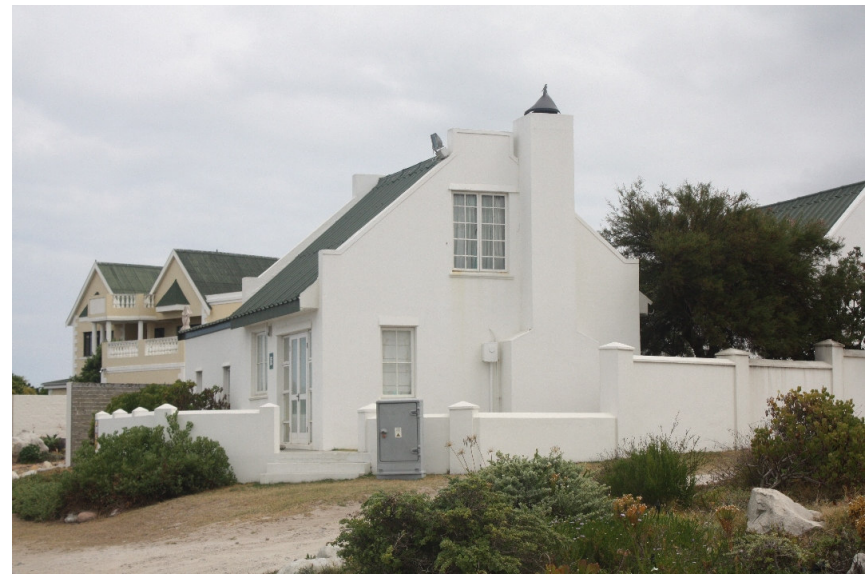
Ungraded
Small rectangular building with pitched asbestos roof, originally thatched.
Front stoep. Project chimney. Boundary wall.
Materials:
Associated landscape features:

Built in circa 1929 as a garage for Blaricum, now located on the adjacent erf. Later converted into a cottage in the early 1970s, again in the 1980s and once again more recently.

Heritage Management Recommendations: Ongoing repair and maintenance
Formal protection in terms of the zoning scheme regulations (Ungraded)

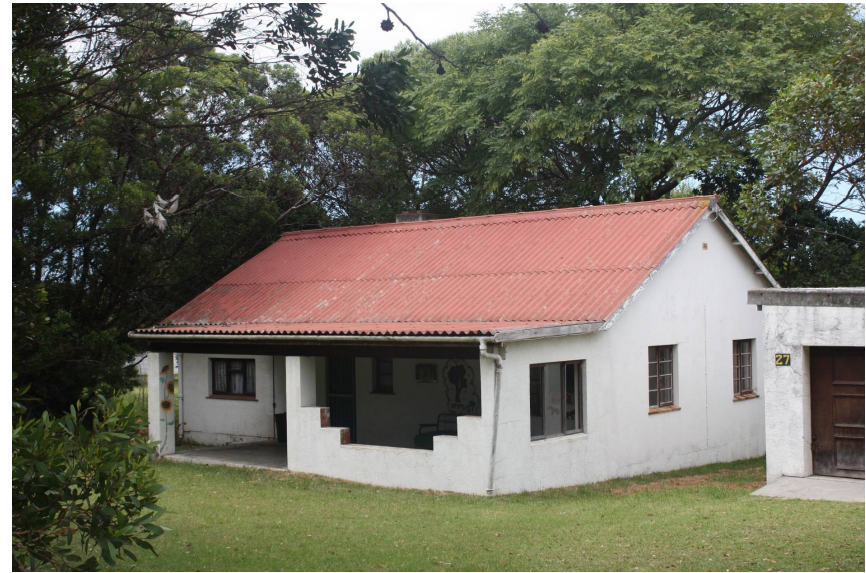
Ungraded
House with pitched corrugated iron roof and verandah. Timber casement windows.
Materials: Brick; Corrugated iron
Associated landscape features:

Heritage Management Recommendations: Ongoing repair and maintenance
Formal protection in terms of the zoning scheme regulations (Ungraded)

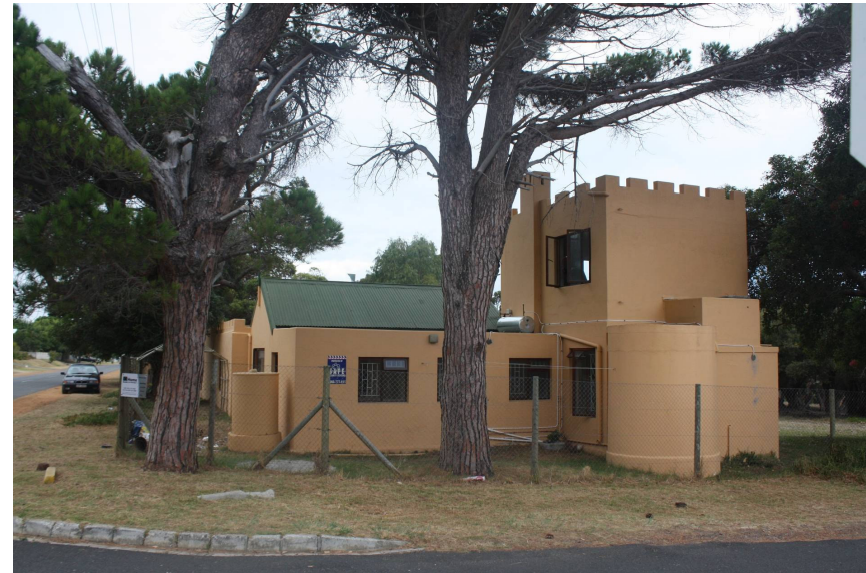
Ungraded
Rectangular cottage with pitched roof and a double storey addition with crenulated turret. Annandale survey (2006) shows a photo (undated) of cattle in front of a barn with sloping mono-pitched roof.
Materials: Brick; corrugated iron
Associated landscape features: Associated mature trees.

Heritage Management Recommendations: Ongoing repair and maintenance
Formal protection in terms of the zoning scheme regulations (Ungraded)
