Public Participation document:

VERMONT

Overstrand Heritage Landscape Group:

Overstrand Municipality

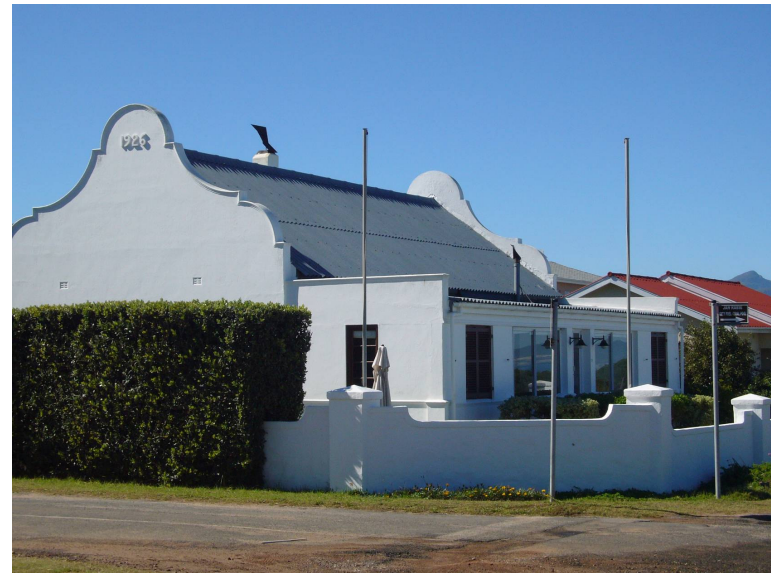
Site name: Vermont House Type of resource: Building
Location: 3419 AC: 34 25' 4.29" S, 19 9' 46.08" E Google Earth
Erf/Farm : 559/
Address: 28 Marine Str Vermont

Pitched corrugated iron roof with Cape Revival gable end. Gable end dated 1926.
Front veranda, now enclosed.
Materials: Brick; Corrugated iron
Associated landscape features:

Original use: Residential
Current use: House
Landscape type: Continuing
Design/Style: Cape Revival
Construction date: 1926
Historical period in which constructed: Union
Theme: Recreation

Significance: Ability to demonstrate the role of Vermont as a holiday destination dating to the early 20th century.
Good example of a Cape Revival house dating to the early 20th century.

Ongoing repair and maintenance
Formal protection in terms of zoning scheme regulations (Grade 3B)

- Conserve
- Remedial action to enhance

- HWC permit of approval required for any demolition, alteration or change in planning status
- Retain historical fabric (predominantly building exterior)

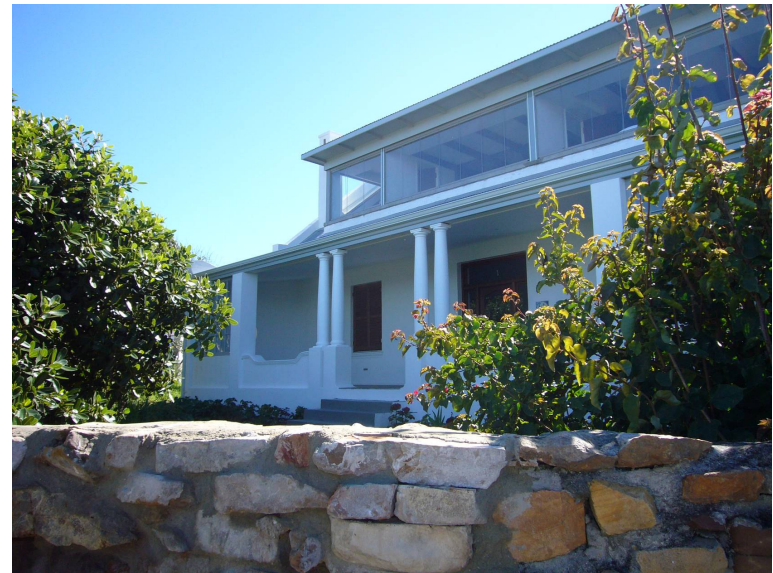
Site name: Vermont House **Type of resource:** Building
Location: 3419 AC: 34 25' 2.22" S, 19 9' 45.70" E Google Earth 2009
Erf/Farm : 1127/
Address: 6 Albatross Str Vermont

Pitched corrugated iron roof with Cape Revival gable ends. Front veranda with solid balustrade and precast columns. Shuttered windows. Stone boundary wall. Recently altered with new loft window.

Materials: Brick; Corrugated iron

Significance: Association with well known Afrikaans writer Jan Rabie, and SA artist, Marjorie Wallace, who lived at Vermont from 1969. Good example of a Cape Revival house dating to the early 20th century.

Ongoing repair and maintenance

Formal protection in terms of zoning scheme regulations (Grade 3B)

- Conserve
- Remedial action to enhance
- HWC permit of approval required for any demolition, alteration or change in planning status
- Retain historical fabric (predominantly building exterior)

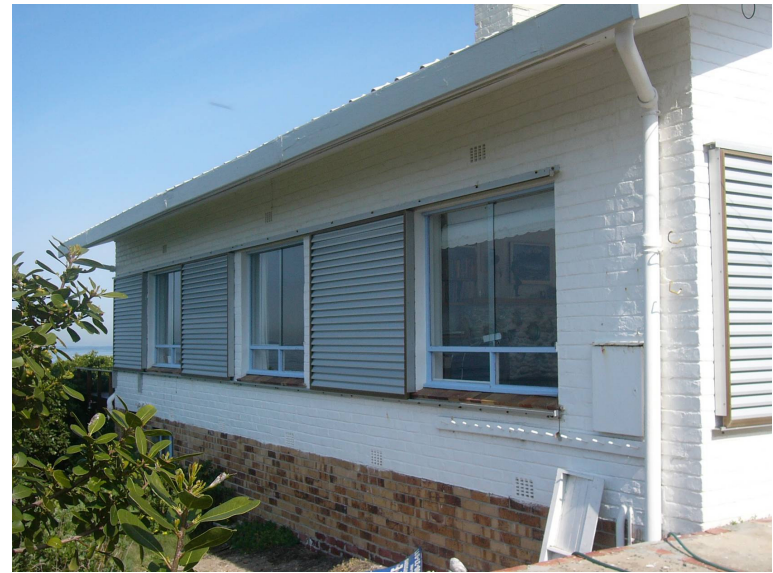
Site name: Vermont House **Type of resource:** Building
Location: 3419 AC: 34 25' 4.11" S, 19 9' 30.98" E Google Earth 2009
Erf/Farm : 1186/
Address: 11 Duiker Str Vermont

Single storey building with low pitched roof. Bagged walls with aluminum framed windows and shutters. House designed for the artist. Significant interior features include the fireplace decorated with perlemon shells by the artist. Spectacular sea views.

Materials: Aluminum shutters and windows

Significance: Association with the life and work of Cecil Higgs, one of the most significant SA women artists of her generations. Cecil Higgs' move to the coast in the 1940s briefly at Onrust and then in Cape Town, influenced her work, especially her compositions of sea-life. She settled at Vermont in 1967.

Ongoing repair and maintenance

Formal protection in terms of zoning scheme regulations (Grade 3C)

- Conserve wherever possible
- Retain historical fabric wherever possible (exterior only)
- Conserve and enhance contribution to overall character and streetscape (predominantly public/private interface)
- HWC permit of approval required for any demolition, alteration or change in planning status
- Demolition only to be considered if appropriate adaptive reuses cannot be established

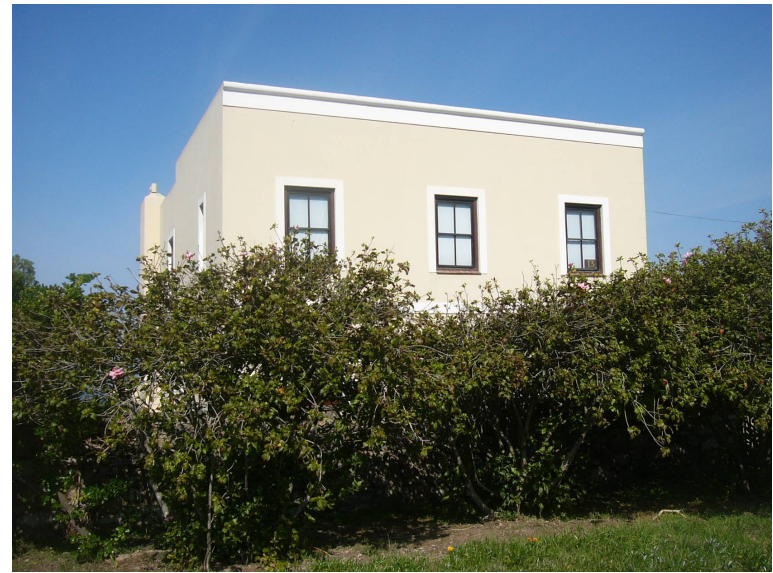
Site name: Vermont House Type of resource: Building
Location: 3419 AC: 34 25' 3.00" S, 19 9' 32.98" E Google Earth 2009
Erf/Farm : 572, 573/
Address: 13-15 Duiker Str Vermont

Double storey flat roofed house
Materials:
Associated landscape features:

Original use: Residential
Current use: Double storey mono pitch
Landscape type: Associated
Design/Style:
Construction date: 1980s
Historical period in which constructed: Republic
Theme: Well-known personality

Significance: Association with life and work of world renowned artist Gregoire Boonzaaier who lived at Onrust from the 1960s until his death in 2005 at the age of 95. Boonzaaier had a major influence on SA art. He was instrumental in the introduction of the modern art form to the South African public from the 1930s to the 1950s and in the creation of Cape Impressionism, and was acknowledged for his teaching efforts in the rural areas.

Heritage Management Recommendations:
Ongoing repair and maintenance
Formal protection in terms of zoning scheme regulations (Grade 3C)

- Conserve wherever possible

- Retain historical fabric wherever possible (exterior only)
- Conserve and enhance contribution to overall character and streetscape (predominantly public/private interface)
- HWC permit of approval required for any demolition, alteration or change in planning status
- Demolition only to be considered if appropriate adaptive reuses cannot be established

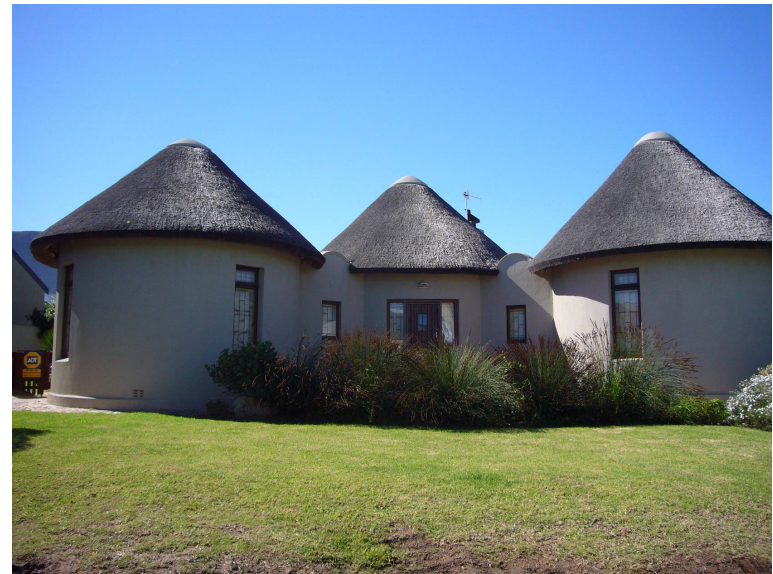
Site name: Vermont House Type of resource: Building
Location: 3419 AC: 34 25' 1.68" S, 19 9' 44.88" E Google Earth 2009
Erf/Farm : 549/
Address: 8 Albatross Str Vermont

Three linked thatched rondawels. Timber frame windows
Materials: Brick; thatch
Associated landscape features:

Original use: Residential
Current use: Rondawel
Landscape type: Continuing
Design/Style: Rondawel
Construction date: Early to mid 20th century
Historical period in which constructed: Union
Theme: Recreation

Significance: Ability to demonstrate the role of Vermont as a holiday destination dating to the early to mid 20th century. Good intact example of a rondawel cottage dating to the early to mid 20th century.

Ongoing repair and maintenance
Formal protection in terms of zoning scheme regulations (Grade 3C)

- Conserve wherever possible
- Retain historical fabric wherever possible (exterior only)
- Conserve and enhance contribution to overall character and streetscape (predominantly public/private interface)

- HWC permit of approval required for any demolition, alteration or change in planning status
- Demolition only to be considered if appropriate adaptive reuses cannot be established

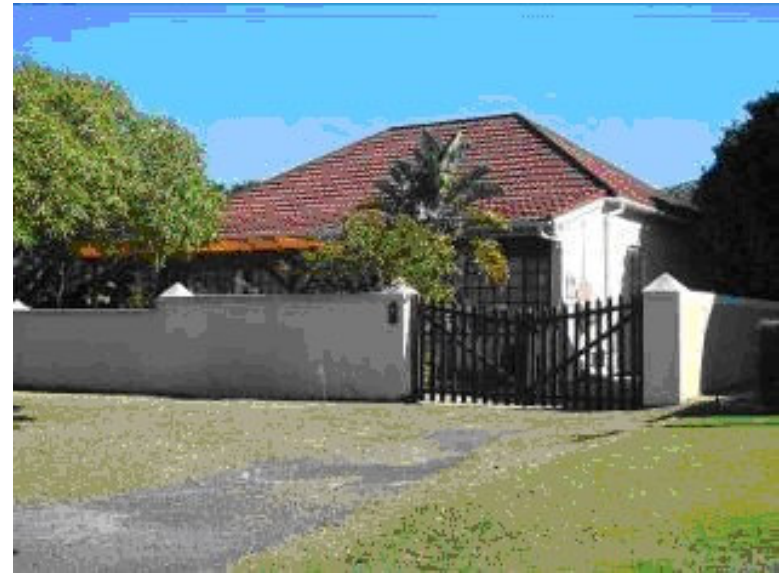
Site name: Vermont House Type of resource: Building
Location: 3419 AC: 34 25' 0.24" S, 19 9' 39.02" E Google Earth 2009
Erf/Farm : 8441/
Address: Vermont Ave Vermont

Hipped red tiled roof. Shuttered sashes. Front stoep has been enclosed. Walled garden.

Materials: Brick; Tile

Significance: Ability to demonstrate the role of Vermont as a holiday destination since the early 20th to mid century.
A fairly intact example of early to mid 20th century house.

Ongoing repair and maintenance

Formal protection in terms of zoning scheme regulations (Grade 3C)

- Conserve wherever possible
- Retain historical fabric wherever possible (exterior only)
- Conserve and enhance contribution to overall character and streetscape (predominantly public/private interface)

- HWC permit of approval required for any demolition, alteration or change in planning status
- Demolition only to be considered if appropriate adaptive reuses cannot be established
