# DRAFT MAINTENANCE MANAGEMENT PLAN and Rehabilitation Plan for Paddavlei Wetland, including the associated hillslope seep areas and ecological corridor upstream and downstream of the vlei in Hawston, Overstrand Local Municipality, Western Cape Province

The Overstrand Local Municipality has initiated a process to compile a rehabilitation and a maintenance management plan for Paddavlei Wetland, situated in Hawston, near Hermanus, in the Western Cape Province (see Figure a: Locality Map). Paddavlei Wetland is an open body of water within a wider wetland area that drains into the Skilpadsvlei and from there to the Bot River Estuary.

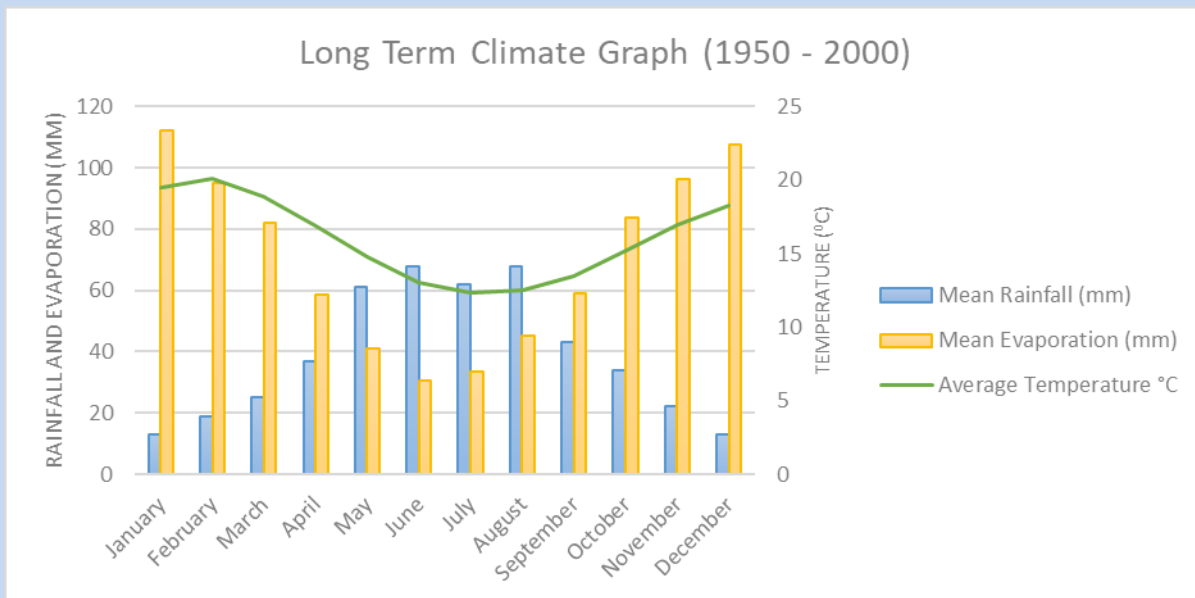
Hawston experiences a Mediterranean climate, with cool wet winters and warm dry summers. Average daily temperatures range from 12-14° C in winter and 15-20°C in summer (Figure 8). The region is the coldest during July when the mercury drops to below 7°C on average during the night. The annual average rainfall for the area is 561 mm, with the lowest rainfall (13 mm) occurring in December and January and the highest (68 mm) in June and August. The total annual evaporation for the area is 845 mm and is highest in January (112 mm). During the driest months (December to March), the area is also exposed to the prevailing southeast winds and the fire hazard is greatest.

**Figure 8: Long term climate graphs for the area (Source: SA Atlas of Climatology and Agrohydrology, 2009, R.E. Schulze)**

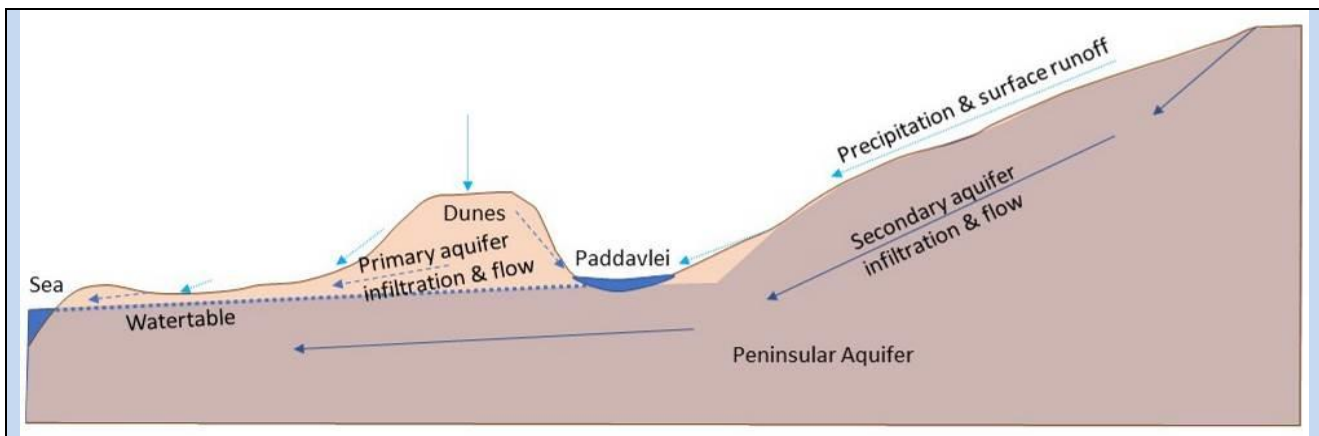
The expected ground and surface water flows at Paddavlei are as follows (illustrated in Figure 9): Rainfall at Paddavlei will infiltrate the surrounding sands and flow in a direction that mimics the topography. It is expected that the wetland area is fed from the mountain run-off and from rainwater infiltration in the low-lying area around the wetland. Rainfall infiltration at the high dune area will infiltrate to the bedrock where it would flow towards the sea. Groundwater from the secondary aquifer is recharged from rainfall in the Onrus Mountain and flows in a south westerly direction towards the sea.

**Figure 9. Schematic diagram of the surface and groundwater interaction at Paddavlei**

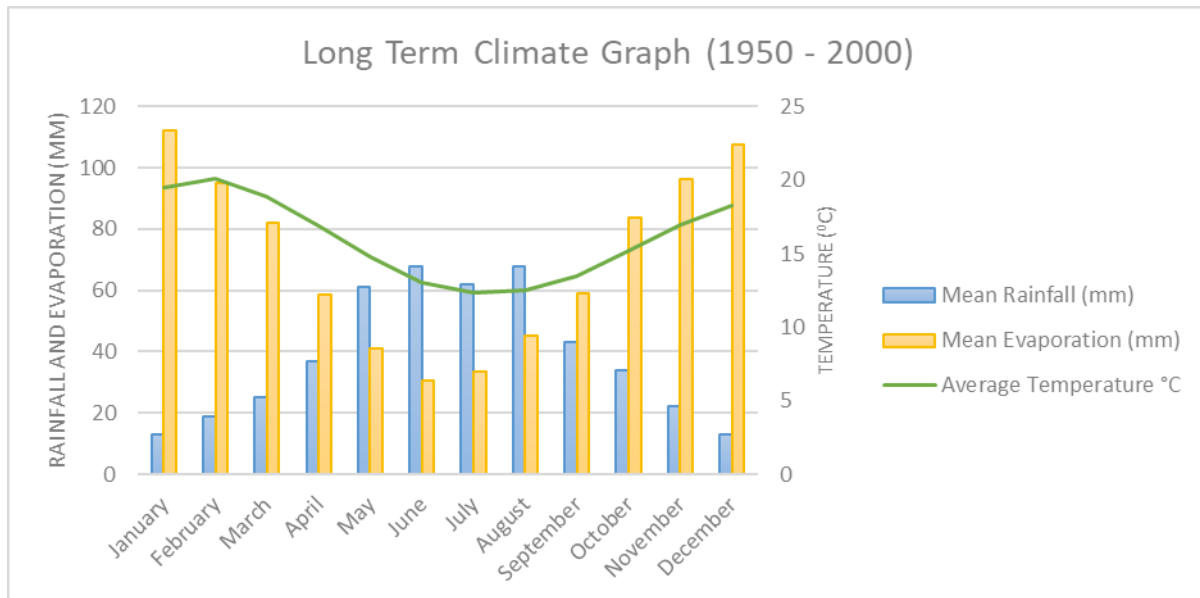
Hawston experiences a Mediterranean climate, with cool wet winters and warm dry summers. Average daily temperatures range from 12-14° C in winter and 15-20°C in summer (Figure 4). The region is the coldest during July when the mercury drops to below 7°C on average during the night. The annual average rainfall for the area is 561 mm, with the lowest rainfall (13 mm) occurring in December and January and the highest (68 mm) in June and August. The total annual evaporation for the area is 845 mm and is highest in January (112 mm). During the driest months (December to March), the area is also exposed to the prevailing southeast winds and the fire hazard is greatest.

Figure 4: Long term climate graphs for the area (Source: SA Atlas of Climatology and Agrohydrology, 2009, R.E. Schulze)

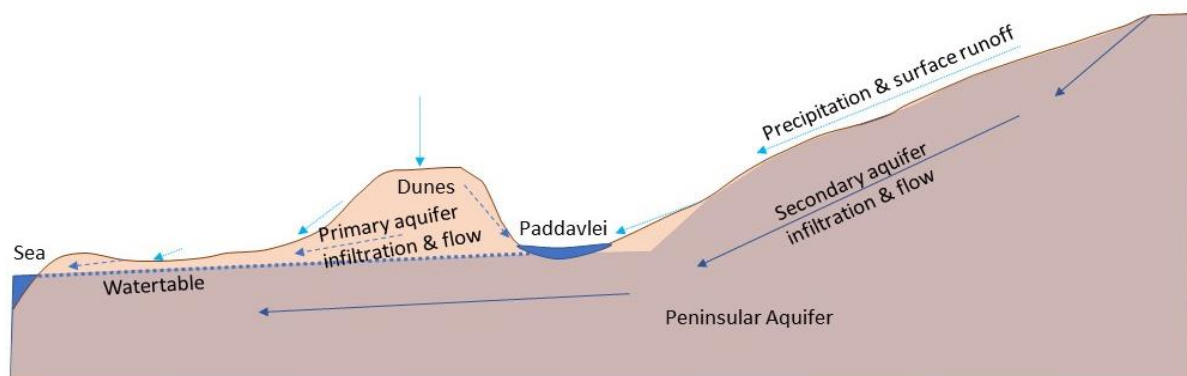
The expected ground and surface water flows at Paddavlei are as described below and illustrated in Figure 7.

Figure 7. Schematic diagram of the surface and groundwater interaction at Paddavlei

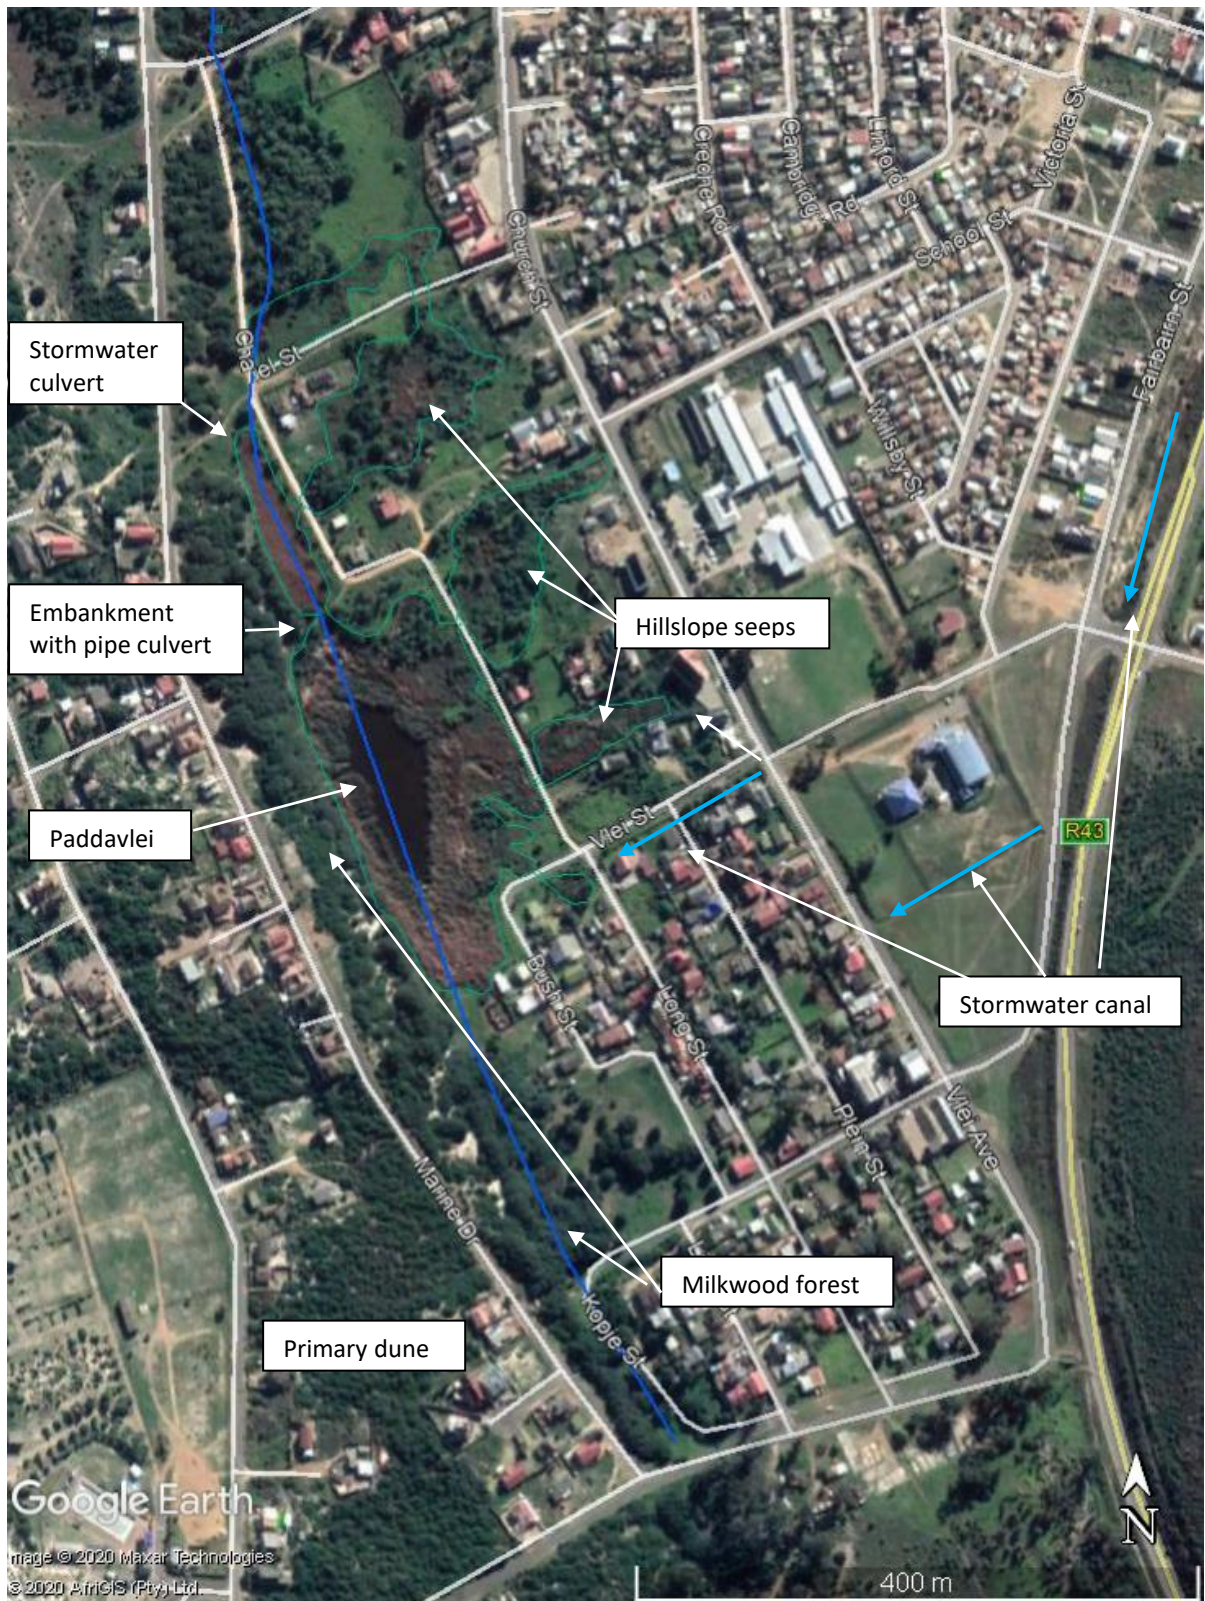
**Figure 12. Google Earth image of Hawston, Paddavlei and the adjacent wetland seep areas, with the main features discussed indicated**

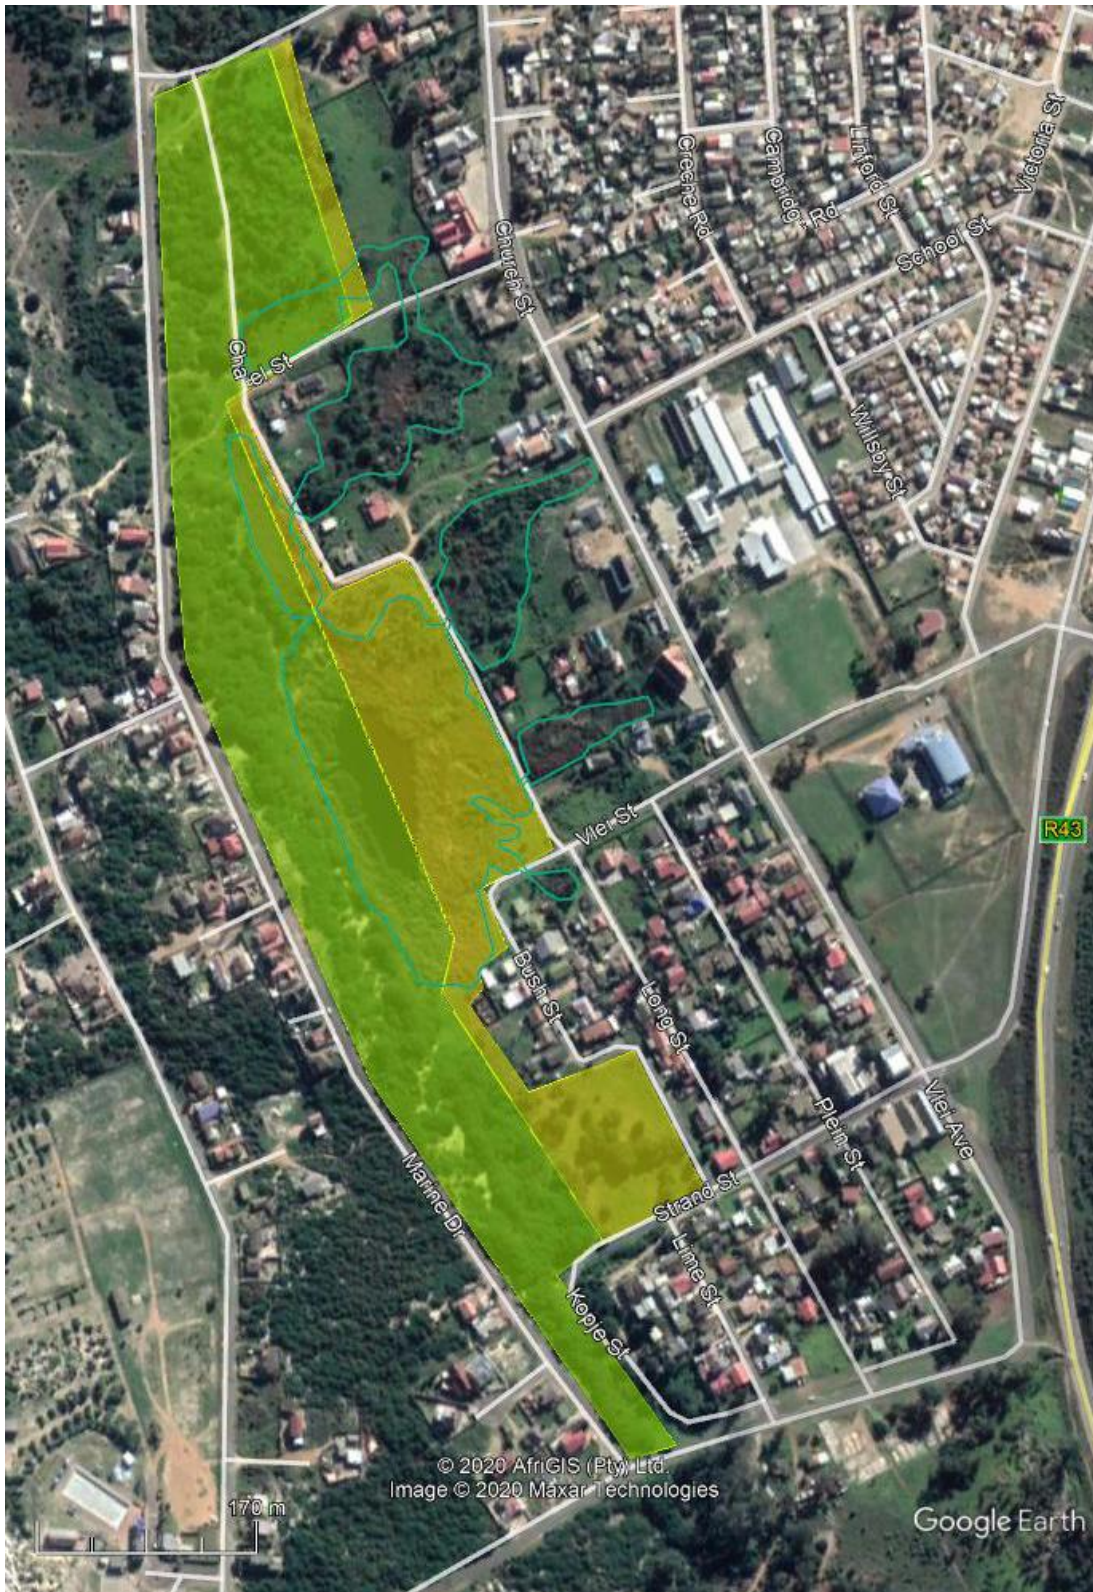
Figure 13. Recommended zonation of Paddavlei, where the green area is the section of the ecological corridor that would be rehabilitated and maintained for biodiversity conservation and the yellow area would be designated for recreational use

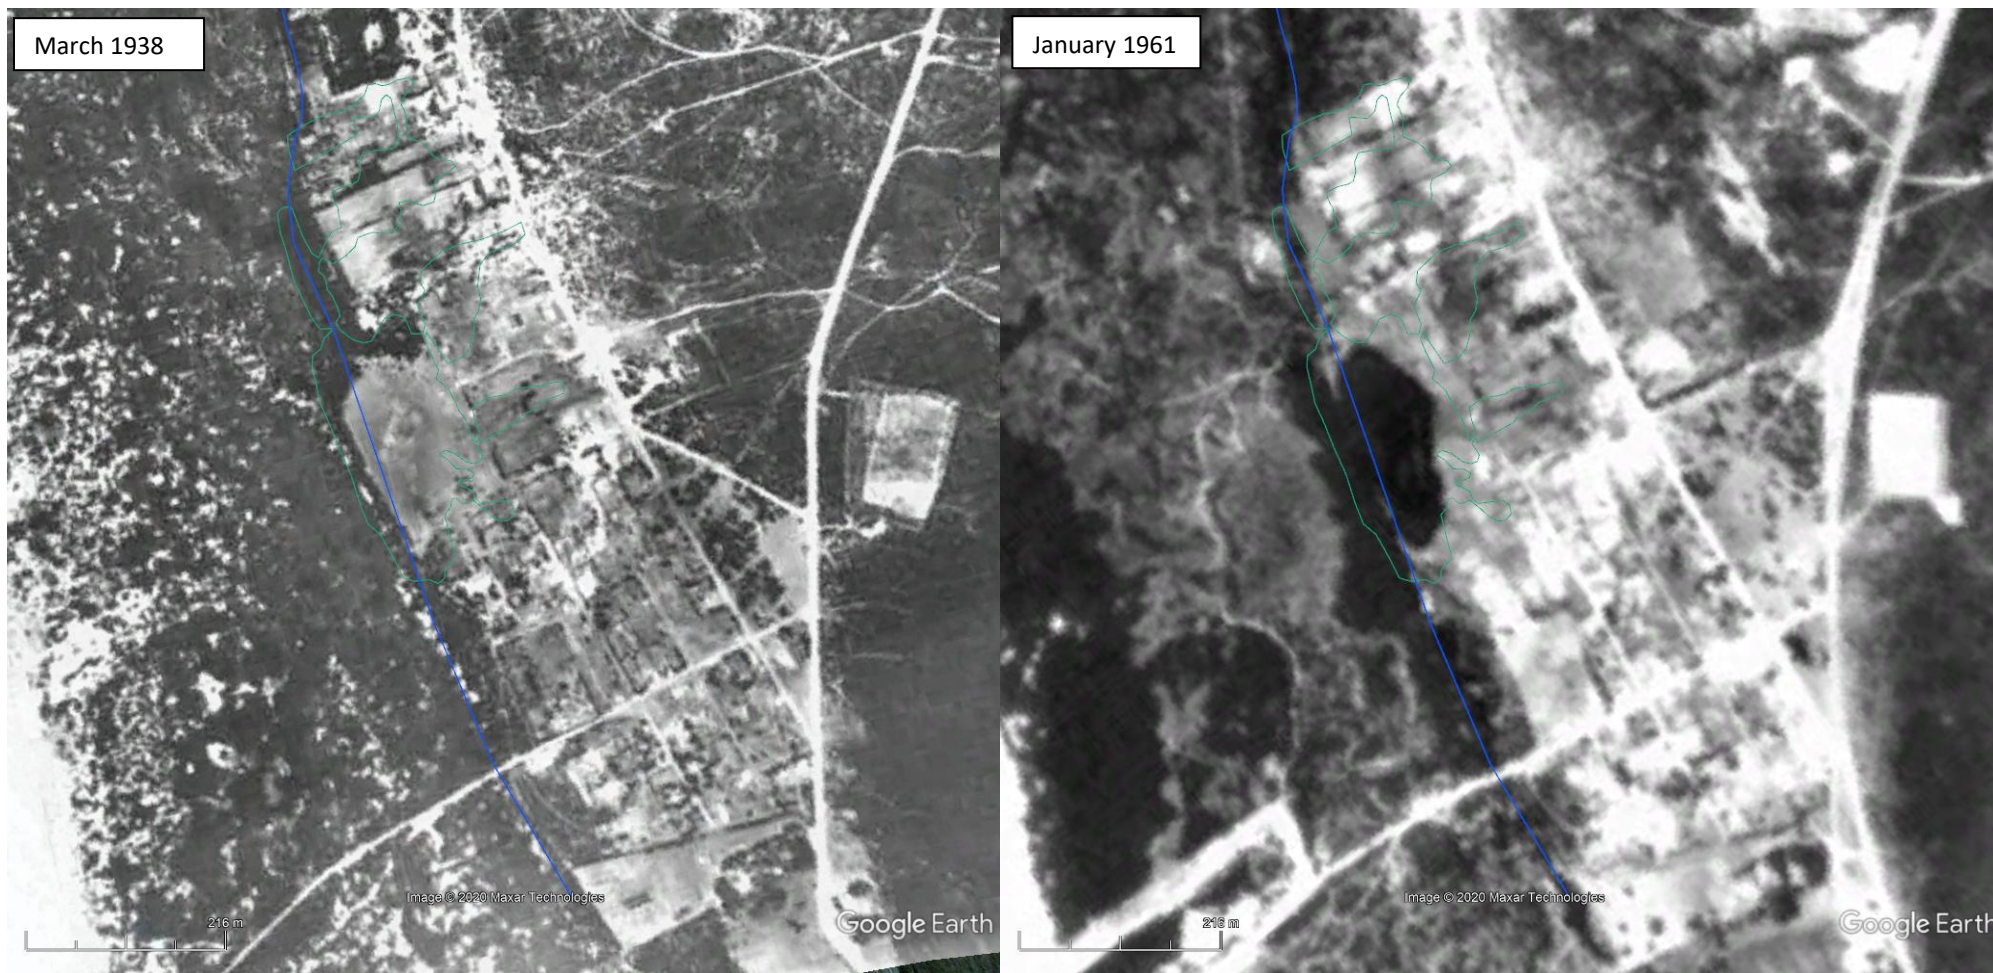
Plate 1. Past aerial imagery of the area taken in 1938 and 1961, overlain in Google Earth with the present-day aquatic features shown

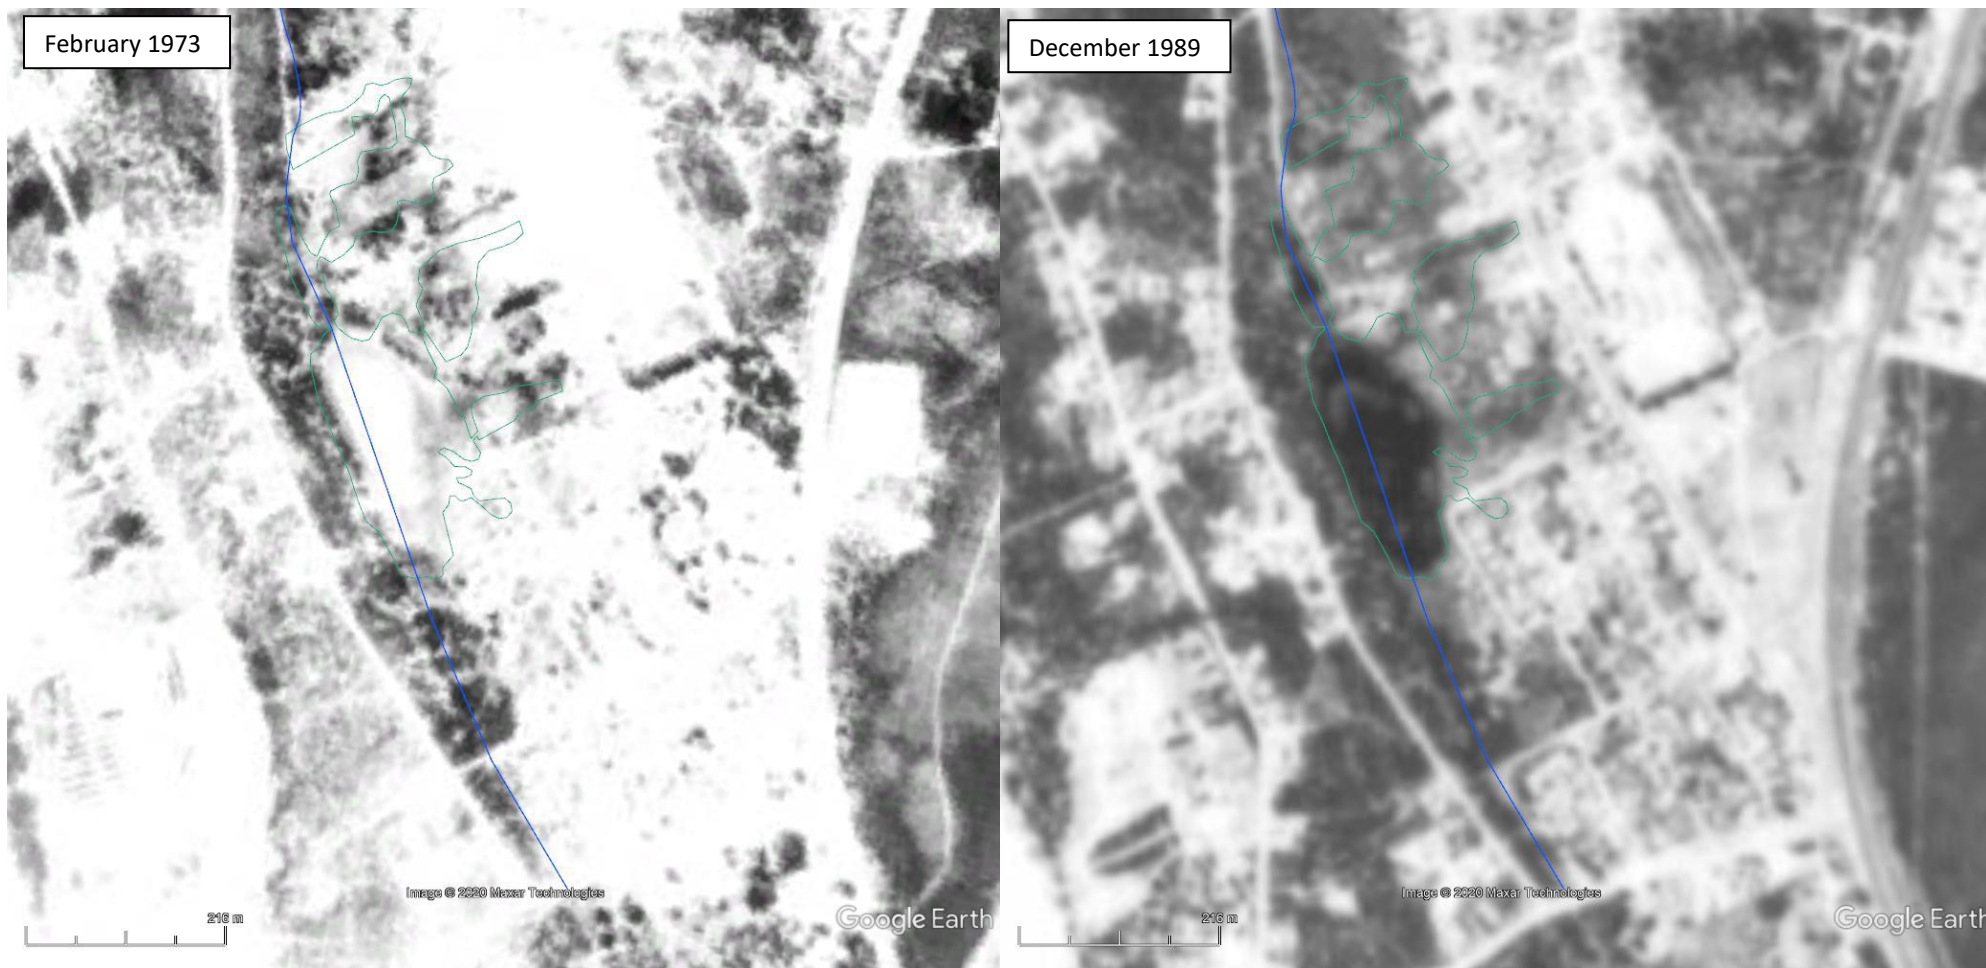
Plate 2. Past aerial imagery of the area taken in 1973 and 1989, overlain in Google Earth with the present-day aquatic features shown

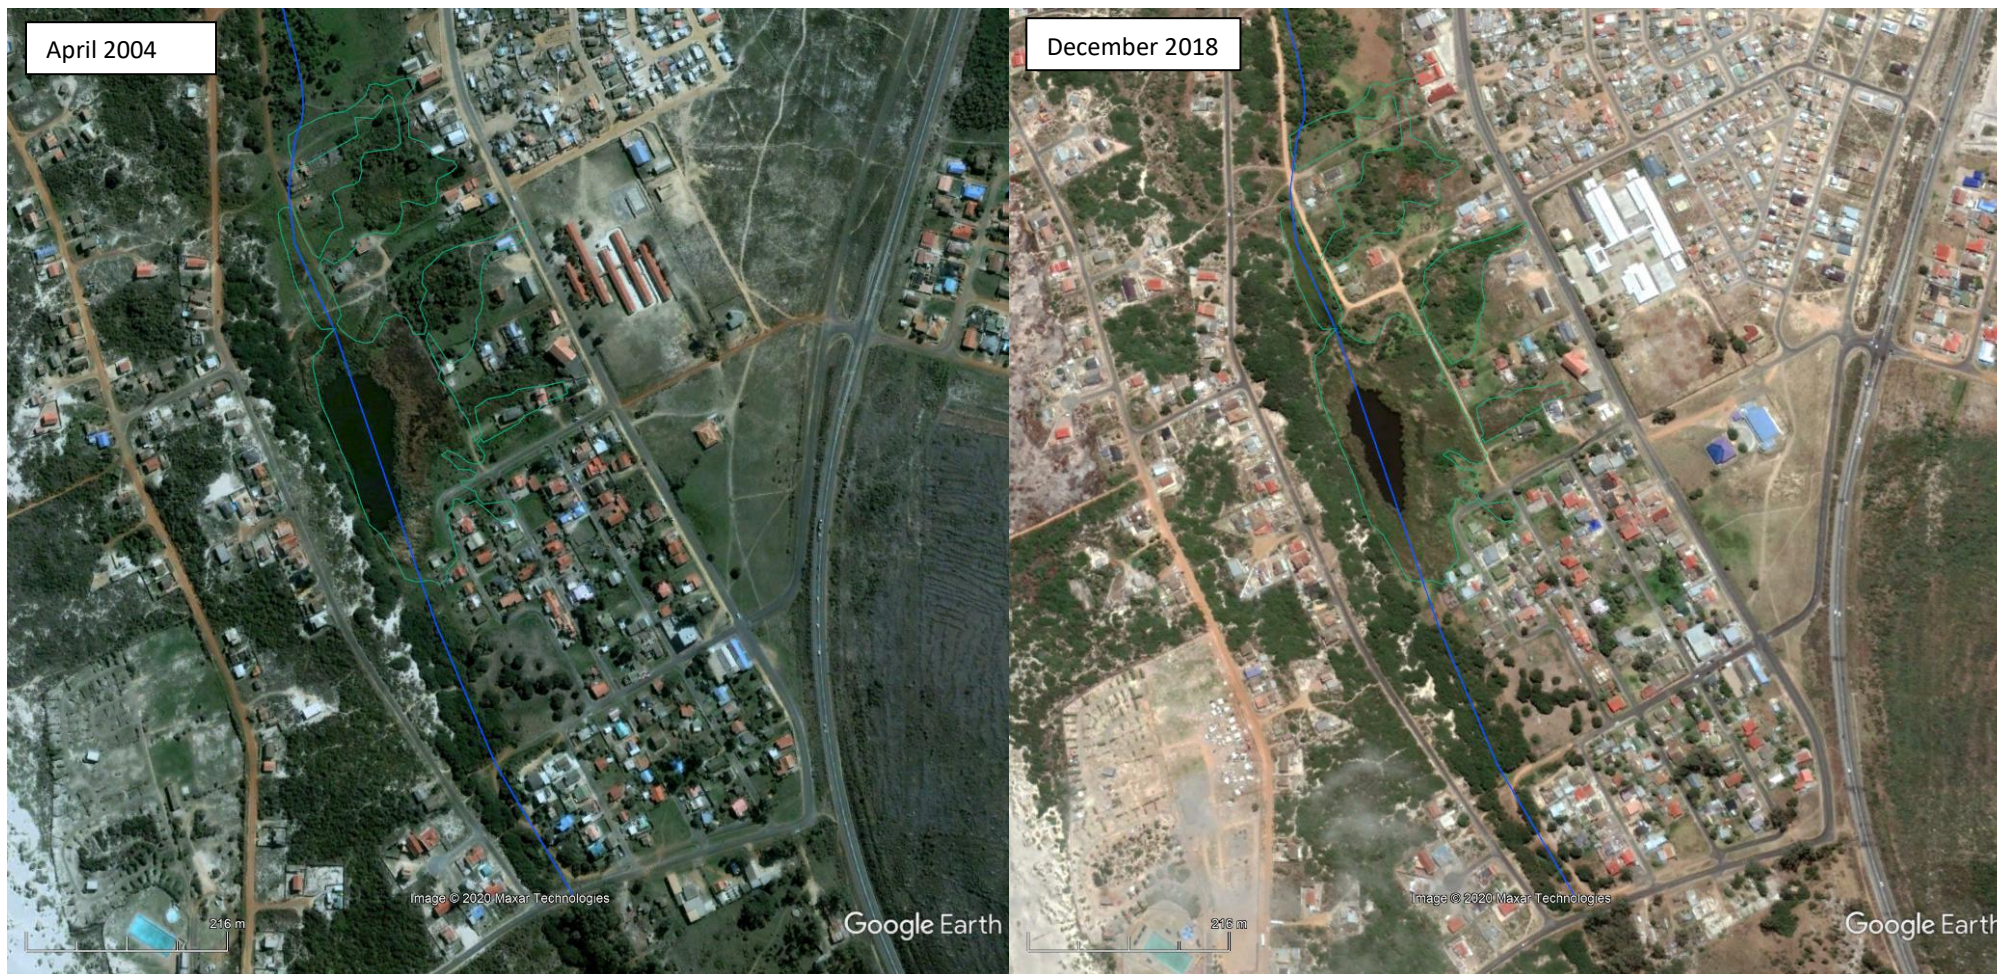
Plate 3. Past Google Earth imagery of the area taken in 2004 and 2018, with the present-day aquatic features shown

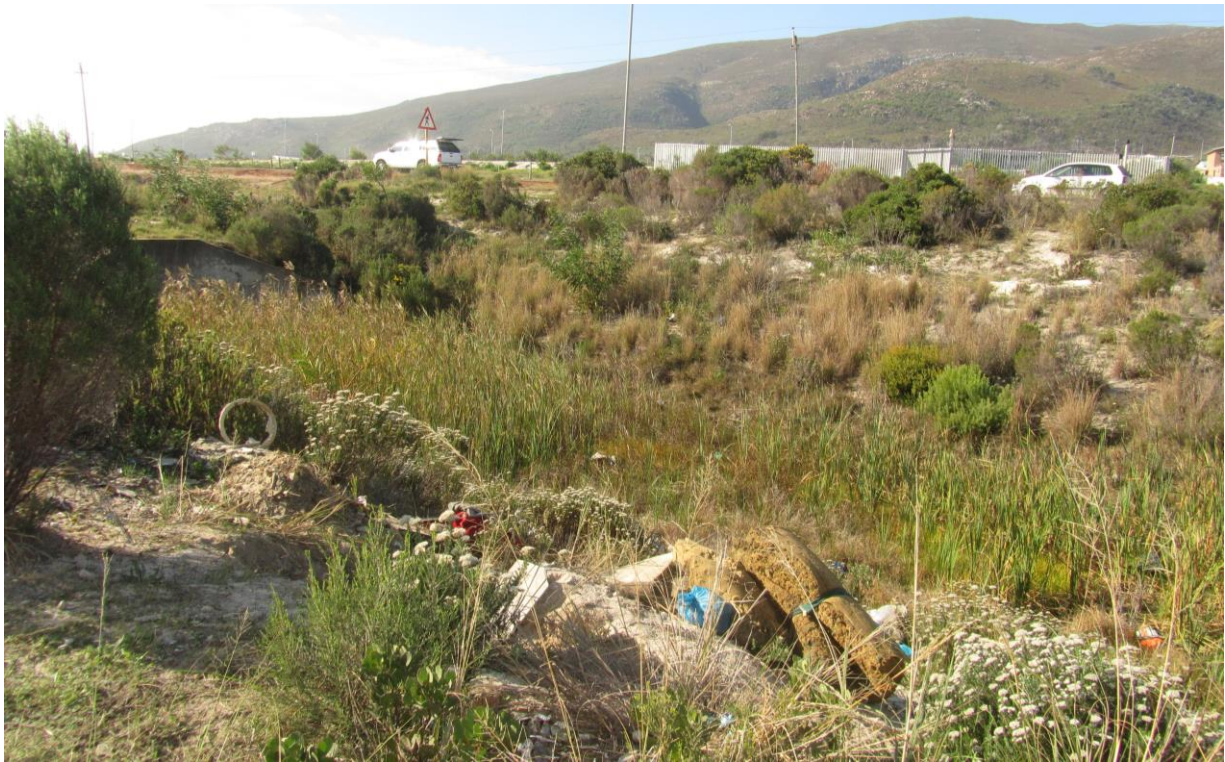
Plate 4: View of the stormwater attenuation adjacent to the R43 Road

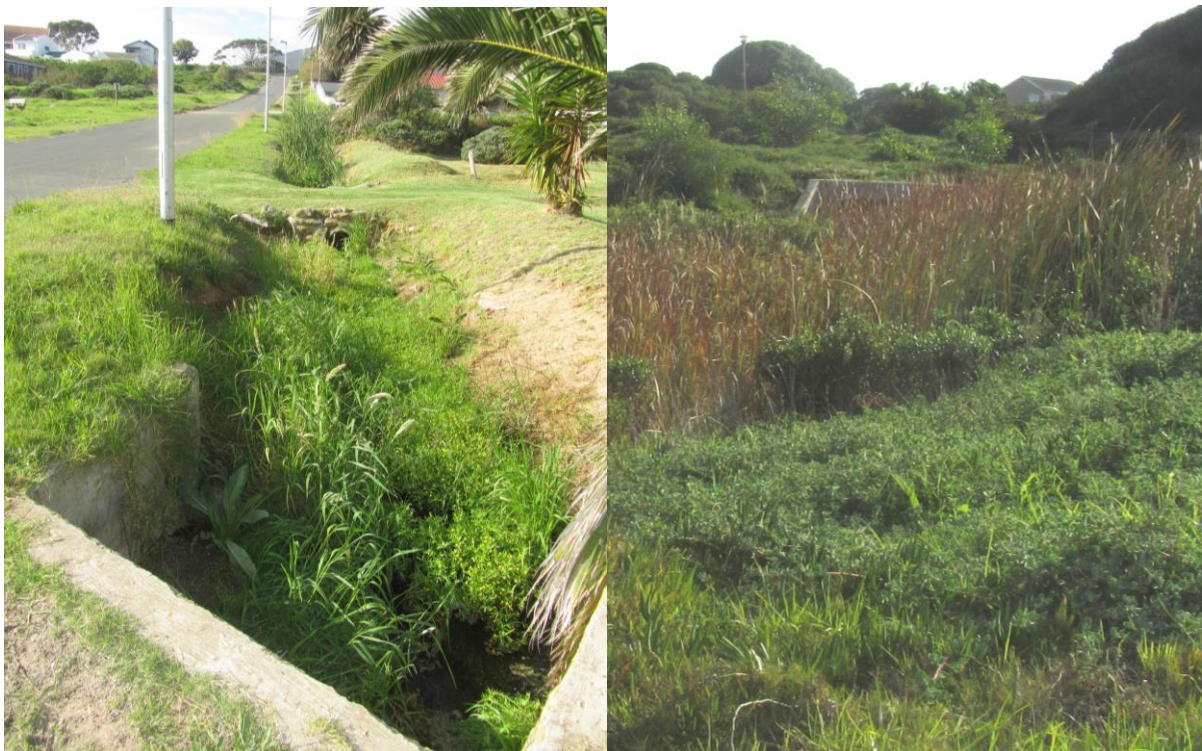
Plate 5. View of the stormwater canal draining into Paddavlei along Vlei Street (left) and the stormwater pipe that installed in the lower Paddavlei

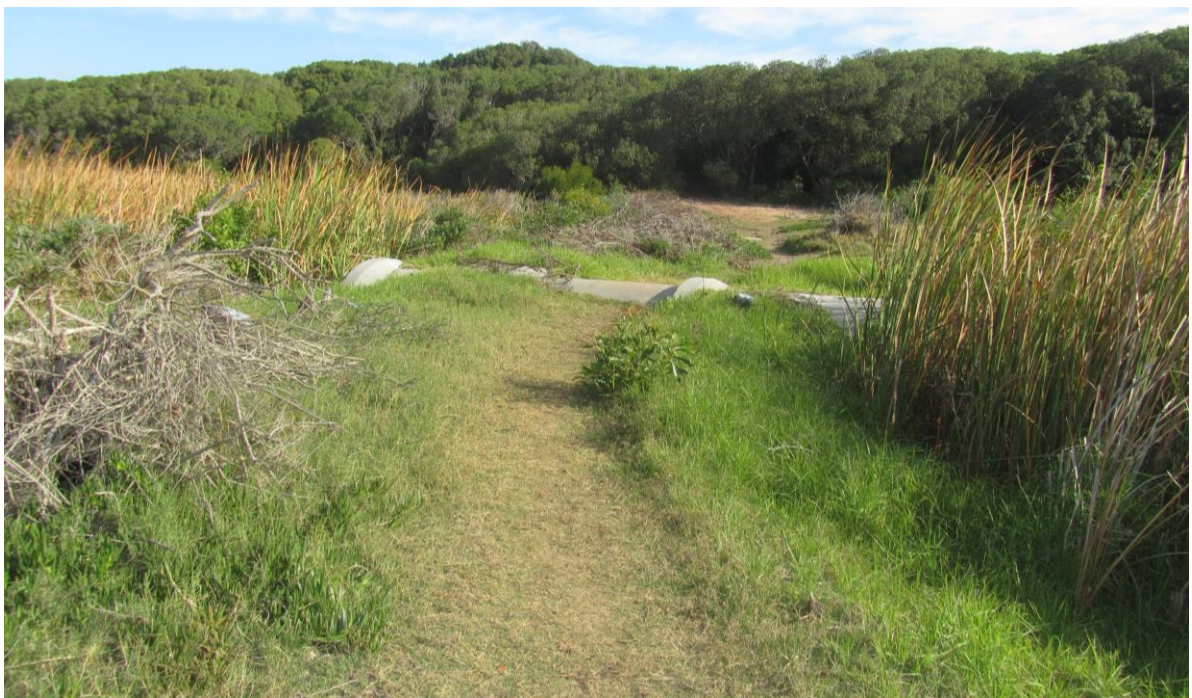
**Plate 11. Photograph of the pipe culvert and embankment that separates the core vlei area from the lower section**

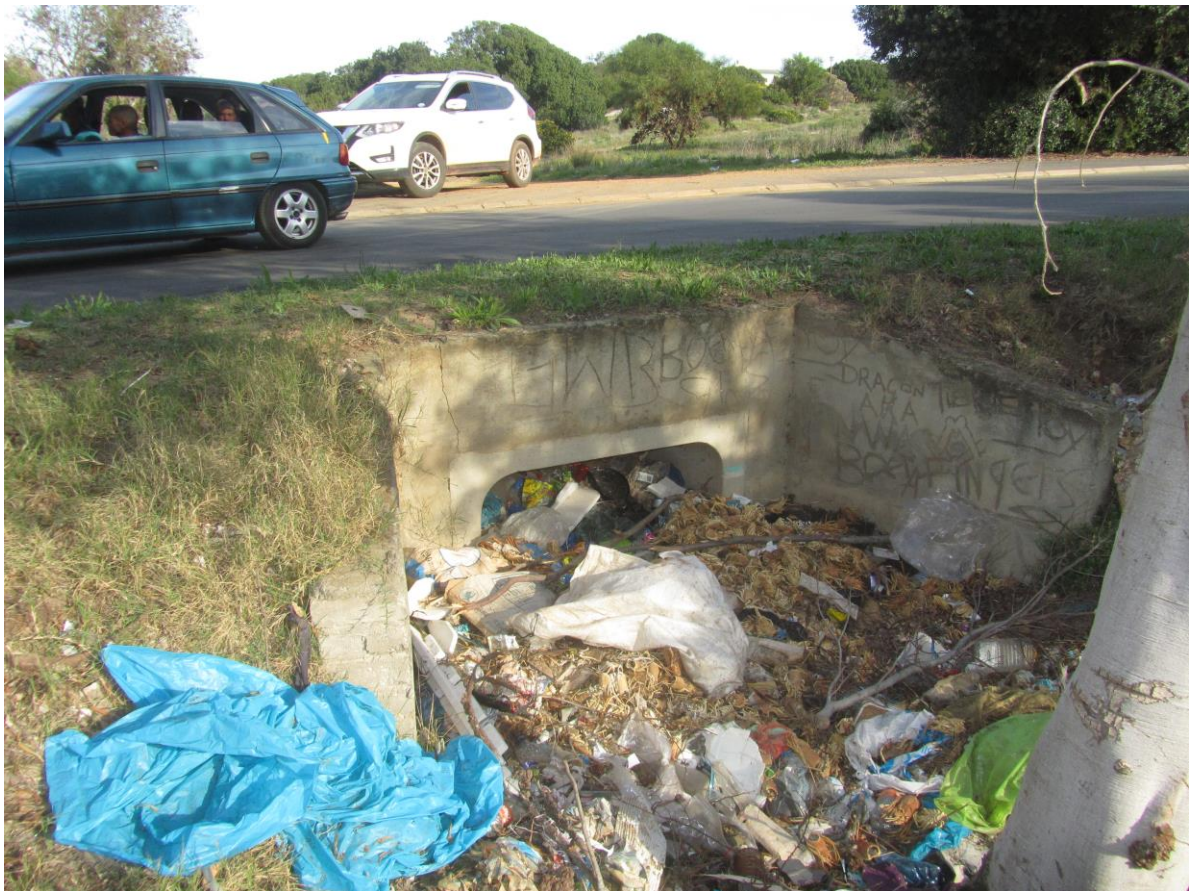
**Plate 13. Photograph of the culvert at George Viljoen Street, filled with litter**
