**AGENDA of the  
Portfolio Committee : Investment & Infrastructure  
2 August 2023  
(Also the agenda for the Mayoral Committee Meeting : 16 August 2023)**

**2.  
OVERSTRAND MUNICIPALITY: NERSA FINDINGS FROM THE COMPLIANCE  
AUDITS CONDUCTED**

**SU Muller  
4 July 2023**

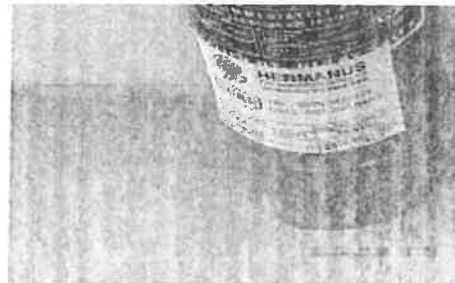
Fire extinguisher serviced in May 2022.

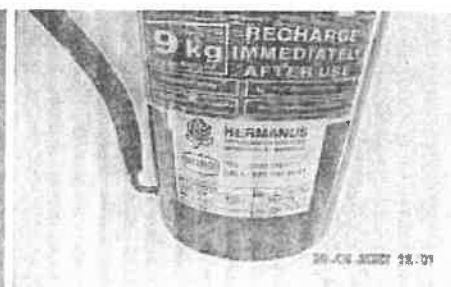
Fire extinguisher serviced in February 2022.
