*Public Participation document:*

**GANSBAAI**

Overstrand Heritage Landscape Group:

Prepared for the

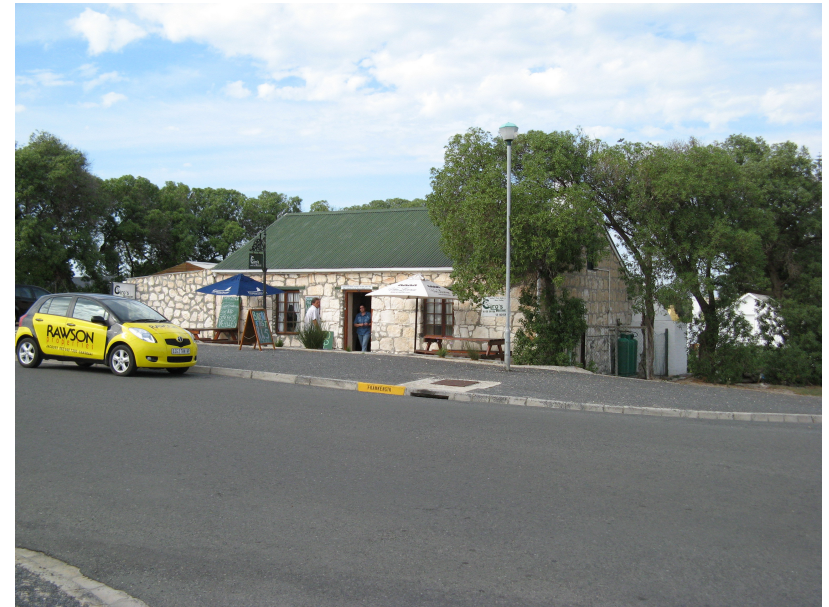
Constraints and Opportunities: Deterioration of calcrete in the absence of lime plaster  
Removal of mature milkwoods

Fairly in tact cottage with mock rustication. Windows have been enlarged.  
Materials: Coursed calcrete rubble walls, corrugated iron roof  
Associated landscape features: Mature milkwood trees

**Heritage Management Recommendations:**

Ongoing repair and maintenance  
Formal protection in terms of zoning scheme regulations (Grade 3B)

- Conserve
- Remedial action to enhance
- HWC permit of approval required for any demolition, alteration or change in planning status

- Retain historical fabric (predominantly building exterior)

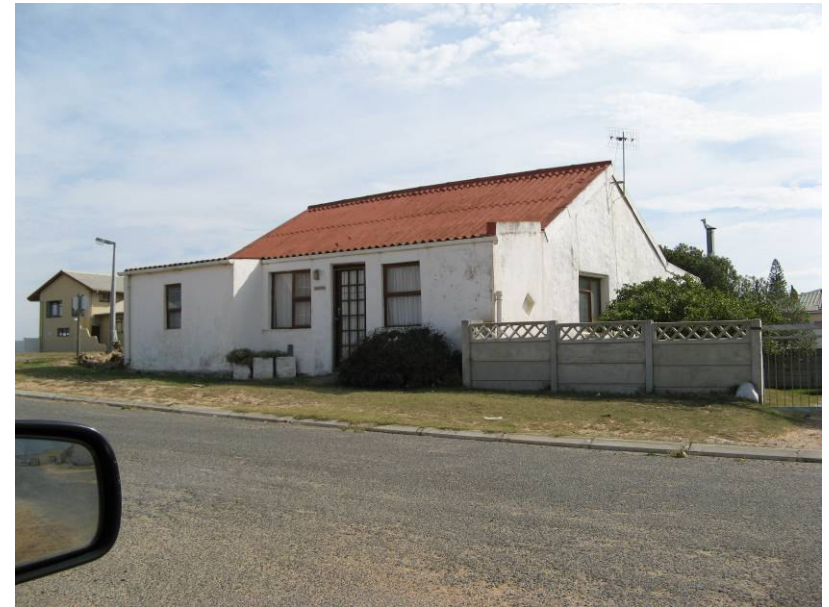
Cottage, Verandah, stoep room. Has Victorian style pointing and rustication  
Materials: Coursed calcrete rubble walls, corrugated iron roof  
Associated landscape features:

Heritage Management Recommendations:

Ongoing repair and maintenance  
Formal protection in terms of zoning scheme regulations (Grade 3C)

- Conserve wherever possible
- Retain historical fabric wherever possible (exterior only)
- Conserve and enhance contribution to overall character and streetscape (predominantly public/private interface)
- HWC permit of approval required for any demolition, alteration or change in planning status
- Demolition only to be considered if appropriate adaptive reuses cannot be established

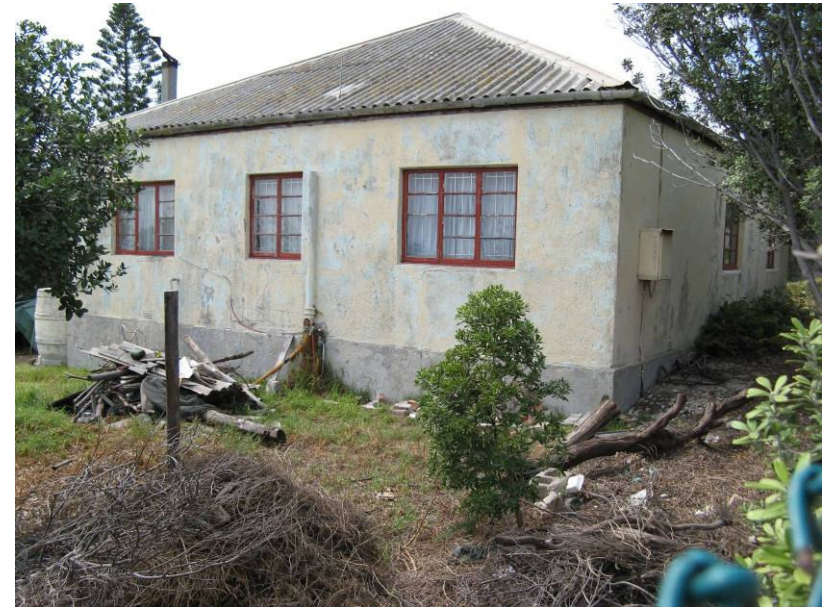
Cottage, altered. Burnt down. Original mud brick and mortar clearly visible in the interior walls.  
Materials: Coursed calcrete rubble; corrugated iron  
Associated landscape features:

Cottage burnt down and subsequently given approval for demolition.

Heritage Management Recommendations:

Ongoing repair and maintenance  
Formal protection in terms of zoning scheme regulations (Grade 3C)

- Conserve wherever possible
- Retain historical fabric wherever possible (exterior only)
- Conserve and enhance contribution to overall character and streetscape (predominantly public/private interface)
- HWC permit of approval required for any demolition, alteration or change in planning status
- Demolition only to be considered if appropriate adaptive reuses cannot be established
