Public Participation document:

HAWSTON

Overstrand Heritage Landscape Group:

June 2009

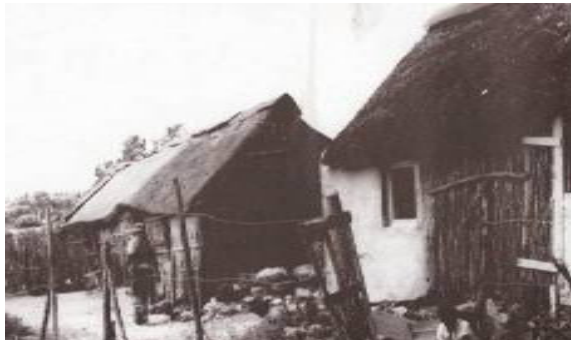
Figure 1: *Palehuise* in Hawston photographed by Fransen in 1963 (In Fransen 2006). Structures no longer exist

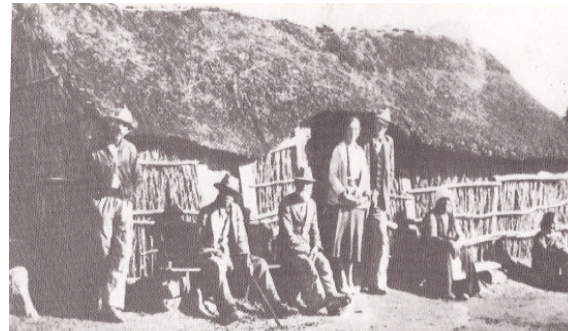
Figure 2: Hawston *palehuis* (In Walton 1995; Hermanus Old Harbour Museum). The structure no longer exists

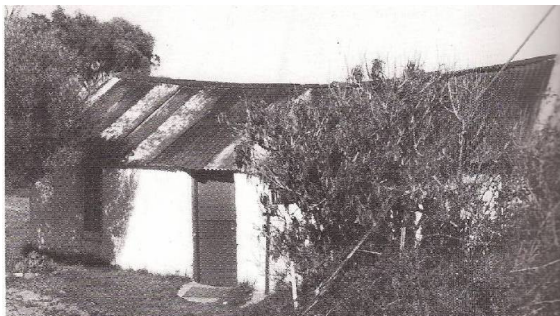
Figure 3: A fisherman's cottage (originally a *palehuis*), Hawston (In Walton 1995, Andre Pretorius 1994). The structure still exists, although one side has collapsed (see Erf 91)

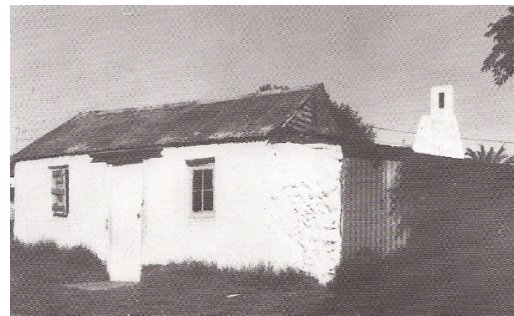
Figure 4: A fisherman's cottage (*palehuis*), Hawston. Corrugated iron kitchen on right added later (In Walton 1995, Andre Pretorius 1994). The structure no longer exists.

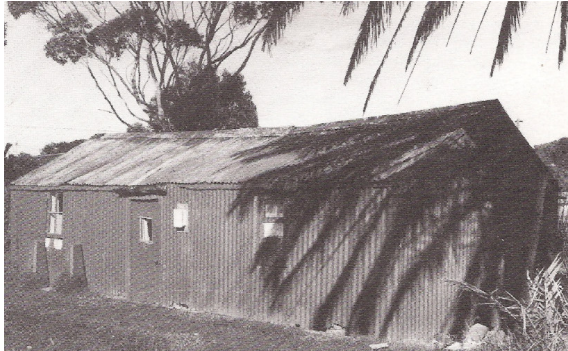
Figure 5: A corrugated iron cottage, Hawston (In Walton 1995, Andre Pretorius 1994). The structure no longer exists.

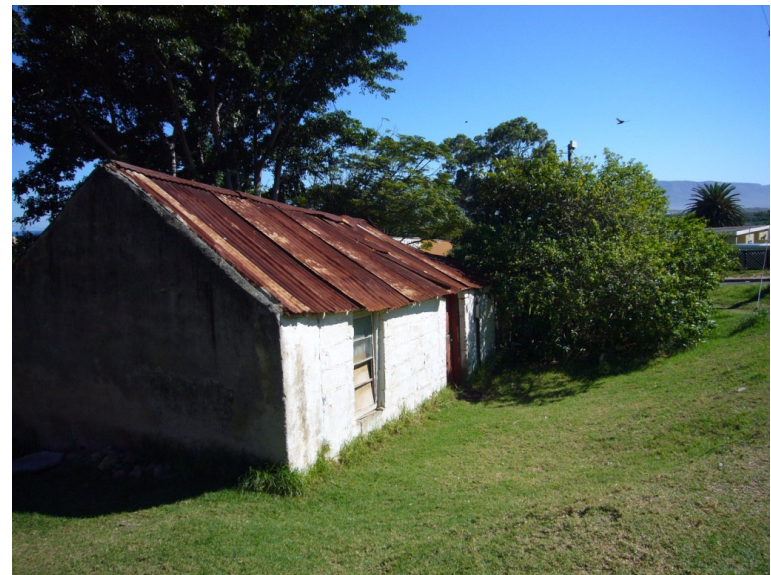
Site name: Hawston Palehuis Type of resource: Building
Location: 3419 AC: 34 23' 39.19" S, 19 8' .21" E Google Earth 2009
Erf/Farm : 91/
Address: Plein Str Hawston

3 bay cottage with pitched roof. Plastered sparretjies: corrugated iron (originally thatch). Parapet gable ends. Narrow vertically proportioned window openings rather than typical square openings. A photograph of this building taken by Andre Pretorius in 1994 appears in Walton (1995). The caption reads: A fisherman's cottage (originally a palehuis), Hawston. The one end wall of this building has now collapsed. **Materials:** Brick: corrugated iron
Associated landscape features:

Significance: Also ability to demonstrate late 19th/early 20th century settlement in Middleveld-South and the role of Hawston as a fishing village
Historical-architectural value as the last known remaining example of a palehuisie, a type of cottage unique to Hawston. Ability to demonstrate the unique construction of a palehuis.
Very poor condition and unlikely to be retained in the short term. At least the building should be properly recorded before disappearing.

Constraints and Opportunities: Condition is very poor
Adaptive reuse potential
Tourism potential

Ongoing repair and maintenance

Formal protection in terms of zoning scheme regulations (Grade 3A)

- Conserve
- Remedial action to enhance significance
- Minimal intervention
- Interpretation
- HWC permit of approval required for any demolition, alteration or change in planning status

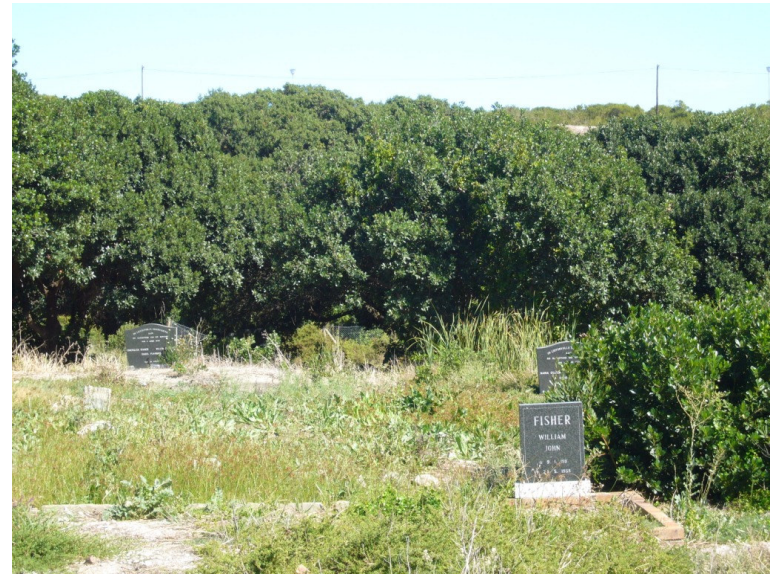
Most of the persons buried here were coloured residents of Hawston including victims of the flu epidemic. In use until 1993 (Maree 2004).

Constraints and Opportunities: Disturbance of graves being caused by tree roots.

Urgent repair and maintenance

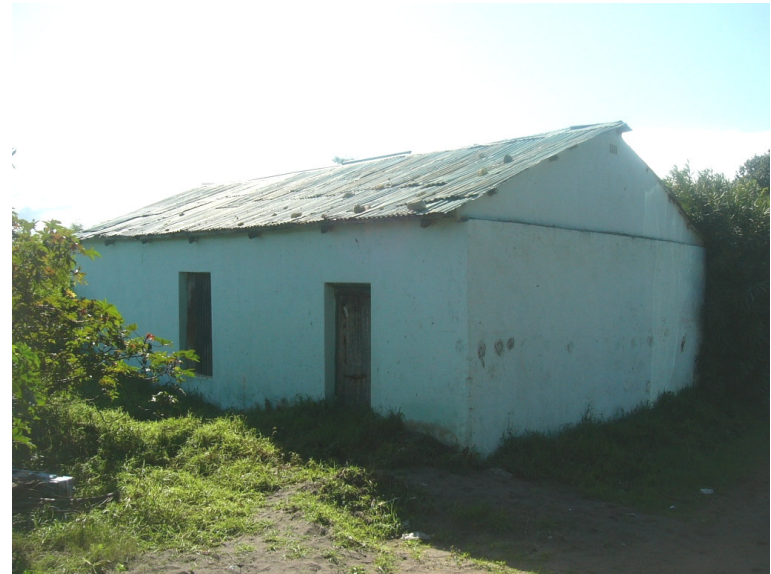
In 1932 a Griqua community settled in Middlevlei and developed vegetable gardens on the 'long plots'. A Griqua Church was held in this stone cottage (Maree 2004).

Ongoing repair and maintenance
Formal protection in terms of zoning scheme regulations (Grade 3B)

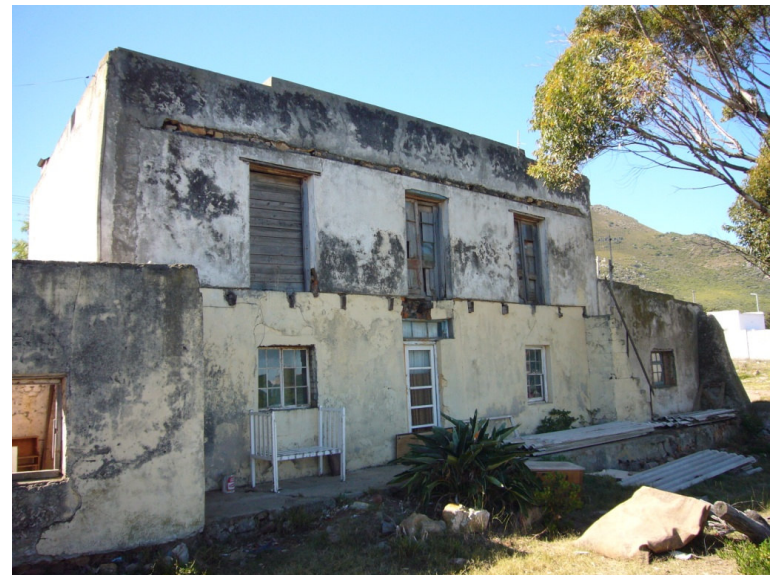
Situated on Church Street with the front of the house facing west overlooking the Paddavlei.
Associated with a long rectangular "garden plot" characteristic of the Middlevlei.
Double storey, 3 bays with mono-pitched parapet roof. Brick: corrugated iron.
Combination 3x2 sashes and steel replacements. Upper storey has vertically divided doors Originally had a double storey veranda. New front door. Raised stoep.
Materials: Brick: corrugated iron.
Associated landscape features: Associated mature trees

Historical architectural value as the only example of a 19th/ early 20th C double storey dwelling in the region.

Constraints and Opportunities: Local conservation efforts should prioritize this building. Deterioration is a major threat. At least the building should be properly recorded.

Ongoing repair and maintenance

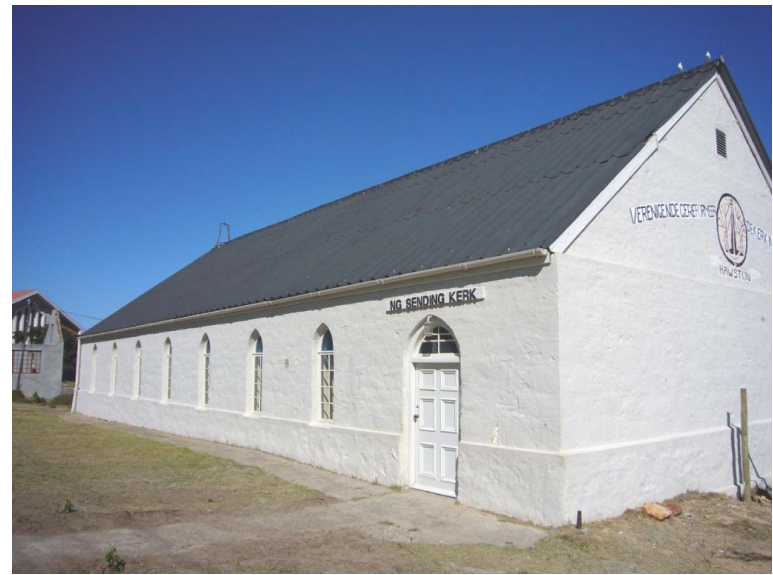
Significance: Associational value in terms of the role of the NG Mission Church in history of Hawston and its community.
Historical architectural value in terms of possessing fairly intact period features and being an example of modest church architecture.
Experiential qualities in terms of the long open views overlooking the Paddavlei.
Situated on the main historical access route thorough town (Church Str) with positive street relationship

Constraints and Opportunities: Pastorie in ruinous state. Needs documentation

Heritage Management Recommendations: Ongoing repair and maintenance
Formal protection in terms of zoning scheme regulations (Grade 3B)

- Conserve
- Remedial action to enhance
- HWC permit of approval required for any demolition, alteration or change in planning status
- Retain historical fabric (predominantly building exterior)

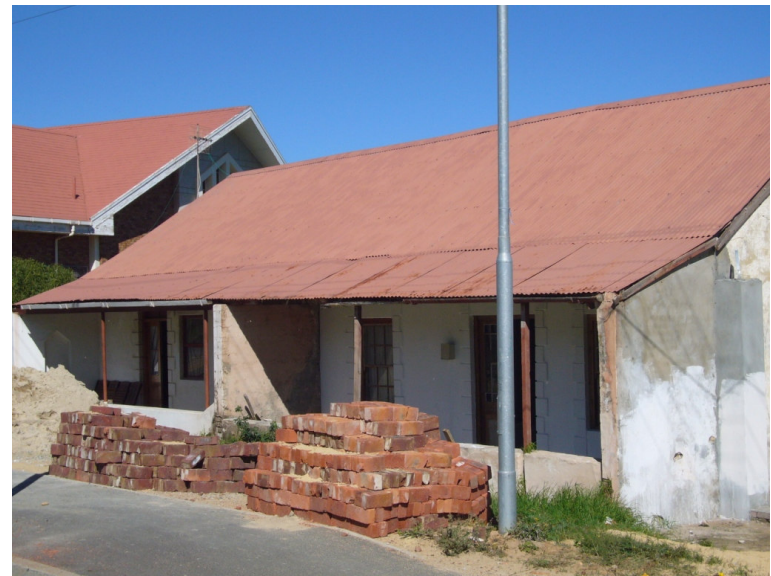
Semi-detached 3 bay cottages with pitched roof and front veranda. 3x2 sashes and panelled front door. Veranda has plain iron supports and low balustrade. When inspected the site in August 2008, the house was undergoing renovations.
Materials: Brick: corrugated iron.
Associated landscape features:

Ongoing repair and maintenance

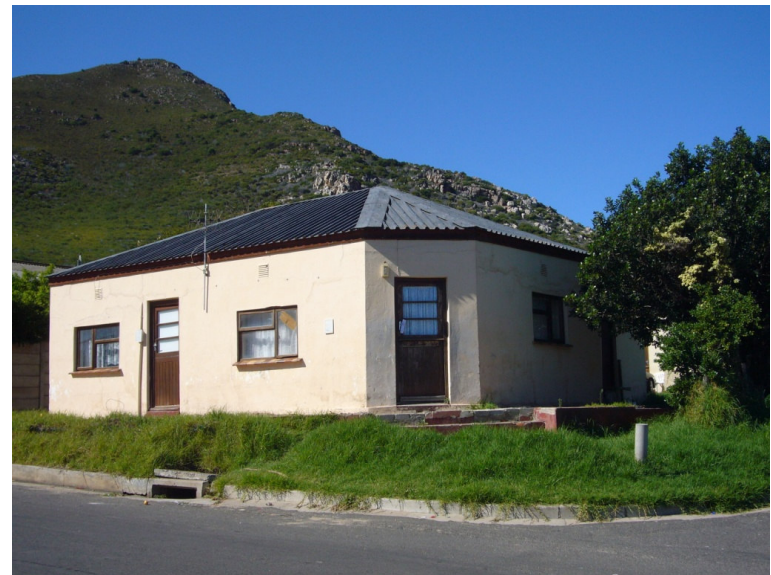
3 bay cottage with pitched roof.
Original joinery has been replaced with meranti. Modern veranda addition.
Materials: Brick/stone: asbestos
Associated landscape features:

Ongoing repair and maintenance
Formal protection in terms of zoning scheme regulations (Grade 3C)

- Conserve wherever possible
- Retain historical fabric wherever possible (exterior only)

- Conserve and enhance contribution to overall character and streetscape (predominantly public/private interface)
- HWC permit of approval required for any demolition, alteration or change in planning status
- Demolition only to be considered if appropriate adaptive reuses cannot be established

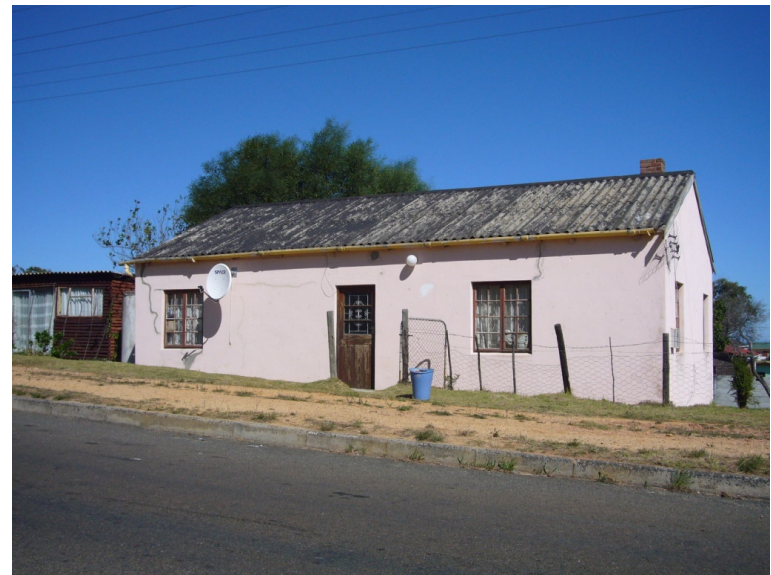
3 bay cottage with pitch roof. Corrugated iron roof with straight parapet gable ends. Later veranda addition has masonry columns and solid balustrade. Original joinery has been replaced. Situated on Strand Street, the main historical link between the village and the coastline.
Materials: Brick: corrugated iron
Associated landscape features:

Heritage Management Recommendations:
Ongoing repair and maintenance

Formal protection in terms of zoning scheme regulations (Grade 3C)

- Conserve wherever possible
- Retain historical fabric wherever possible (exterior only)
- Conserve and enhance contribution to overall character and streetscape (predominantly public/private interface)
- HWC permit of approval required for any demolition, alteration or change in planning status
- Demolition only to be considered if appropriate adaptive reuses cannot be established

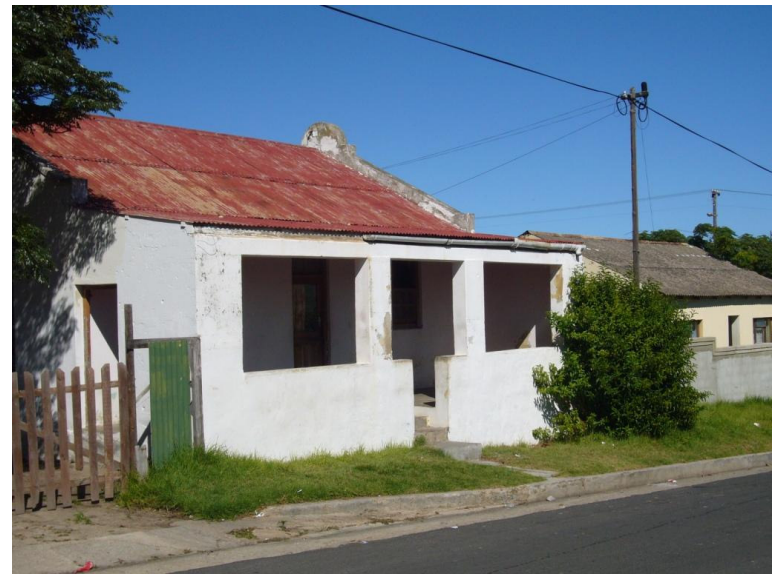
3 bay cottage with pitched corrugated iron roof. Later veranda addition, partially enclosed. Original joinery has been replaced.
Situated on Strand Street, the main historical link between the village and the coastline.

Materials: Brick: corrugated iron
Associated landscape features:

Heritage Management Recommendations:
Ongoing repair and maintenance

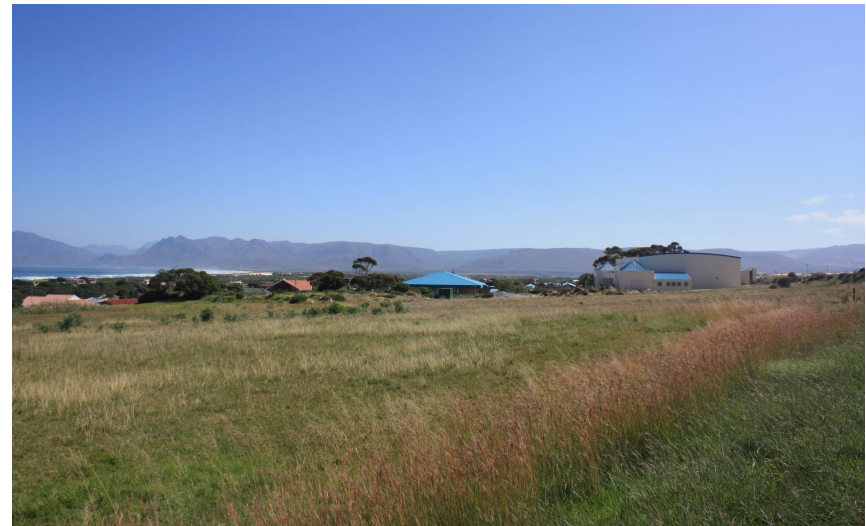
'Die Kraal' & associated well/spring became important gathering place. Fish sold to hawkers from Genadendal, Caledon and Somerset West. Popular camping spot, particularly for weekend fishermen. Site of annual Anglican Church bazaar (Maree 2004). Was in use from the 1930s onwards

Ongoing repair and maintenance

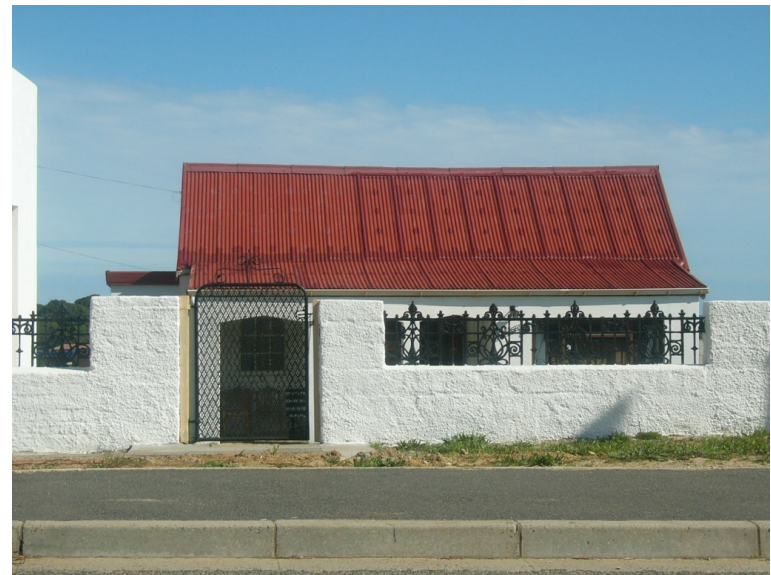
3 bay cottage with pitched roof and front veranda. Asbestos roof with straight parapet gable ends.
Original joinery has been replaced. Later lean-to side addition.

Ongoing repair and maintenance
Formal protection in terms of zoning scheme regulations (Grade 3C)

- Conserve wherever possible
- Retain historical fabric wherever possible (exterior only)
- Conserve and enhance contribution to overall character and streetscape (predominantly public/private interface)
- HWC permit of approval required for any demolition, alteration or change in planning status
- Demolition only to be considered if appropriate adaptive reuses cannot be established

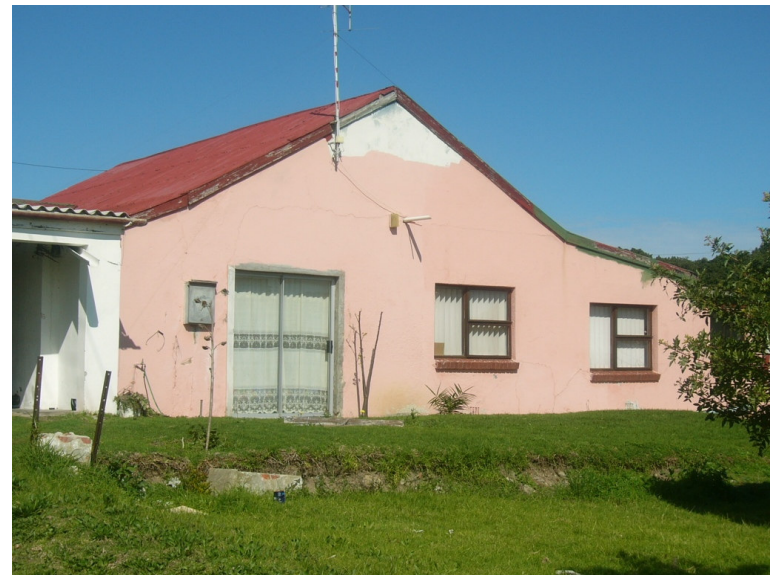
Ungraded
3 bay cottage with pitched roof. Original joinery has been replaced.
Materials: Brick/stone: asbestos
Associated landscape features:

According to Doris Maree (pers com 2008), a corrugated iron house was located on the adjacent site.

Heritage Management Recommendations:
Formal protection in terms of zoning scheme regulations (Ungraded)

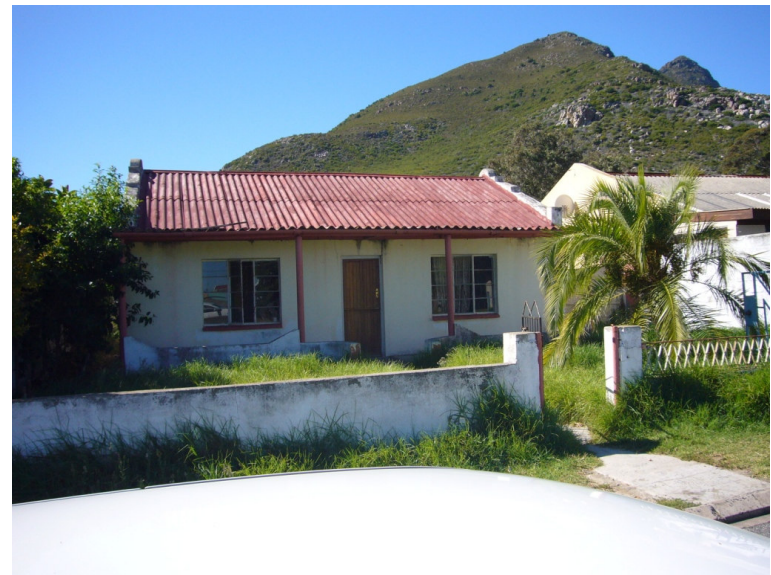
Ungraded
3 bay cottage with pitched roof. Asbestos roof with curvilinear parapet gable ends.
Original joinery has been replaced.
Materials: Brick: asbestos
Associated landscape features:

Heritage Management Recommendations:
Formal protection in terms of zoning scheme regulations (Ungraded)

- Demolition could be considered
- HWC permit of approval required for demolition

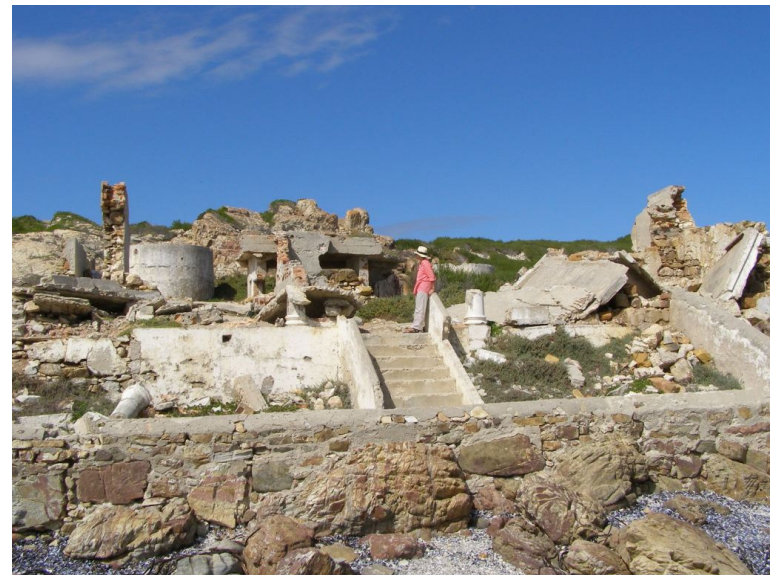
Ruins of a house situated on the rocks at the edge of beach.
19th century fabric: walls of shale with mud mortar and lime plaster, most likely built by the van Blommensteins when it was known as Maria's Cottage.
1920s fabric: precast columns, reinforced concrete slabs (photograph circa 1940s shows colonnaded veranda and Cape Revival gables and a collection of loosely arranged extensions and outbuildings to the rear). Most likely built by the Delpors.
Materials:
Associated landscape features:

Significance: Ruinous state does not warrant protection
Some archaeological potential to remaining 19th century fabric

Heritage Management Recommendations:
Formal protection in terms of zoning scheme regulations (Ungraded)

- Demolition could be considered
- HWC permit of approval required for demolition
