**AGENDA of the  
Portfolio Committee : Investment & Infrastructure  
2 August 2023  
(Also the agenda for the Mayoral Committee Meeting : 16 August 2023)**

**2.  
OVERSTRAND MUNICIPALITY: NERSA FINDINGS FROM THE COMPLIANCE  
AUDITS CONDUCTED**

**SU Muller  
4 July 2023**

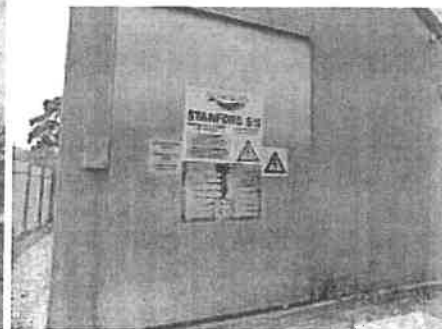
Single line diagram available.
